ASHFIELD LAKE DAM

PHASE I

INSPECTION / EVALUATION REPORT

Dam Name: Ashfield Lake Dam
NID#: MA00523
Owner: Town of Ashfield
Town: Ashfield, Massachusetts
Consultant: Tighe & Bond, Inc.
Date of Inspection: May 18, 2023

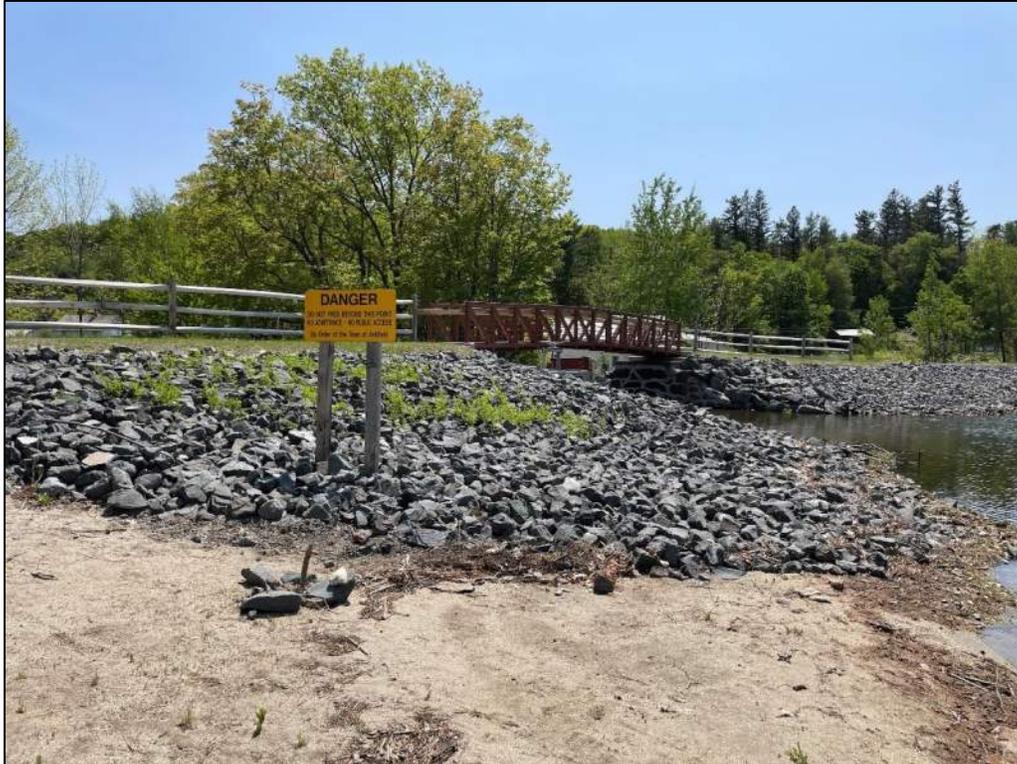
- Some vegetation was observed growing in the voids in between the riprap on the upstream slope. The vegetation appears to be regularly maintained but consists of fast-growing species.

Photo 7 – Upstream slope to the left of the spillway; note some vegetative regrowth in riprap

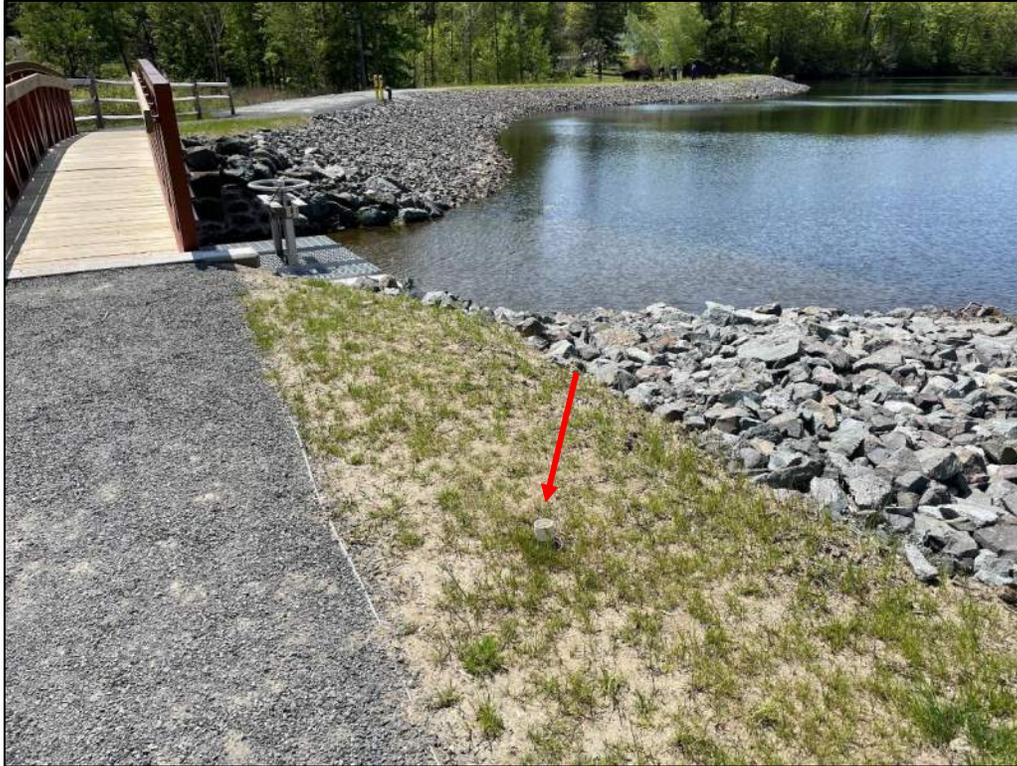
- Instrumentation (Photos 9)
 - There are reported monitoring wells observed during previous inspections but are not believed to be functional.
- Access Roads and Gates (Photos 32, 38, 47, 50)

Photo 9 – Stone footpath approaching spillway footbridge left abutment; arrow points to monitoring well

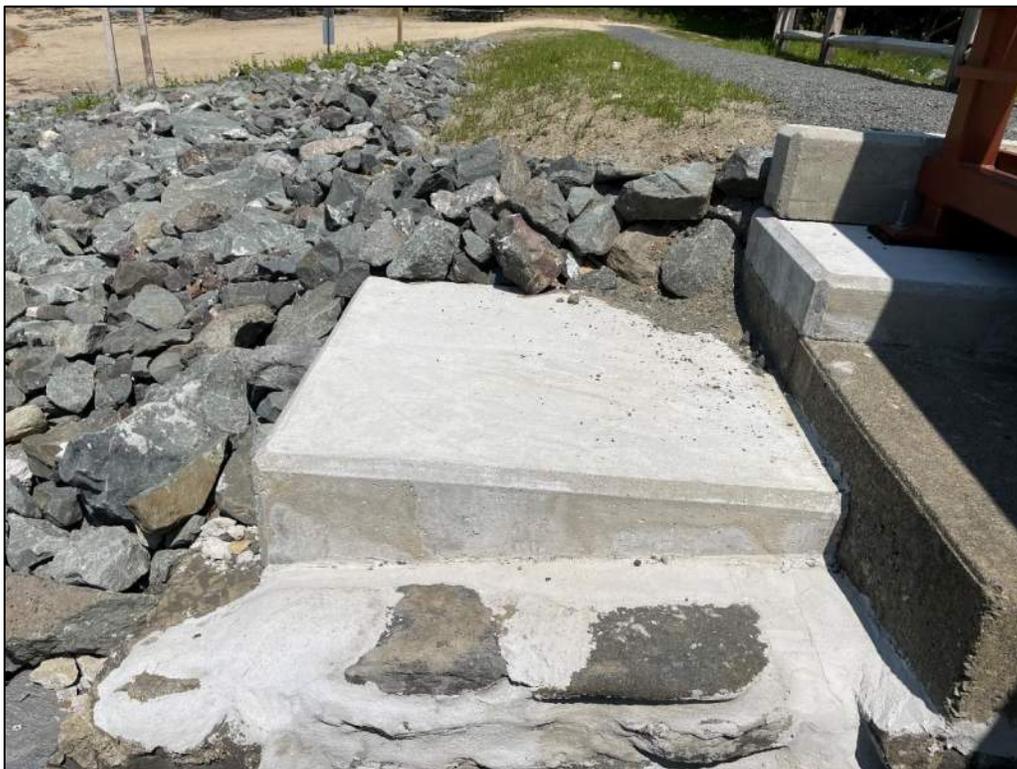
- Minor erosion was observed at the left side of the footbridge, near the spillway operator concrete access pad.
- Sparse vegetation is present in areas along the crest where the grass has not fully revegetated.

Photo 12 – Note minor erosion at concrete pad next to spillway footbridge

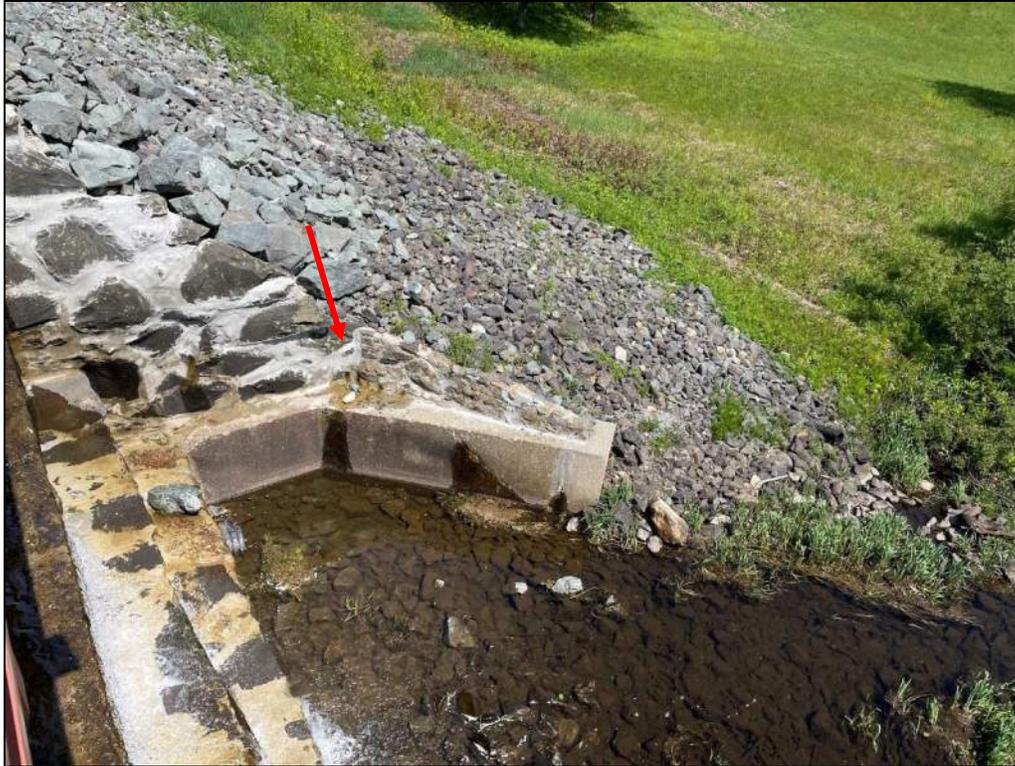
- Minor seepage was observed from the left training wall, including from the masonry and from a concrete footing below the downstream end of the wall.

Photo 17 – Spillway steps and left training wall; note some seepage through downstream training wall

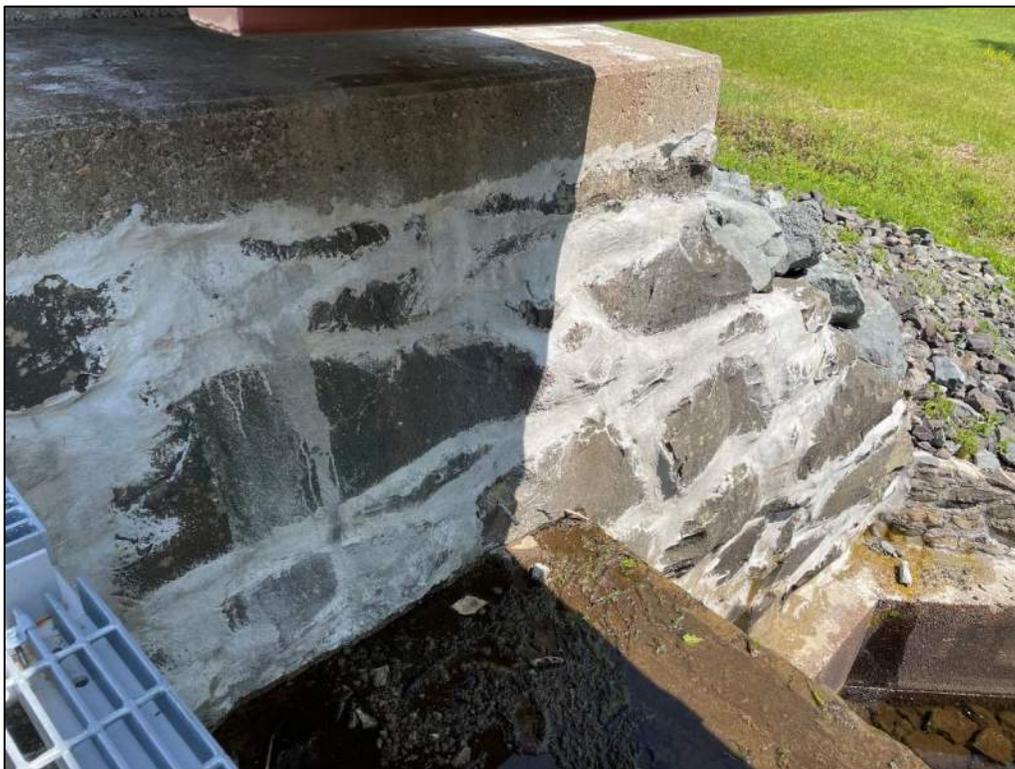
Photo 18 – Close up view of mortar installed to repair cracks in left training wall

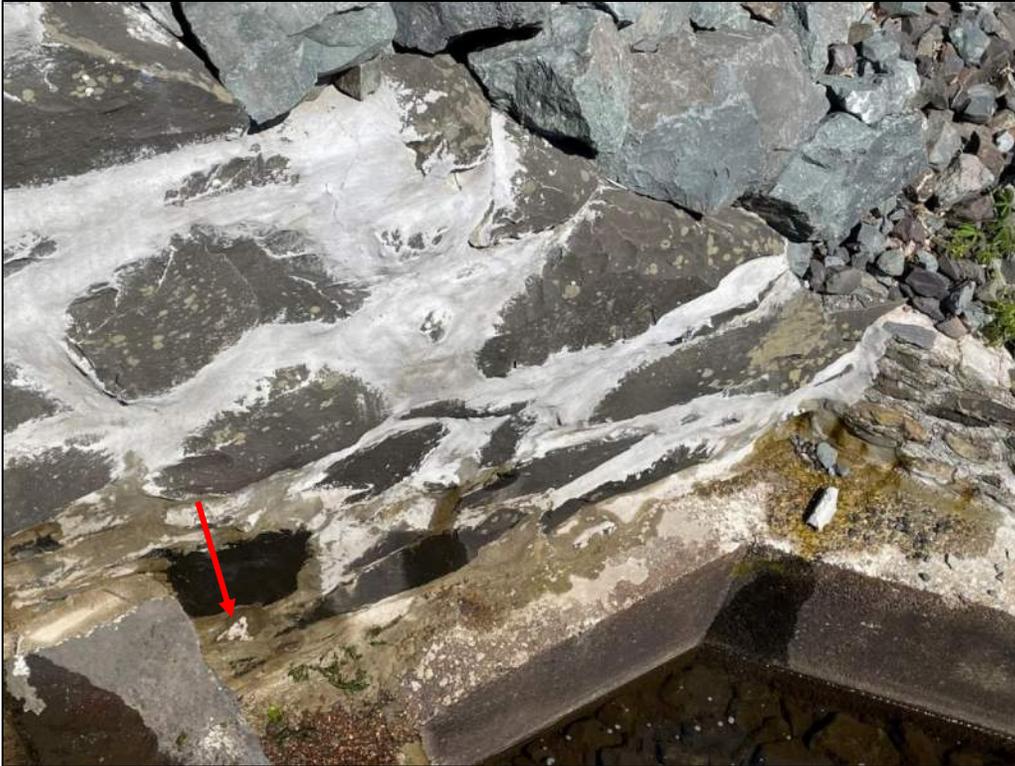
Photo 19 – Closer view of weeping in left downstream training wall; arrow points to previous void repaired during 2022 upgrades

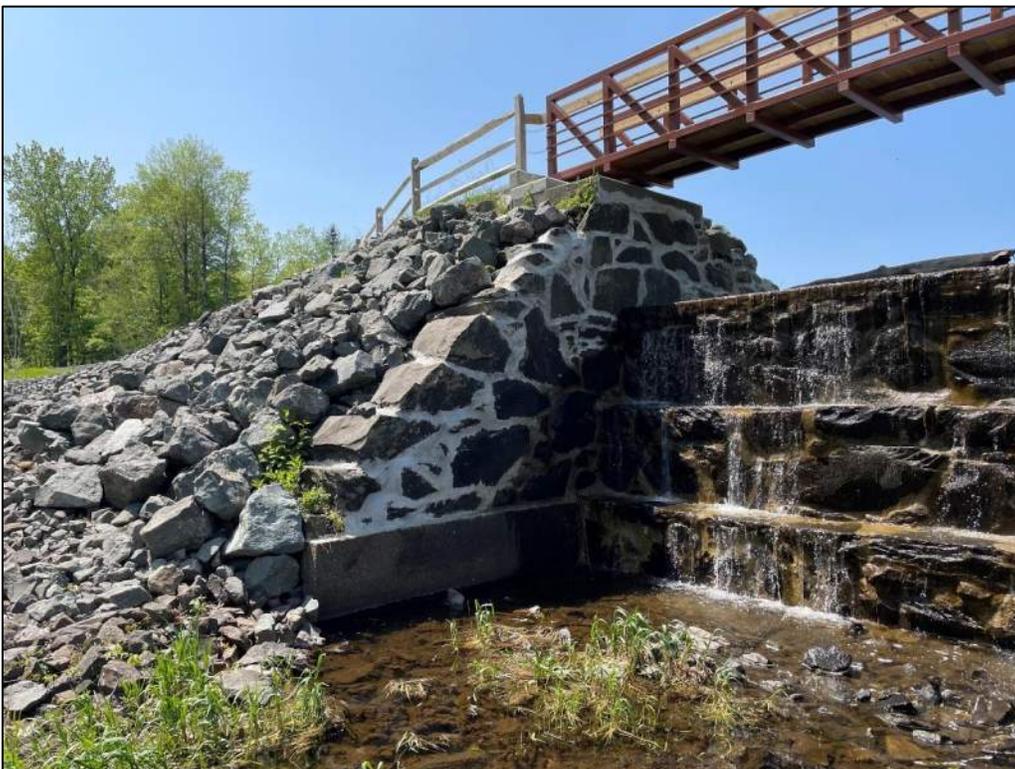
Photo 20 – Right training wall and spillway viewed from downstream; note some vegetative regrowth

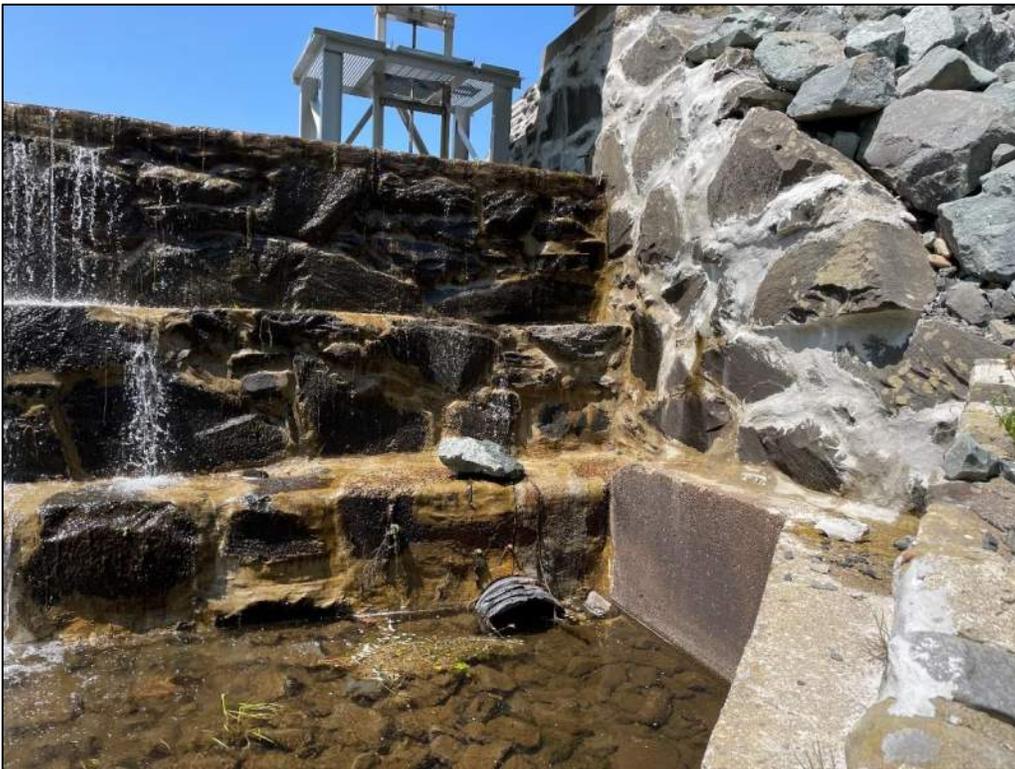
Photo 21 – Downstream spillway and low-level outlet gate operator and outlet pipe; note riprap thrown onto spillway from footbridge

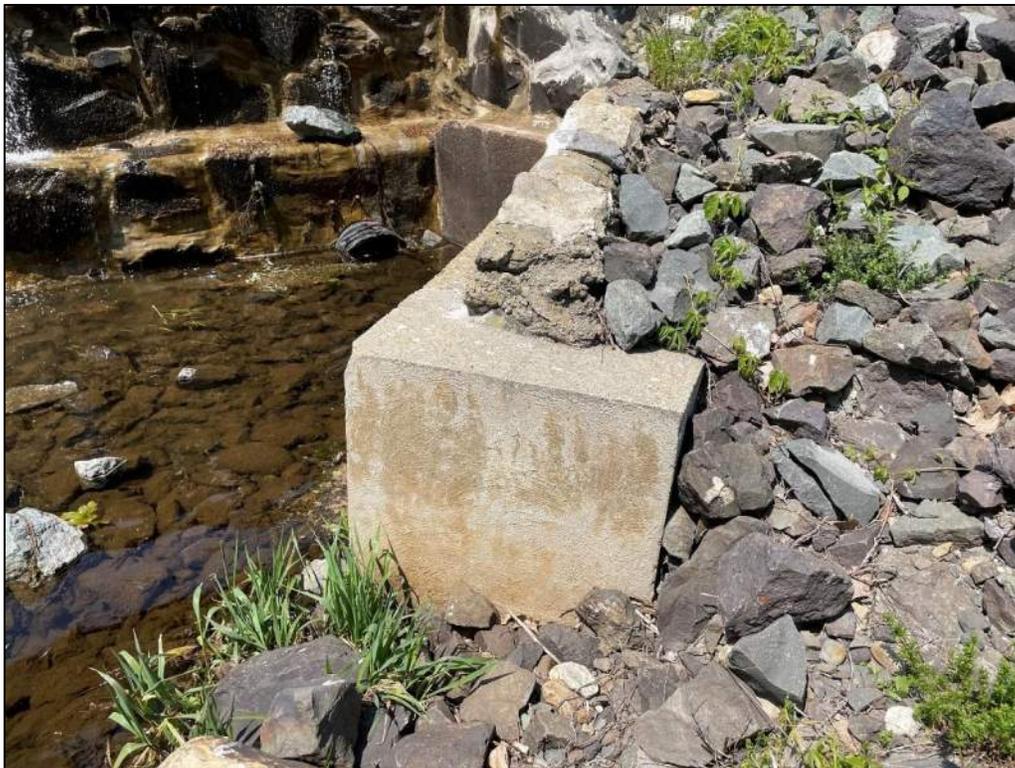
Photo 23 – End of left spillway training wall; note vegetative regrowth

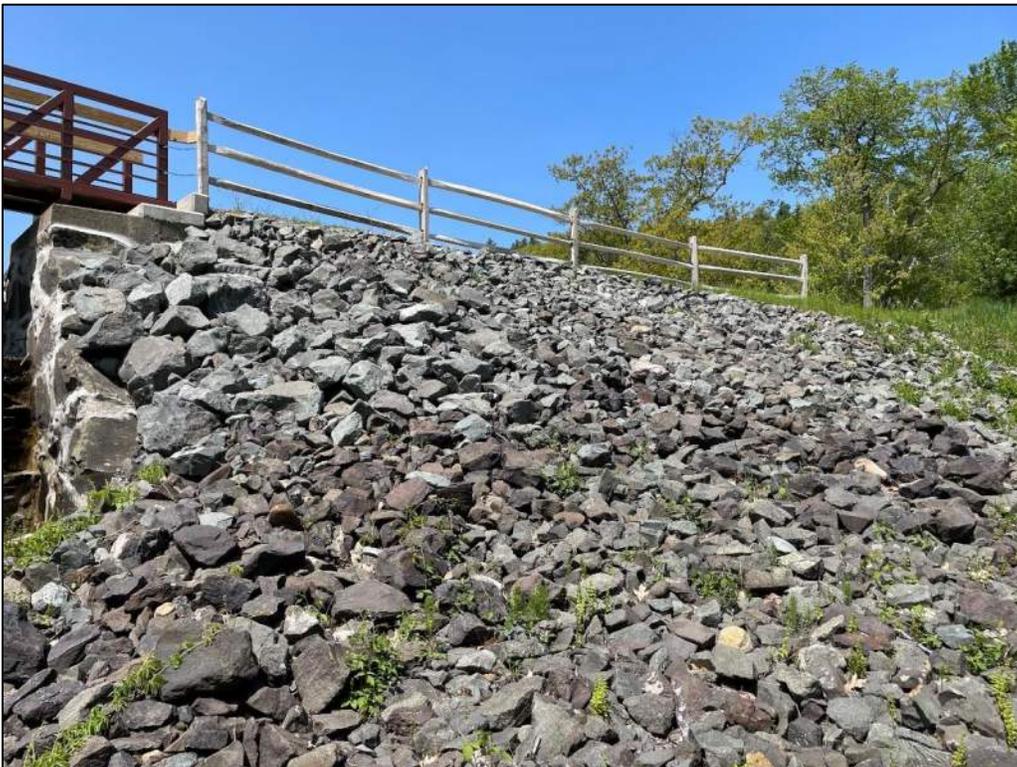
Photo 26- Downstream slope to left of spillway with some vegetative regrowth through riprap

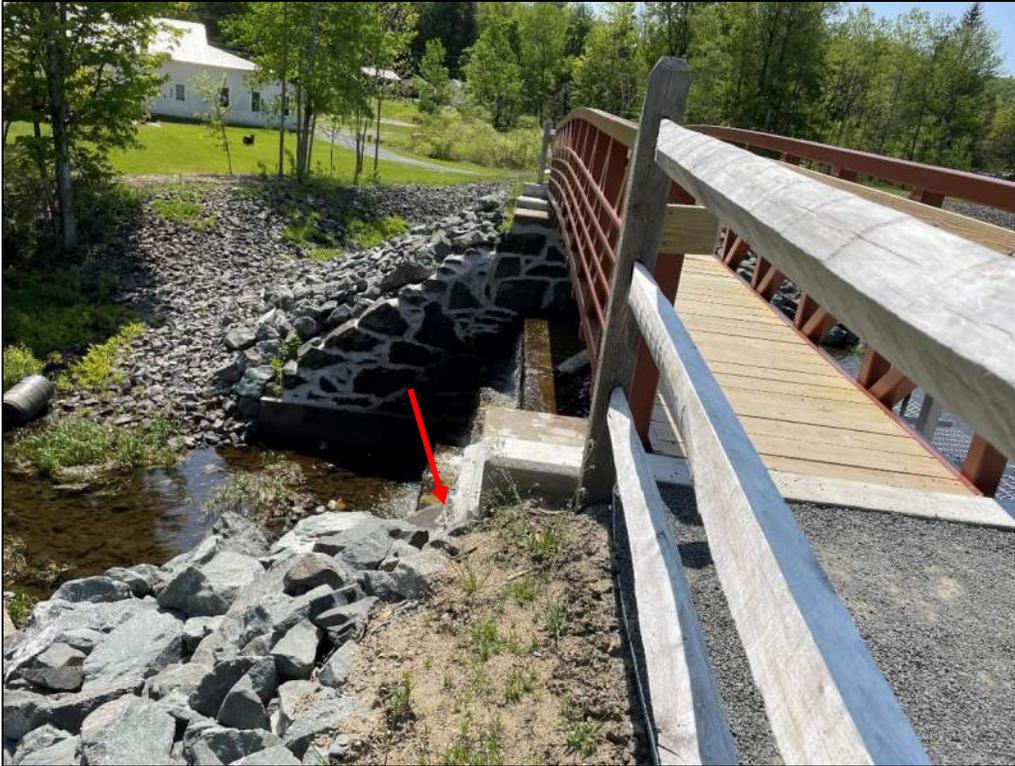
Photo 27- View of right training wall and spillway from left; arrow points to minor erosion

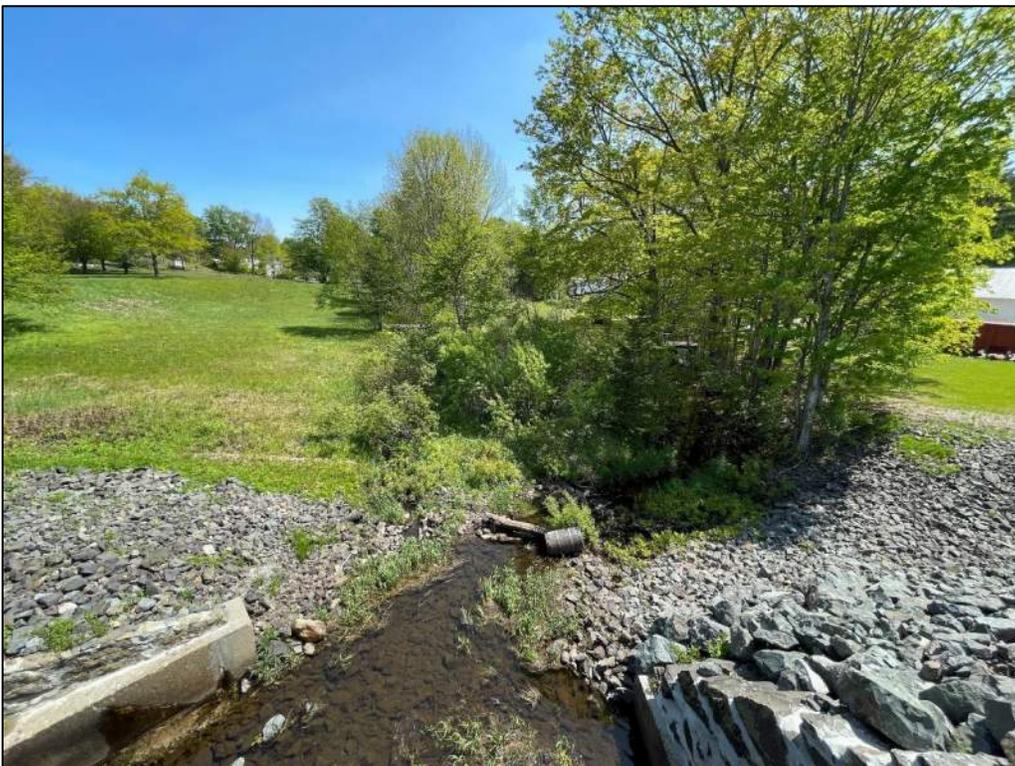
Photo 28 – Downstream area viewed from footbridge; note herbaceous vegetation in the channel and plastic barrel

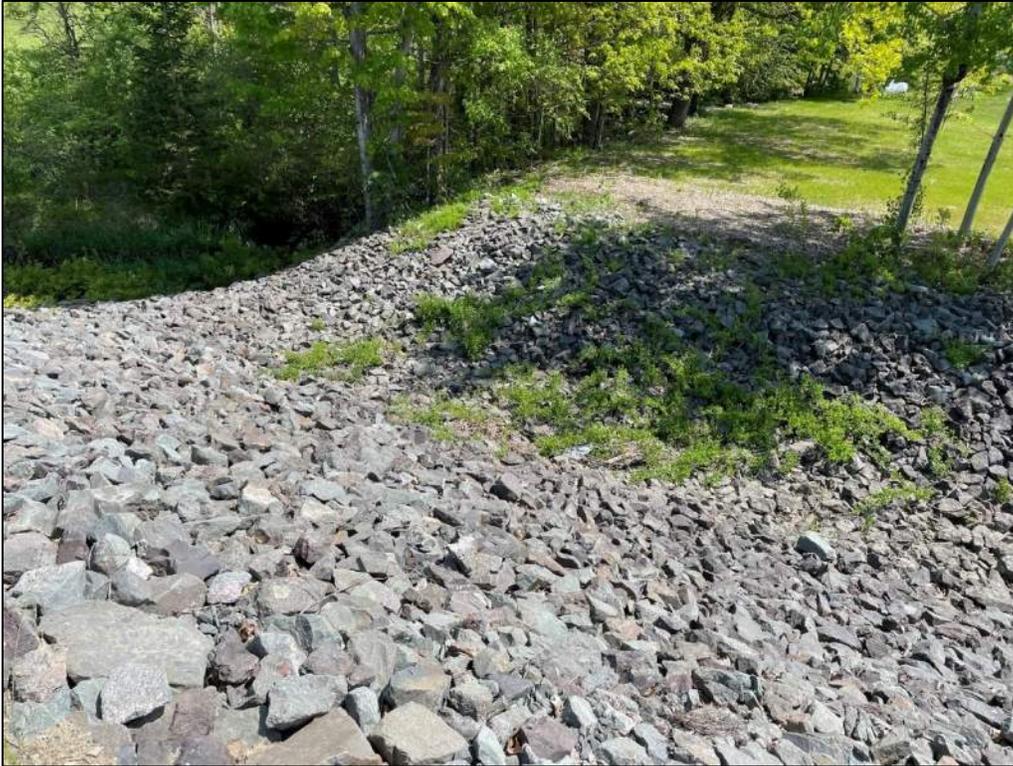
Photo 35 – Downstream slope to the right of the spillway viewed from the dam crest; note vegetative regrowth through riprap

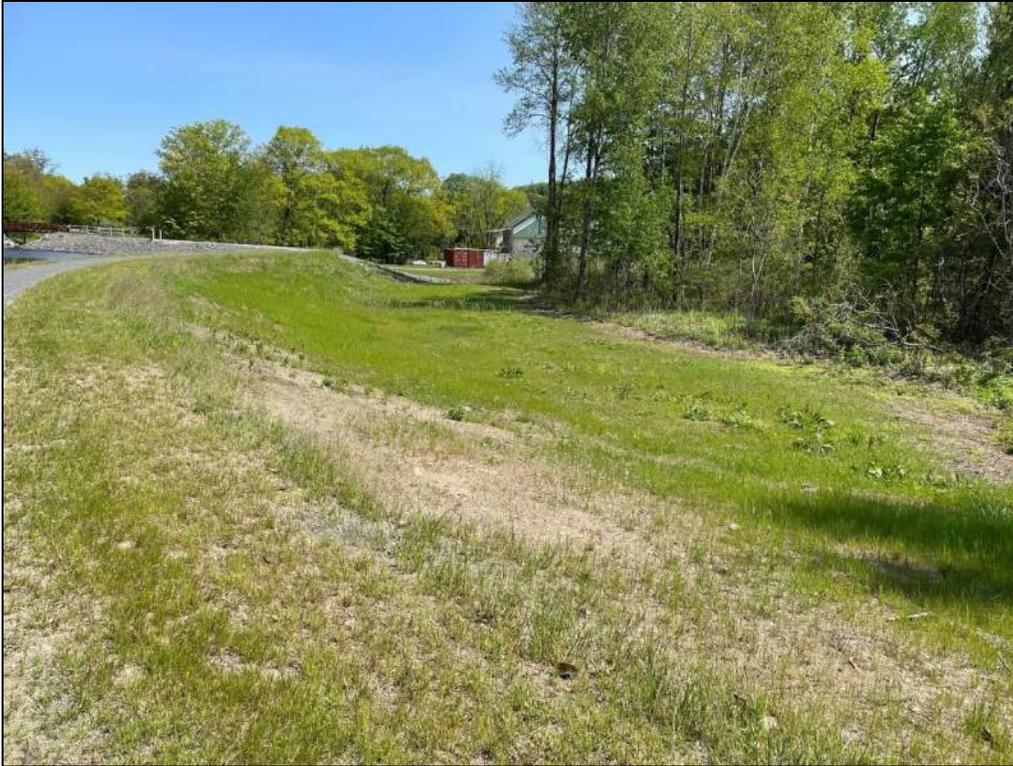
Photo 39 – Downstream slope and toe area; note sparse grass cover

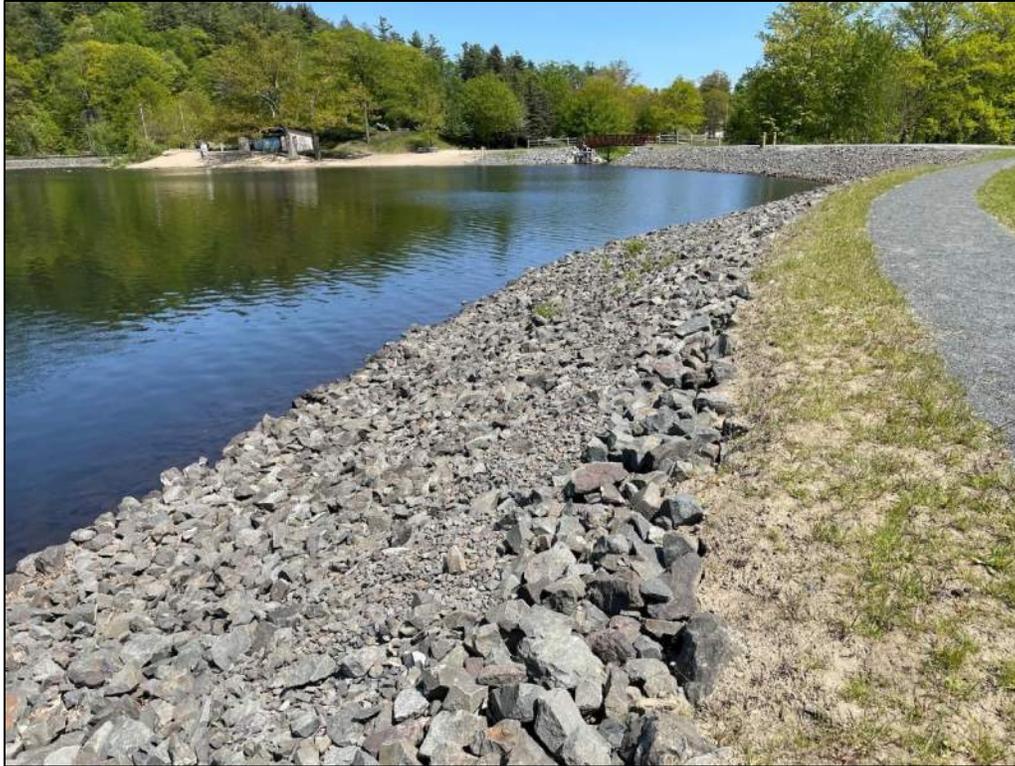
Photo 41 – Upstream slope armored with riprap; note sparse grass cover

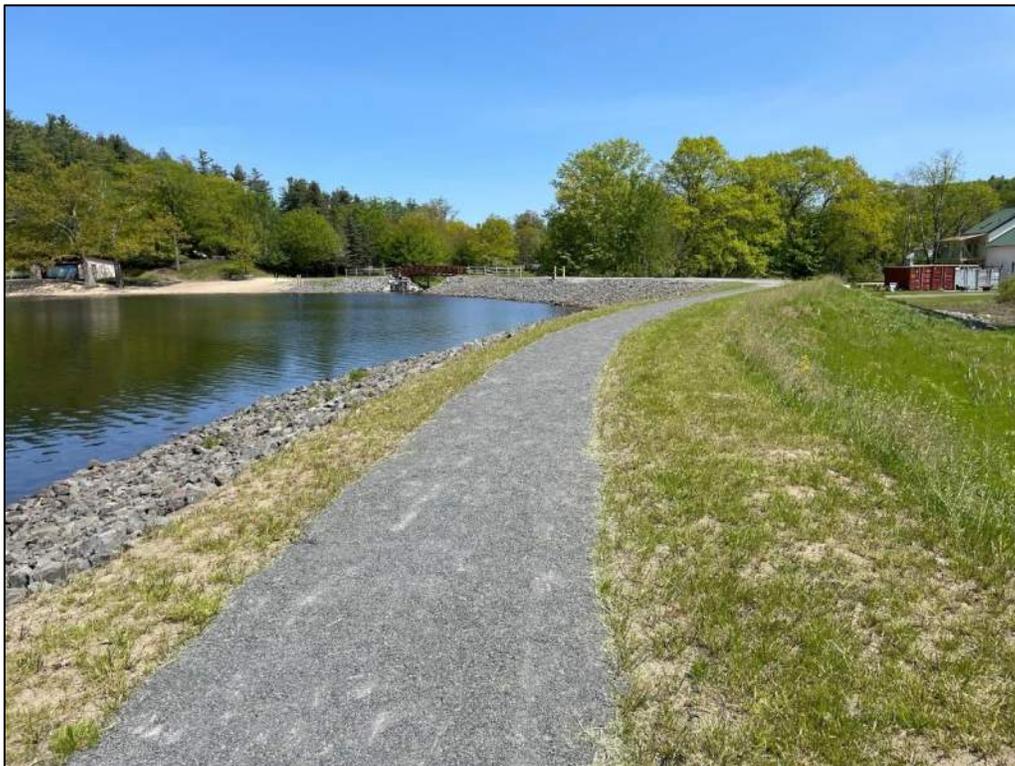
Photo 42 –View along dam crest looking towards spillway and access driveway; note sparse grass cover

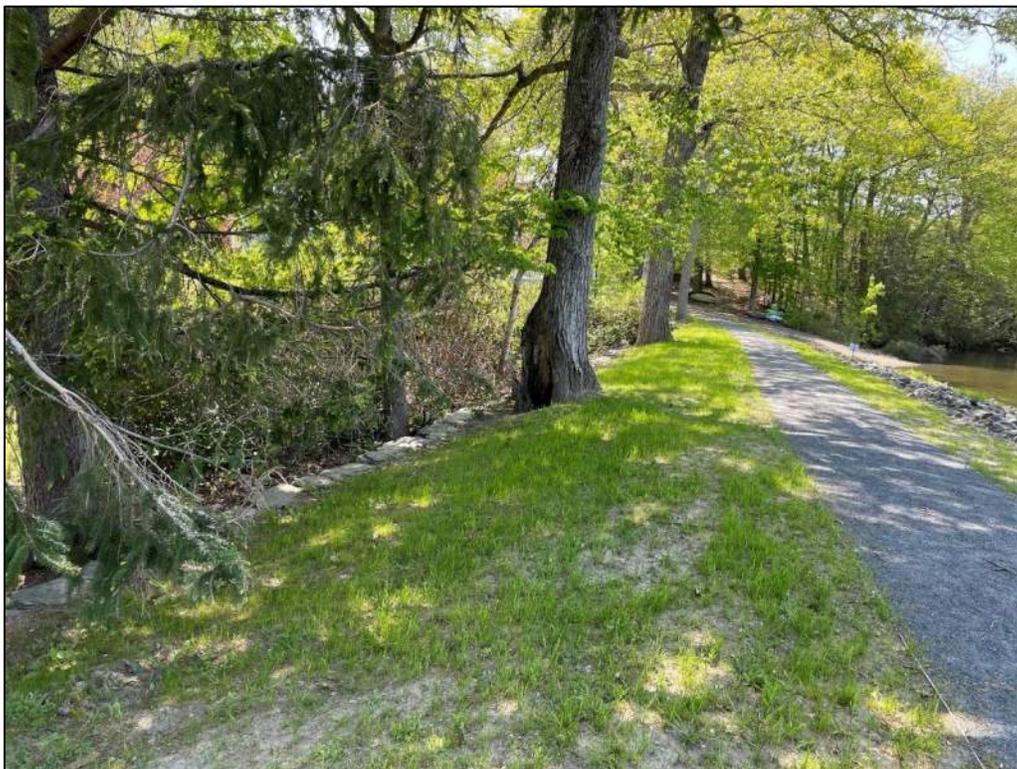
- Three to four large trees and a dense stand of landscape vegetation were present on the downstream slope along the section of masonry wall near the west abutment. Along this segment of embankment, the elevation of the downstream area is at the same or higher elevation than the impoundment normal pool elevation, mitigating the potential impact of the tree roots on the embankment under normal pool conditions. In addition, the Town and abutters have agreed that the health of the trees will be monitored and unhealthy trees removed and not replaced.

Photo 46 – Dam crest near right abutment; note large trees growing on embankment

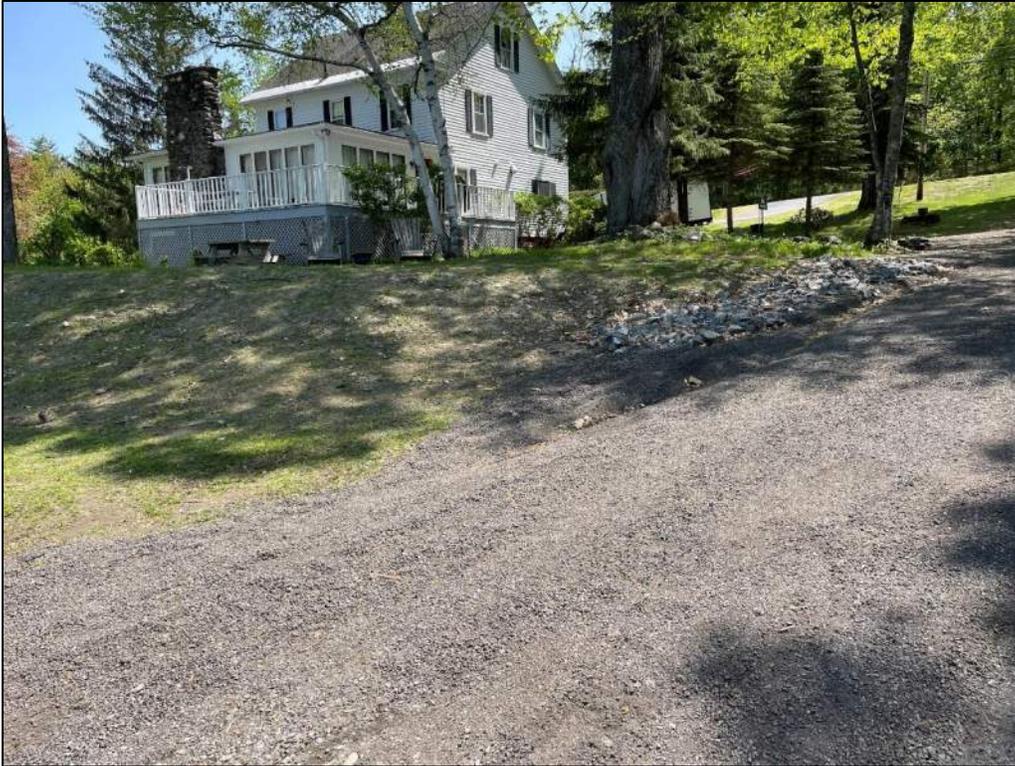
- A bare area is present where the beach blends into the embankment; reseeding of the area was planned following the inspection.
 - In the area immediately adjacent to the west abutment, the dam embankment is protected from erosion by modified rockfill. Minor surface erosion was noted but the erosion was not impacting the dam.

Photo 47 – Boat access drive with rutting and erosion from storm runoff, although dam embankment is protected with modified rockfill

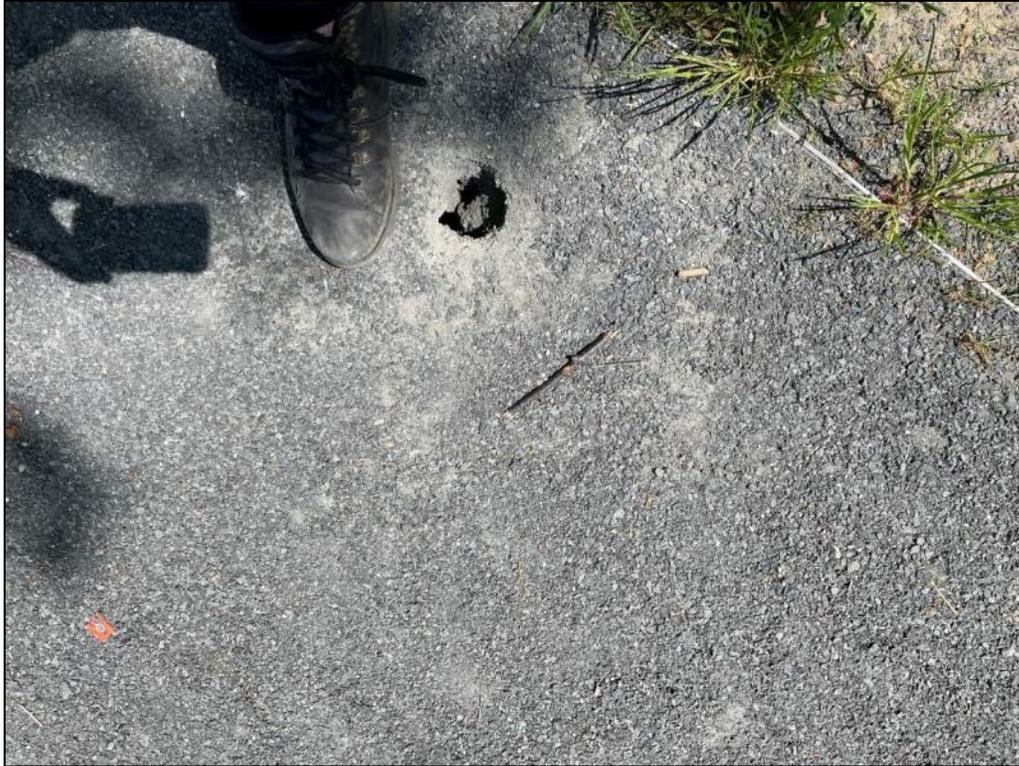
- A small animal burrow was noted on the crest near the west abutment.

Photo 55 – Animal burrow on dam crest near boat ramp

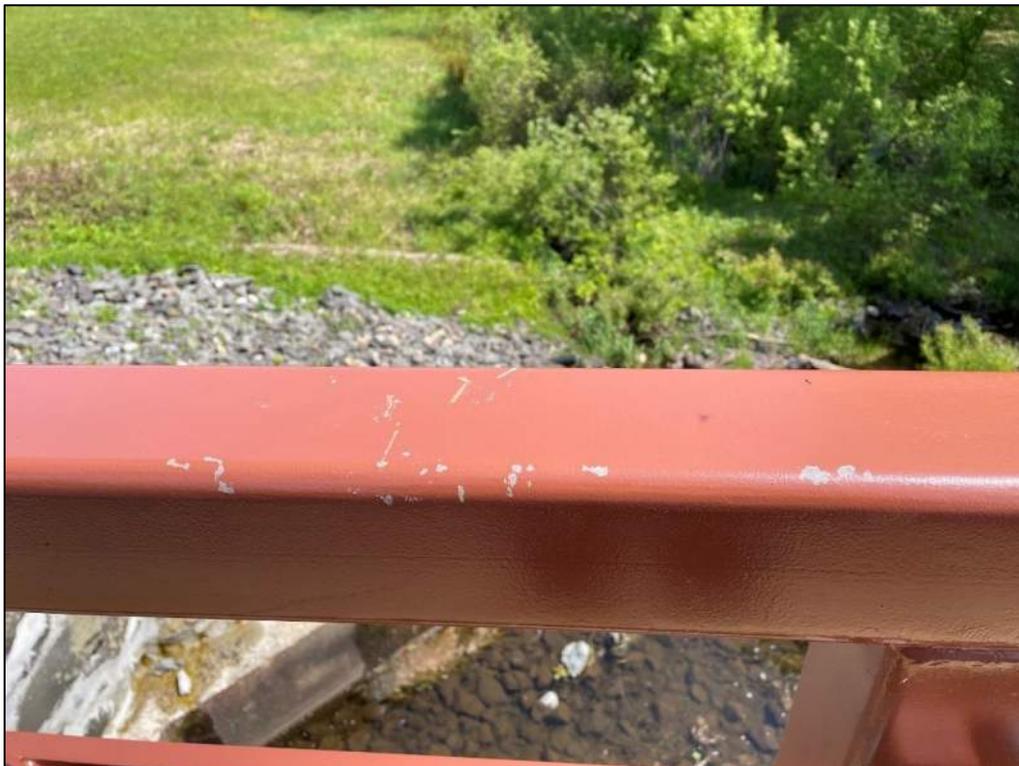
- The steel footbridge was recoated as part of the 2022 rehabilitation and in good condition. An area along the downstream rail had some scratches and paint chipping.

Photo 56 – Paint damaged on footbridge from people throwing riprap onto spillway steps
