STRUCTURES INSPECTION FIELD REPORT

ROUTINE & SPECIAL MEMBER INSPECTION

BR. DEPT. NO.  
A-13-027

Structure A-13-027 (0FP) carries Beldingville Road over the Bear River in the Town of Ashfield (**Sketch 1**). The bridge is a simple single span structure comprised of four (4) steel beams supporting a reinforced concrete deck overlaid with an asphalt wearing surface.

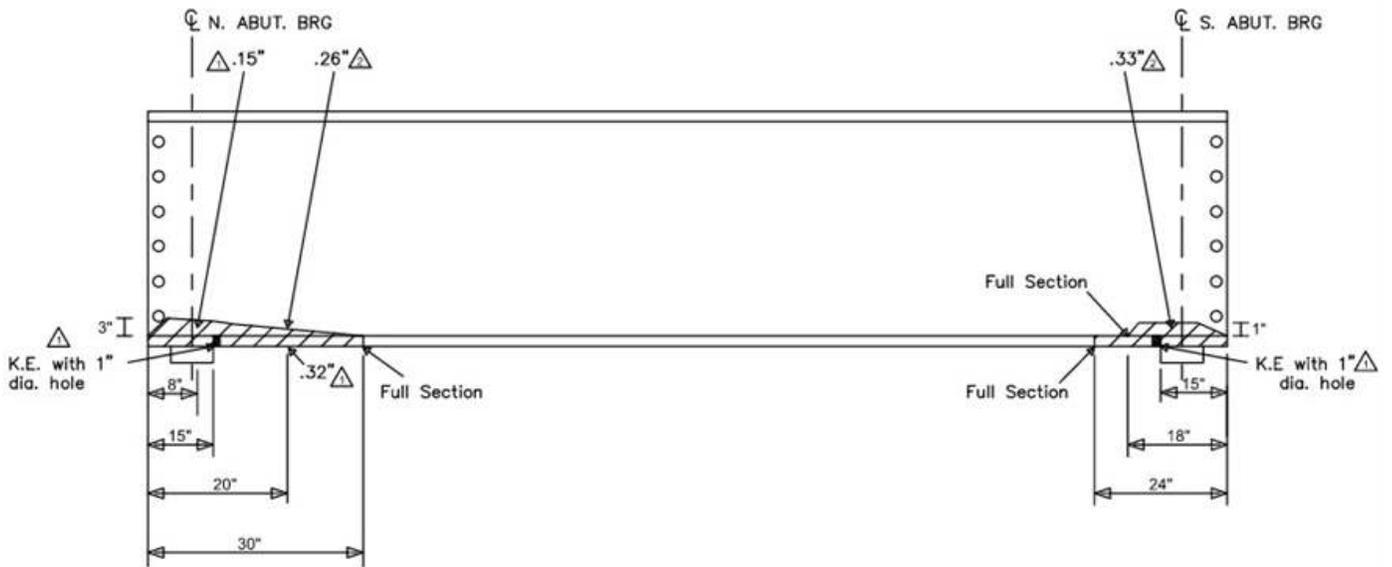
BEAM 1 WEST ELEVATION  
(N.T.S)

- Web and bottom flange near North and South Abutment: Section loss (**Sketch 3 and Photo 11**).

ORG. SECTION = 21" WF 59 ORG. FLANGE = 0.575" ORG. WEB = 0.390"
---

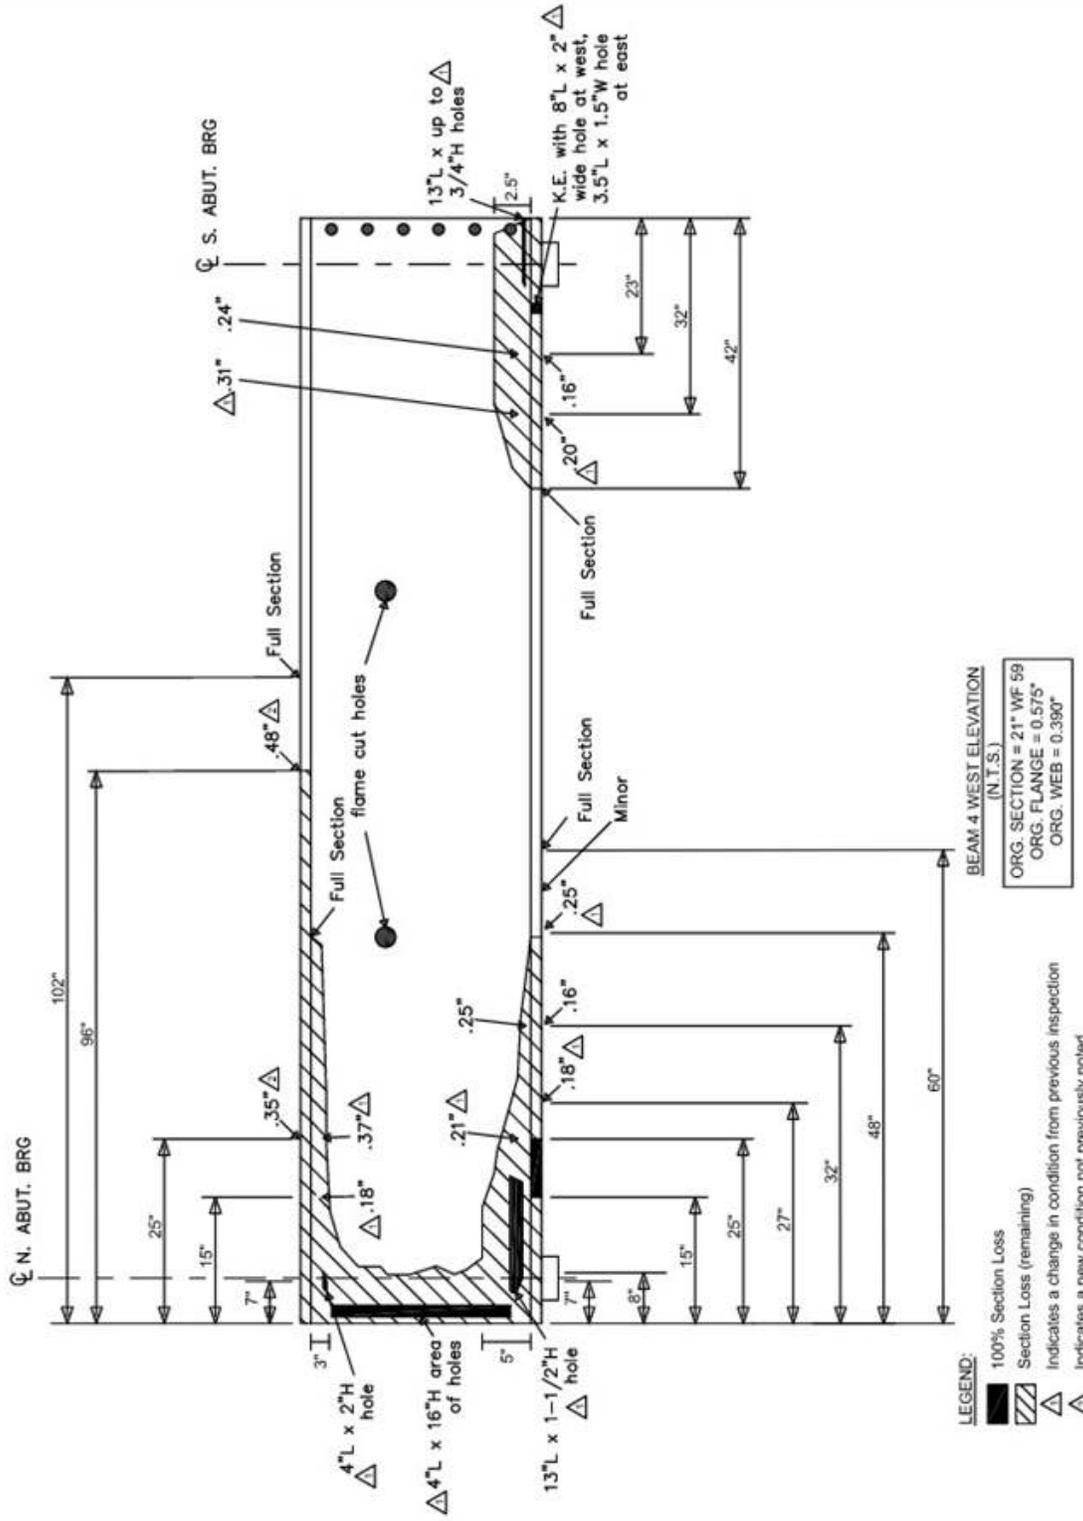
**Sketch 4: Beam 4, West Elevation: Section loss.**

- Web, bottom flange and top flange near North and South Abutment: Section loss (**Sketch 4 and Photos 14-15**).
- Web at South Abutment: Bent out of plane 1/2" over 6" high.

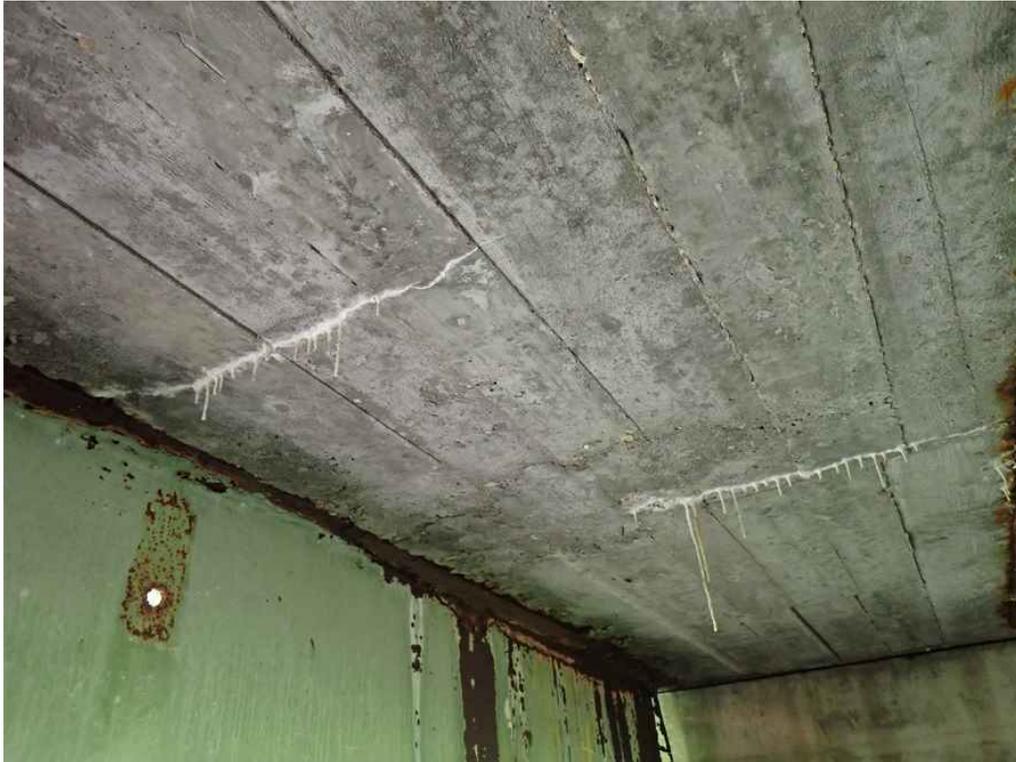
- East deck overhang: Four (4) 6" diameter x 1" deep spalls with exposed rebar.
- Bays 2 and 3 and south deck overhang: Scattered transverse hairline cracks with efflorescence and stalactites (**Photo 9**).
- West deck overhang: Three (3) 6" diameter x 1" deep spalls with exposed rebar (**Photo 10**).

**Photo 9:** Deck underside in Bay 2 with hairline cracks with efflorescence and stalactites.

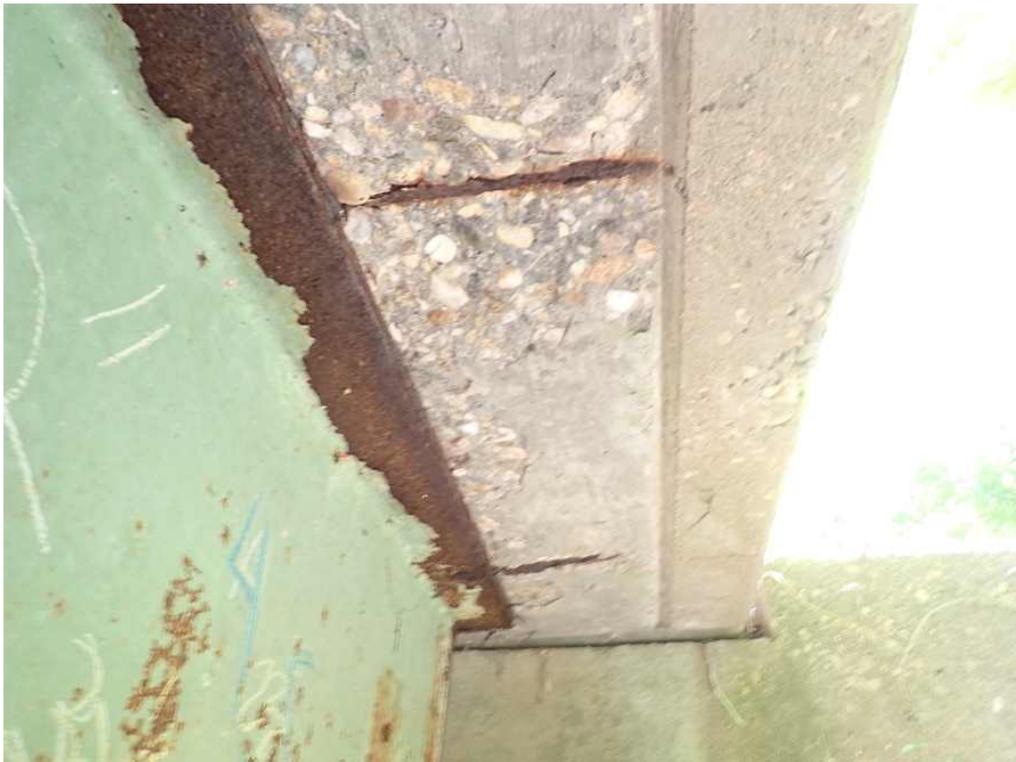
**Photo 10:** West deck overhang at the South Abutment with spalls with exposed rebar (negligible section loss).

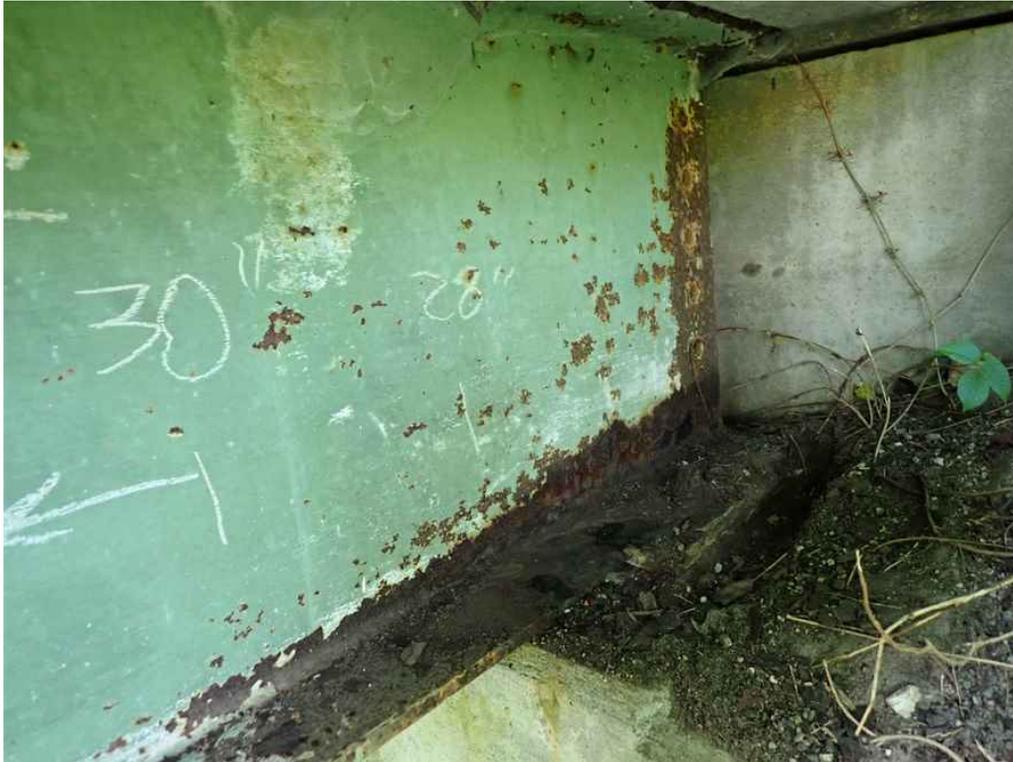
**DEF = S-A: The beams have scattered areas of light to moderate rust throughout and isolated areas of up to heavy rust with up to 100% section loss. Isolated beam webs are bent out of plane.**

There is typically scattered freckled rust throughout the superstructure with isolated locations of failed paint to isolated beams (**Photos 8 and 11-15**). See **Item 59.4 - Girders and Beams** for additional comments.

**Photo 11: Beam 1 east face at North Abutment with section loss to web and bottom flange.**

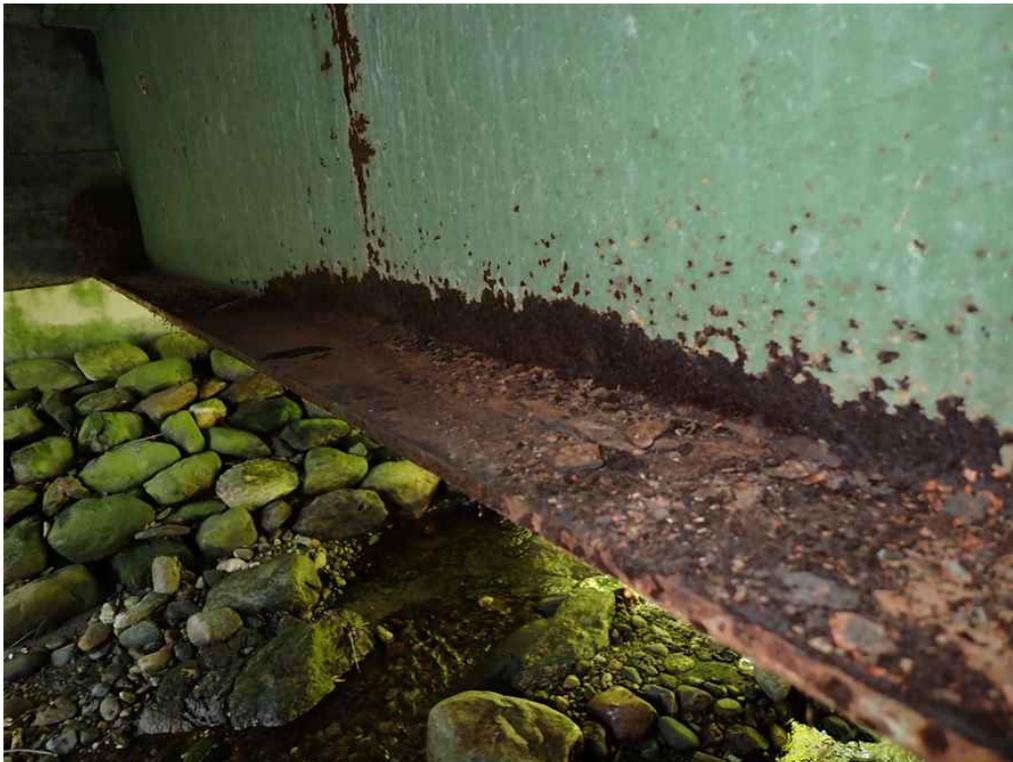
- Lower web at North Abutment: Up to 12" long x 1" high x up to 1/16" section loss (0.33" remaining).
- Bottom flange, 6'-6" from North Abutment: 2'-0" long x 1/16" section loss (0.51" remaining) (**Photo 12**).

**Photo 12: Beam 2 east bottom flange 6'-6" from North Abutment with section loss.**

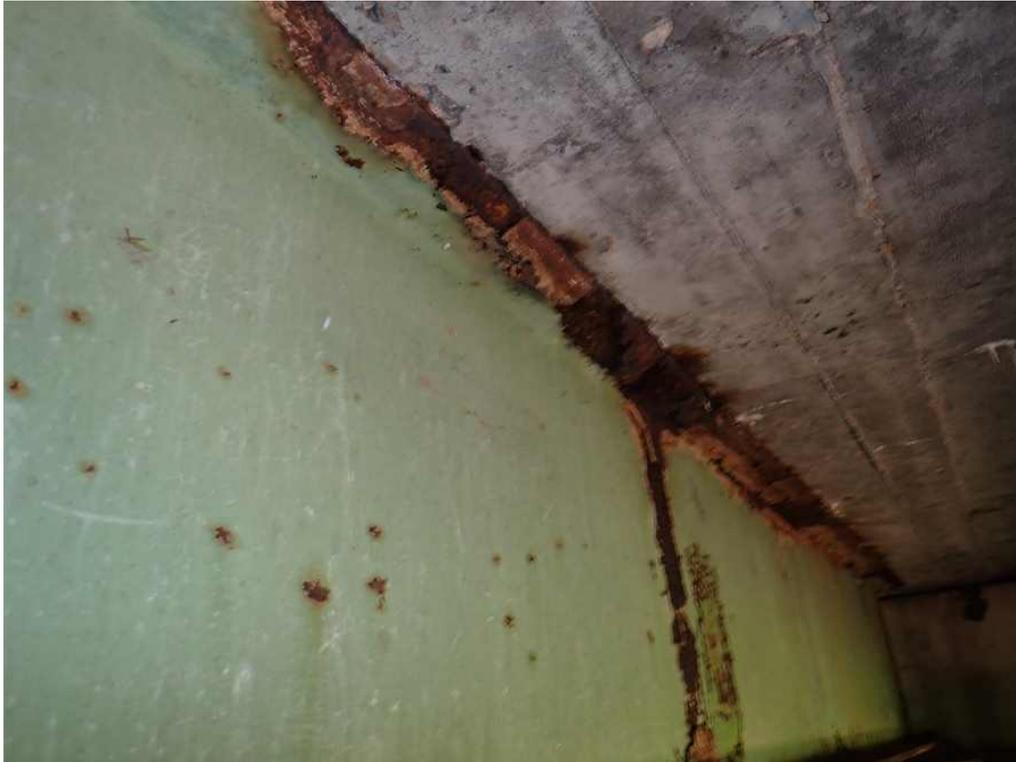
- Top flange, 6'-0" from North Abutment: 4'-0" long x 0.08" section loss (0.5" remaining) (**Photo 13**).
- Lower web at North Abutment: Up to 12" long x 1" high x up to 1/16" section loss (0.33" remaining).

**Photo 13: Beam 3 north top flange near North Abutment with section loss.**

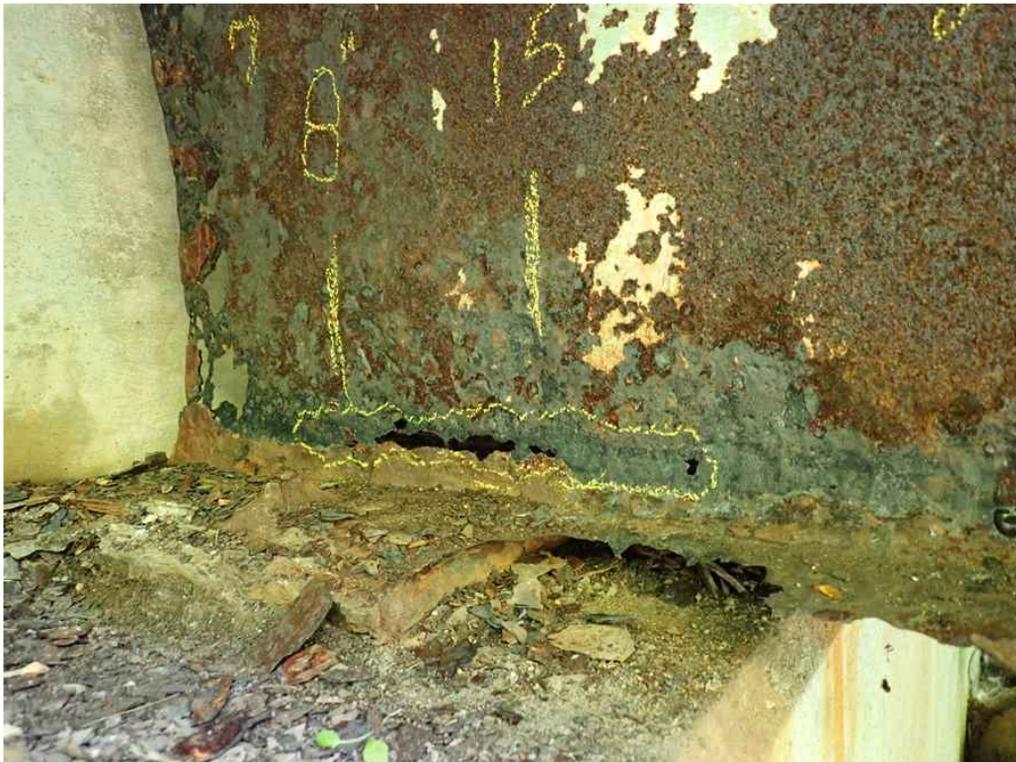
**Photo 14: Beam 4 west web and bottom flange at North Abutment with up to 100% section loss.**

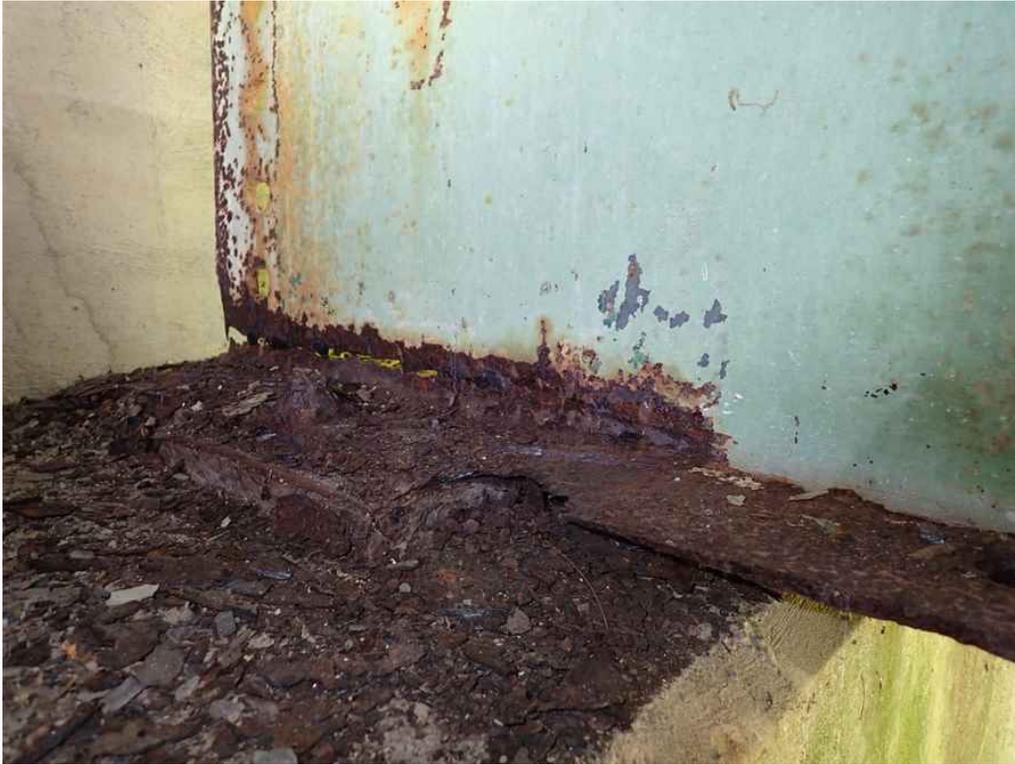
**Photo 15: Beam 4 east web and bottom flange at South Abutment with up to 100% section loss.**

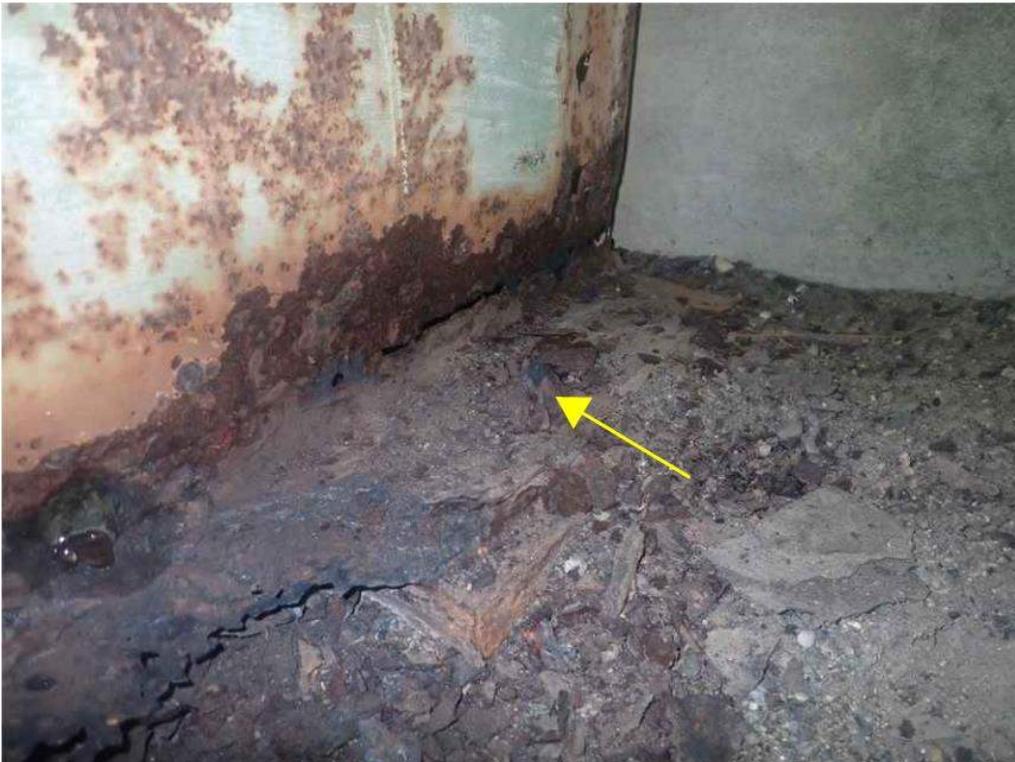
The bearings have up to heavy rust with minor section loss. The anchor bolt nuts at the fascia beams have section loss up to 100%. See the following for specific locations and conditions:

- Bearing 1 at North Abutment: Up to 25% section loss to anchor bolt nuts.
- Bearing 1 at South Abutment: Up to 50% section loss to anchor bolt nuts.
- Bearing 4 at North and South Abutment: Up to 100% section loss to anchor bolt nuts (**Photo 16**).

**Photo 16: Bearing 4 west anchor bolt nut at South Abutment with 100% section loss.**

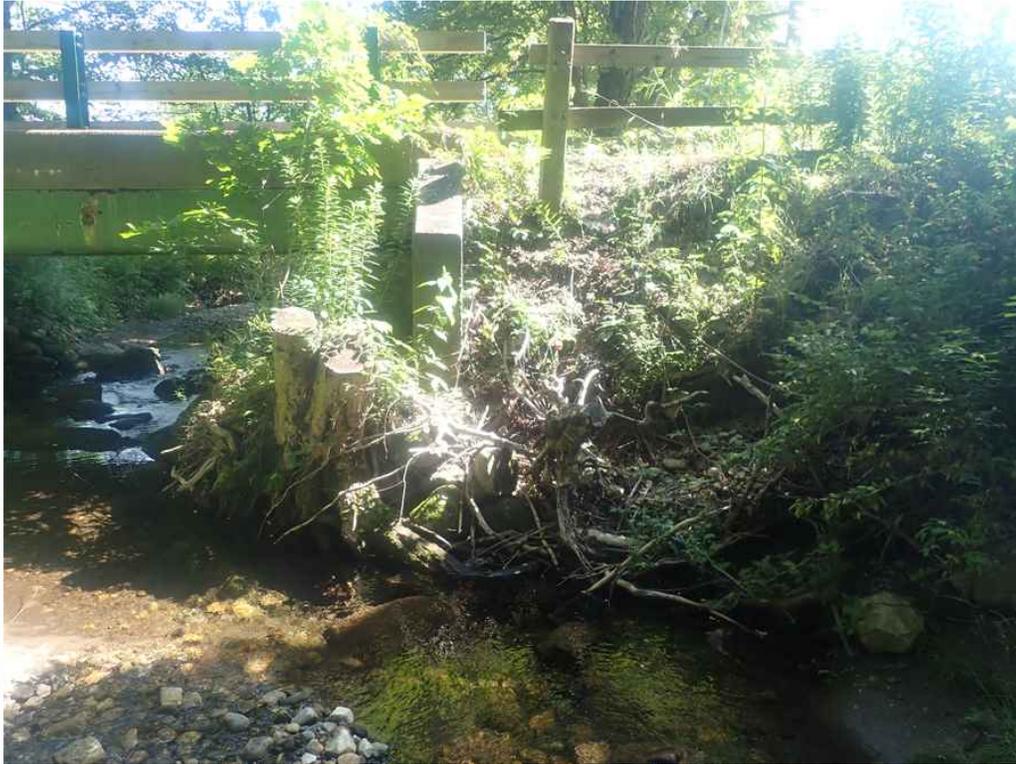
**DEF = S-A: The transition rails have minor rot and random splits and checks. The southwest transition is tipped 2'-0" away from traffic due to undermining from embankment erosion (Photos 17-18). The northeast transition is tipped 10" away from traffic.**

**Photo 17: Southwest embankment with erosion causing undermining to transition post.**

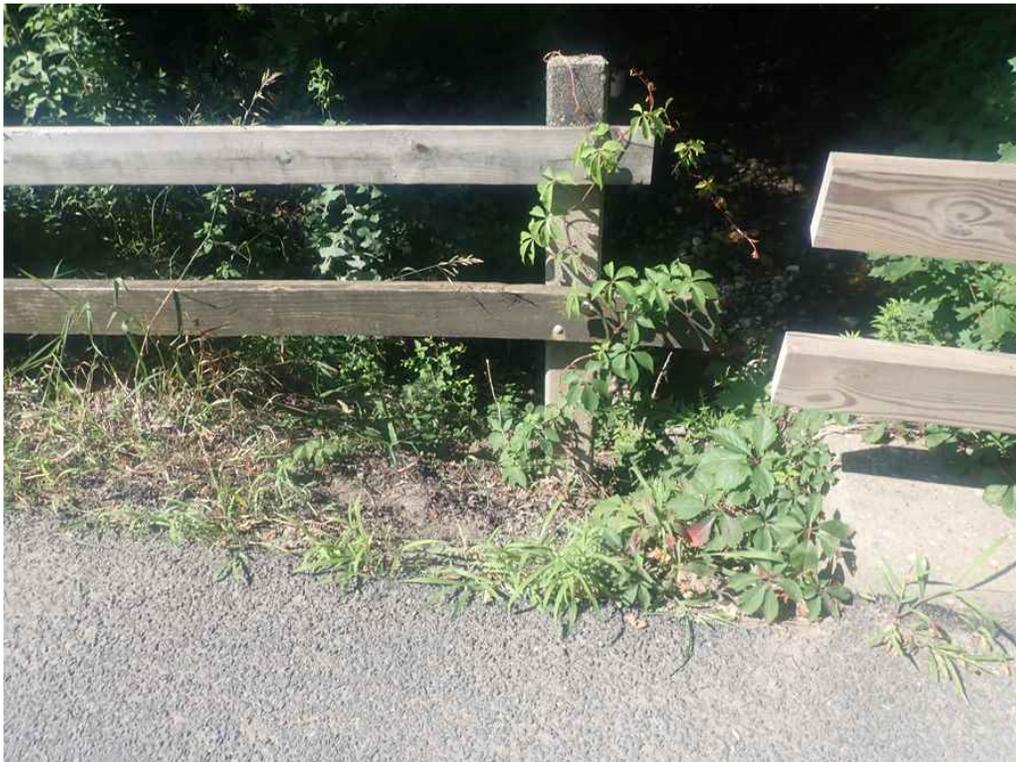
**Photo 18: Southwest transition leaning away from traffic due to undermining from embankment erosion.**

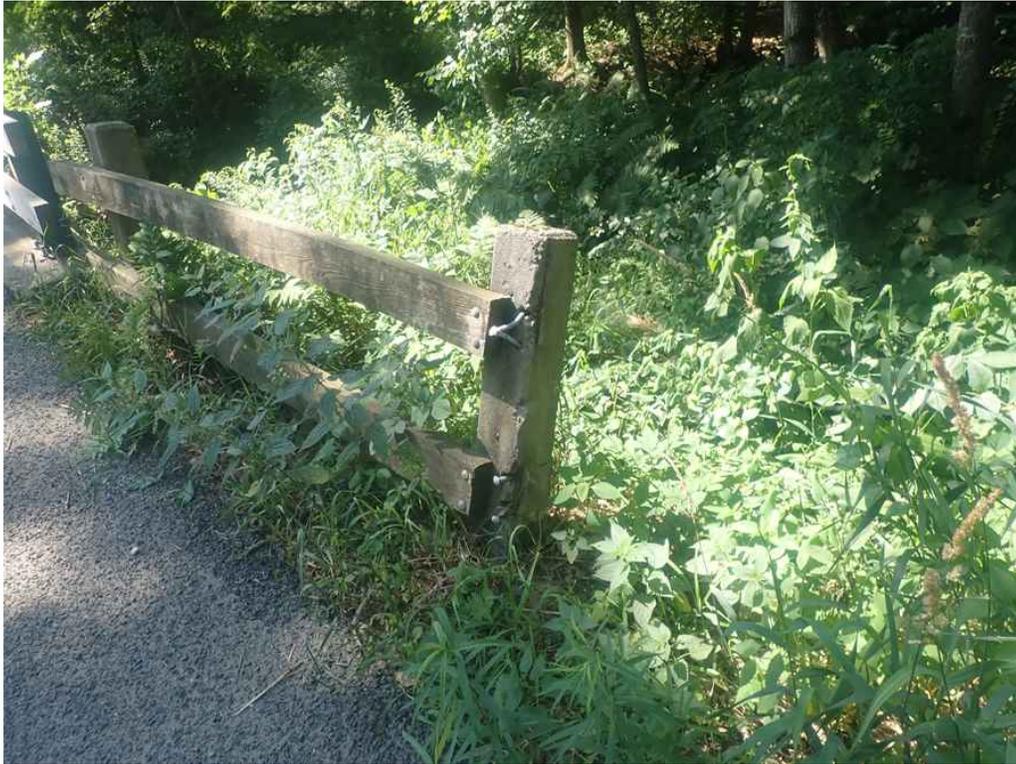
At the northwest corner the concrete post is broken, leaning away from traffic and the rails have fallen off (**Photo 19**). The last concrete post at the northeast has a 2'-0" high x 5" wide x 5" deep spall with exposed rebar (negligible loss).

**Photo 19:** Northwest Approach Guardrail with post leaning away from traffic, end rails have fallen off.
