STRUCTURES INSPECTION FIELD REPORT

ROUTINE INSPECTION

BR. DEPT. NO.  
A-13-023

Structure A-13-023 (OFL) carries Bullitt Road over the South River in the town of Ashfield (**Sketch 1**). The bridge is a single-span structure comprised of six (6) rolled-shaped steel beams (30WF108 per plans) with a Cast-in-Place concrete deck overlaid with an asphaltic wearing surface. The beams are designated as Beams 1 through 6 and the bays are designated as Bays 1 through 5 from west to east, upstream to downstream. The substructure consists of two (2) reinforced concrete abutments labeled South Abutment and North Abutment (**Sketch 2 and Photos 1 – 8**).

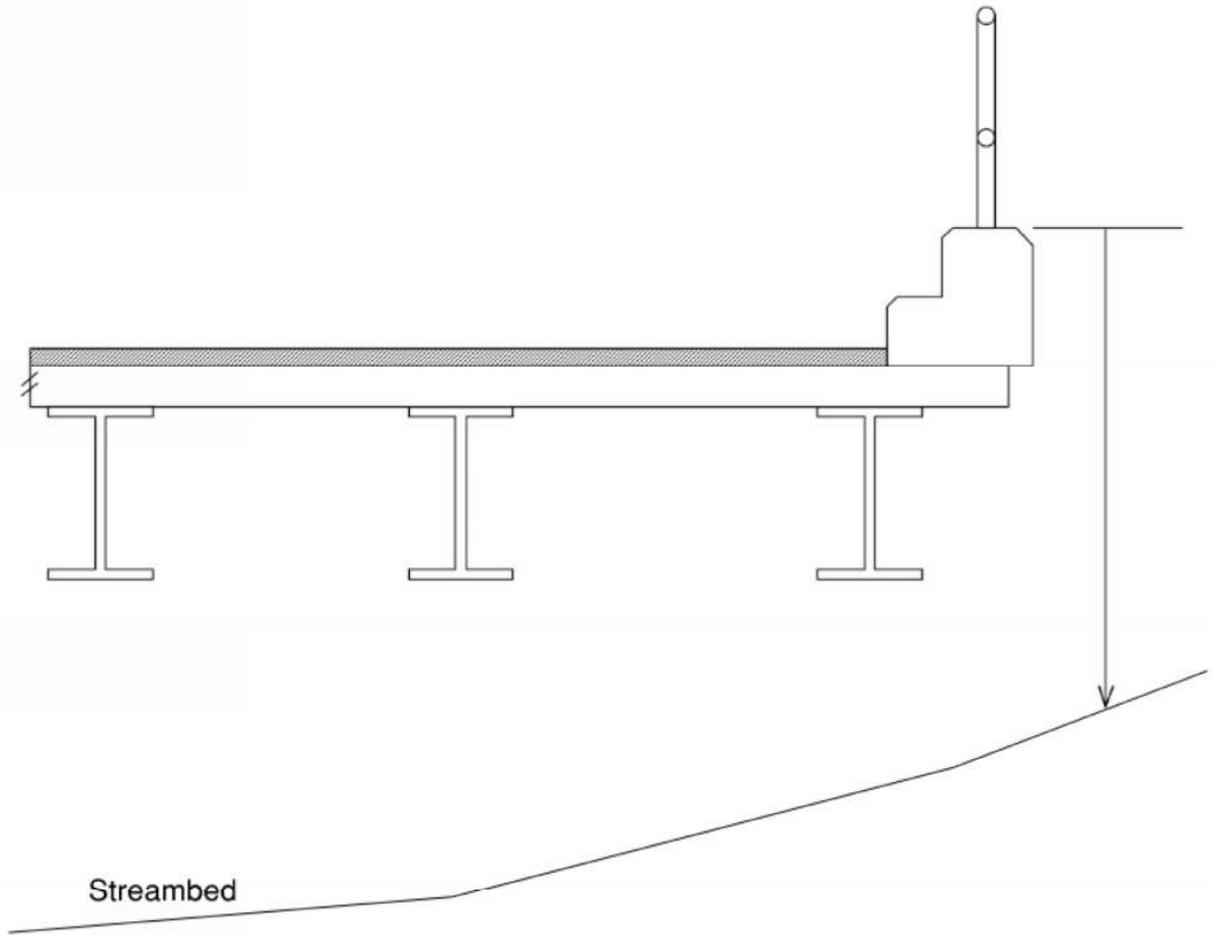
**Sketch 3: Channel Profile Measurements.**

BIN OFL - Channel Profile Readings								
East Fascia								
DATE	Post 1	Post 2	Post 3	Post 4	Post 5	Post 6	Post 7	Post 8
3/31/2025	11.8'	13.3'	13.8'	14.7'	13.8'	13.0'	11.2'	10.3'

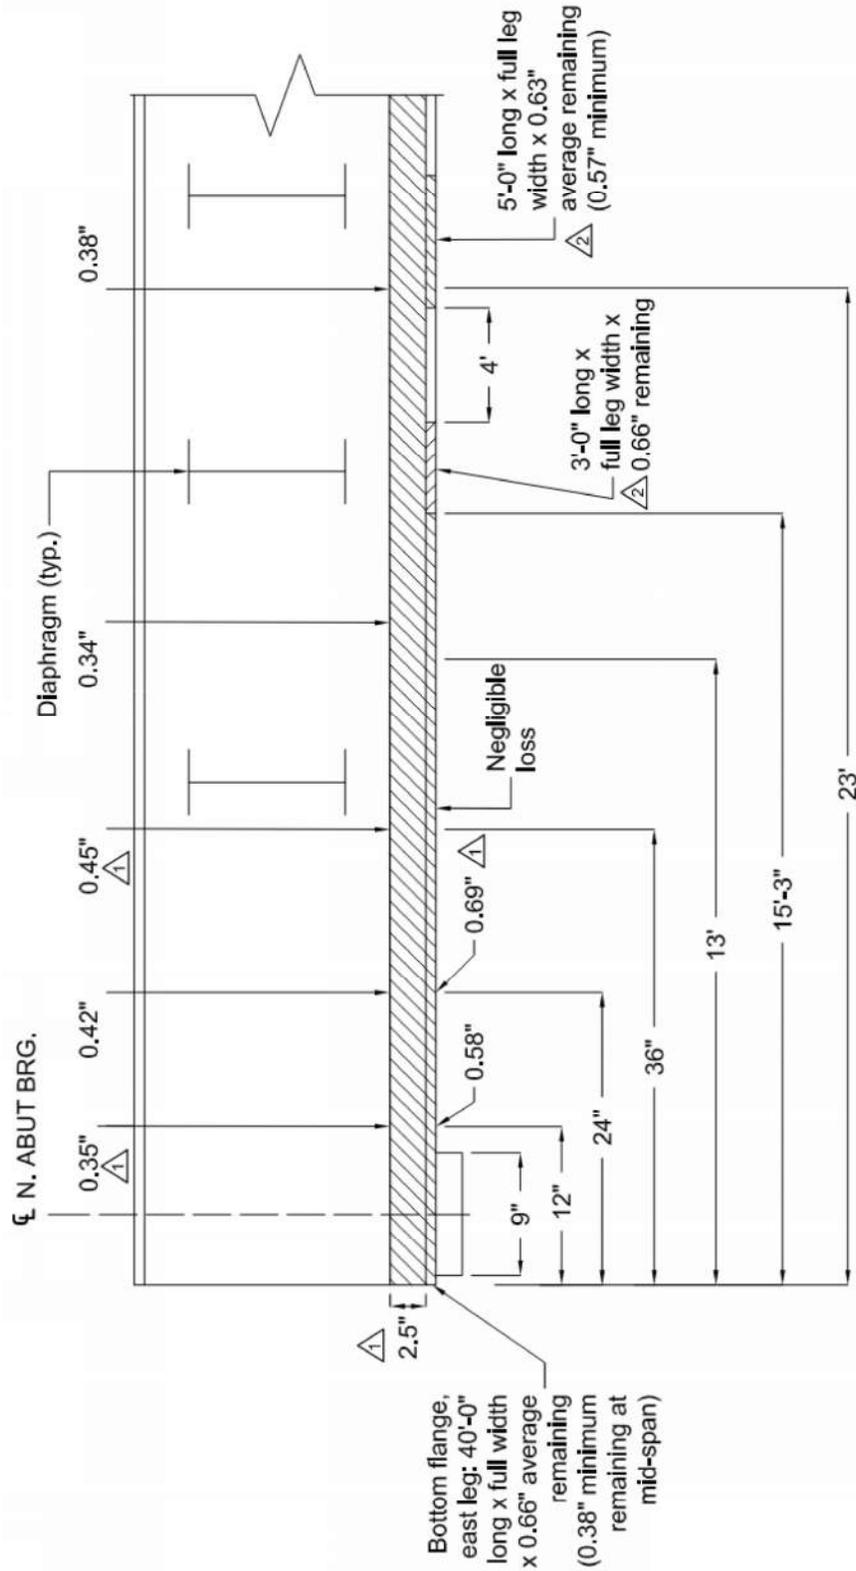
**BEAM 1 AT NORTH ABUTMENT  
WEST ELEVATION  
(N.T.S.)**

**SECTION PROPERTIES (PLANS):**  
 ORIGINAL SECTION = 30WF108  
 ORIGINAL WEB = 0.548"  
 ORIGINAL FLANGE = 0.76"

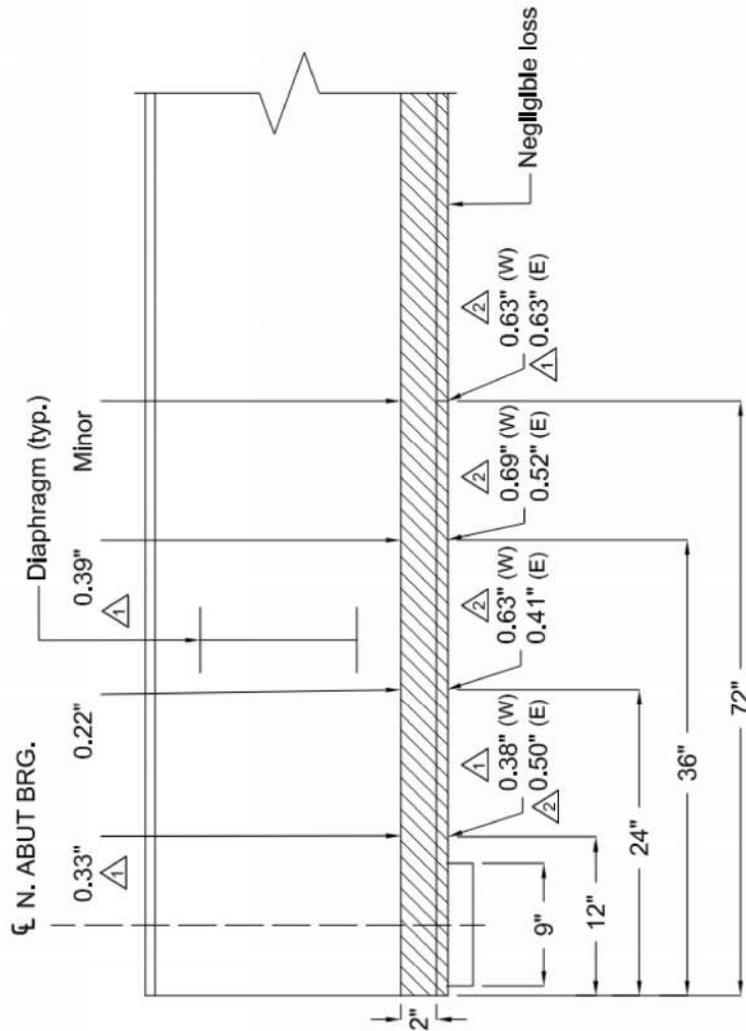
BEAM 2 AT NORTH ABUTMENT  
WEST ELEVATION  
(N.T.S.)

SECTION PROPERTIES (PLANS):  
 ORIGINAL SECTION = 30WF108  
 ORIGINAL WEB = 0.548"  
 ORIGINAL FLANGE = 0.76"

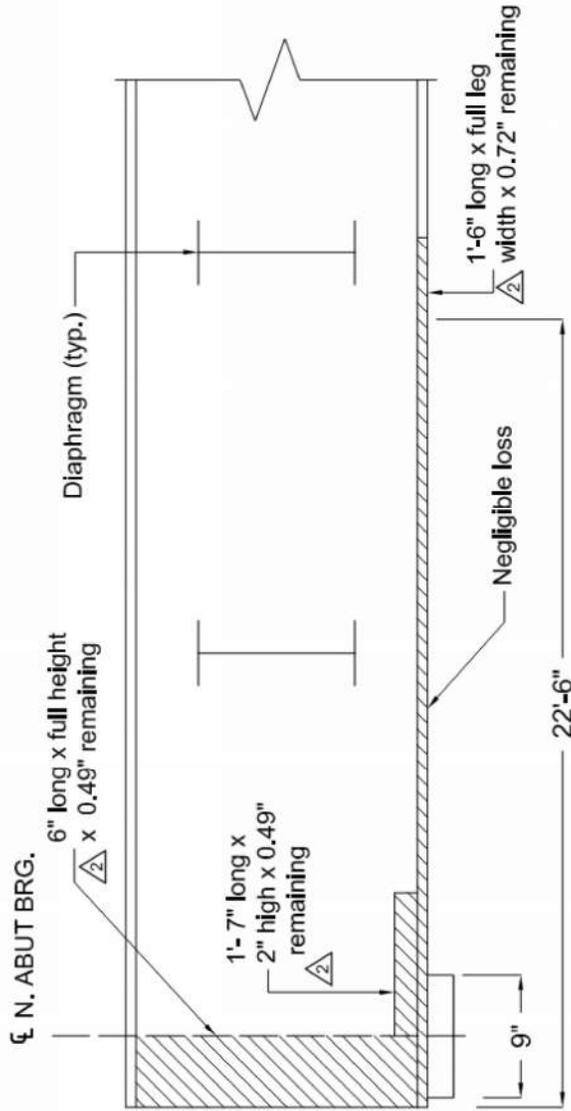
**BEAM 5 AT NORTH ABUTMENT**  
**WEST ELEVATION**  
**(N.T.S.)**

**SECTION PROPERTIES (PLANS):**  
 ORIGINAL SECTION = 30WF108  
 ORIGINAL WEB = 0.548"  
 ORIGINAL FLANGE = 0.76"

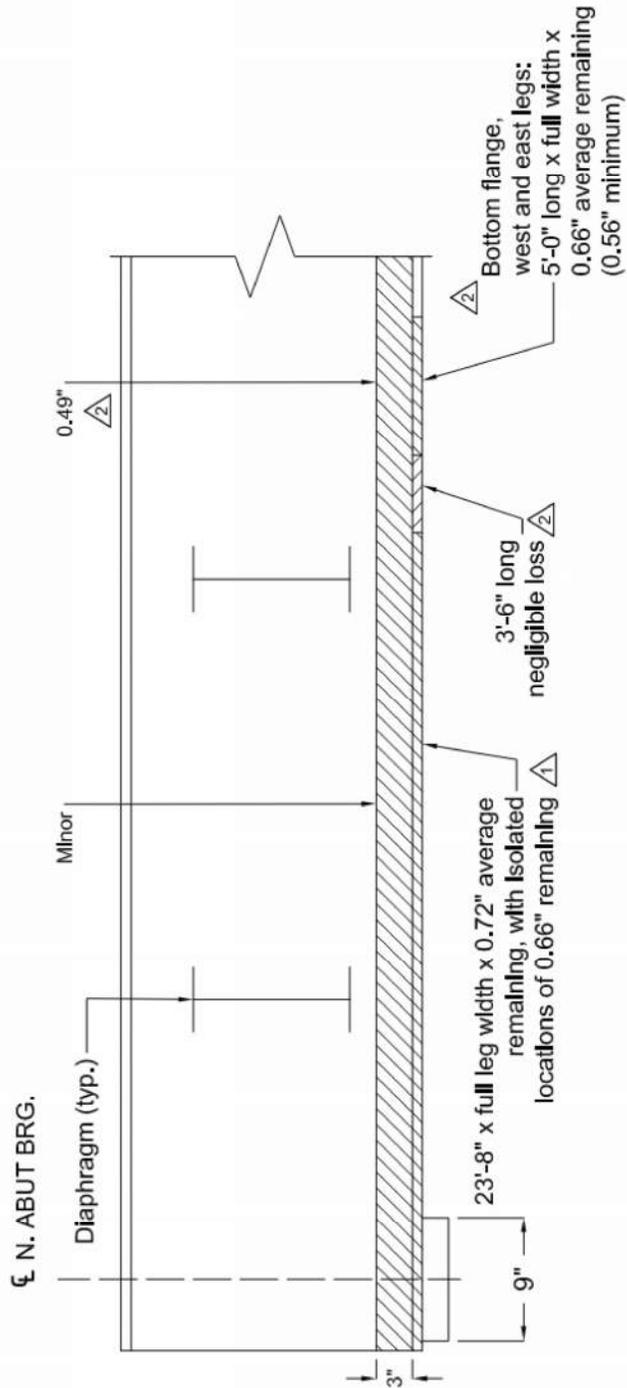
**BEAM 6 AT NORTH ABUTMENT  
WEST ELEVATION  
(N.T.S.)**

**SECTION PROPERTIES (PLANS):**  
 ORIGINAL SECTION = 30WF108  
 ORIGINAL WEB = 0.548"  
 ORIGINAL FLANGE = 0.76"

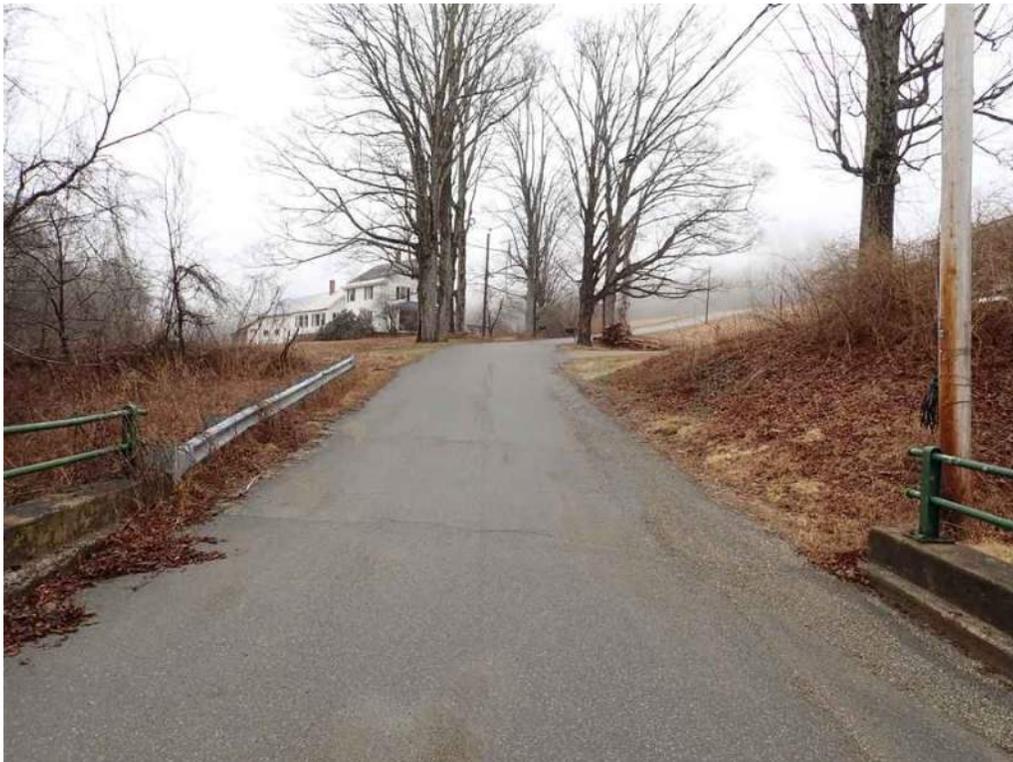
The South Approach Pavement has isolated transverse cracks up 11'-0" long x up to 1/4" wide adjacent to the deck end and an isolated full roadway width x 1" wide transverse crack approximately 20'-0" from the deck end (**Photo 4**).

**Photo 4: South Approach from bridge, looking south. Note: transverse cracks south of the deck end.**

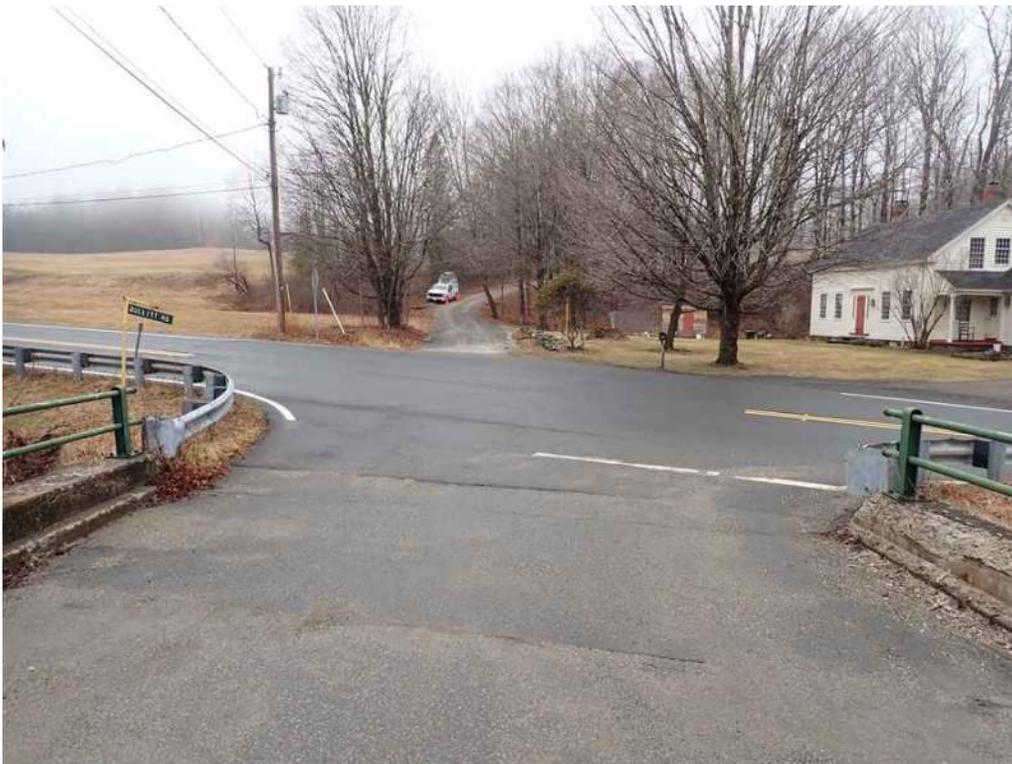
The North Approach Pavement has a 19'-7" long x up to 3/4" wide transverse crack near the deck end and an adjacent 19'-0" long x up to 1/2" wide x up to 1" deep transverse crack (**Photo 6**).

**Photo 6:** North Approach from bridge, looking north. Note: settlement and transverse cracks just north of the deck end.

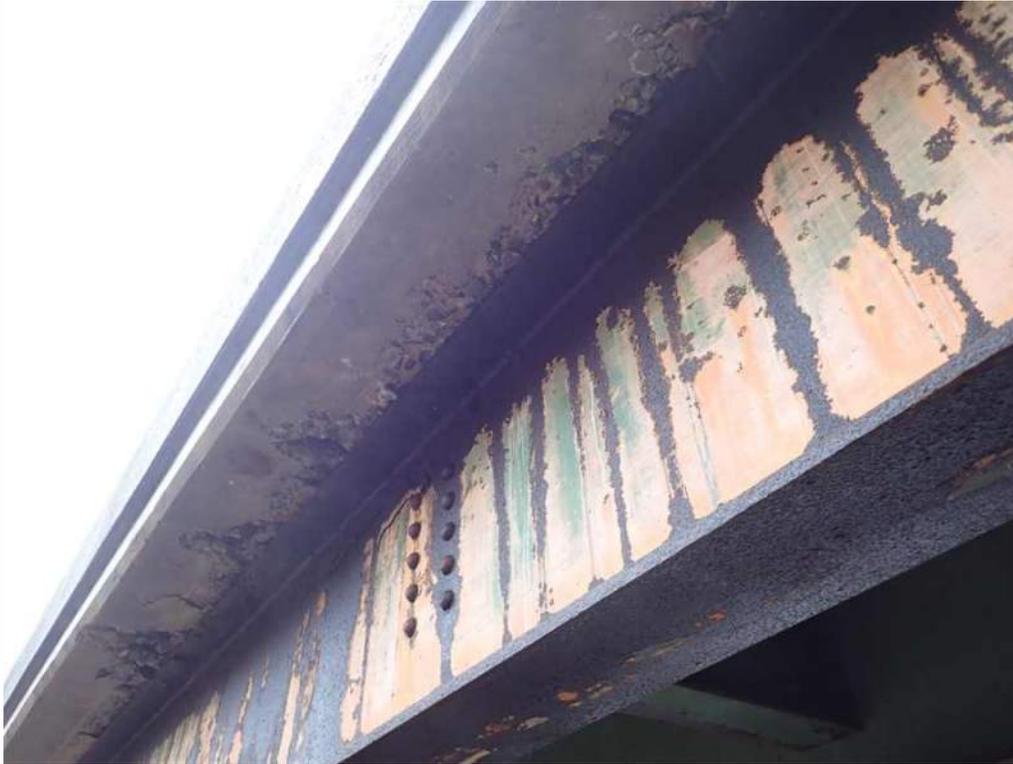
- There are scattered areas of scale up to 1 square foot x 1/4" deep.
- West Deck Overhang, near South Abutment: 18'-0" long x full width x up to 2" deep spall with exposed rebar with laminated rust (**Photo 9**).

**Photo 9: West Deck Overhang at Diaphragm 2 with spalls and exposed rebar.**

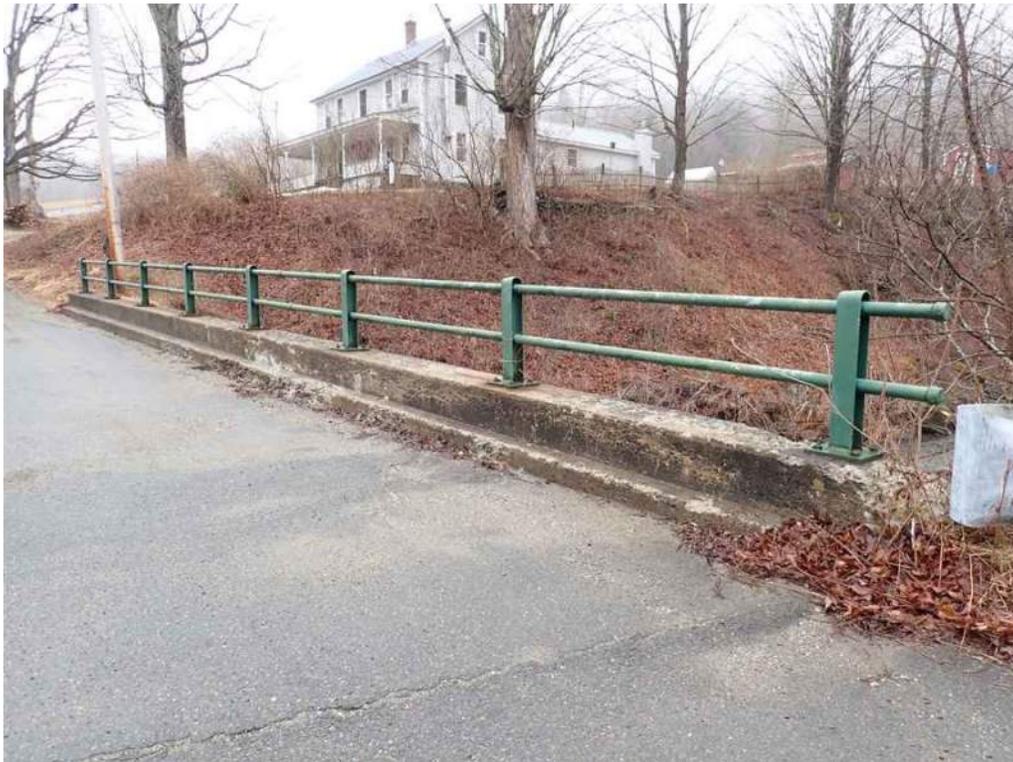
- At mid-span: 4'-4" long x 7" high x up to 1-1/2" deep spall (**Photo 10**).
- Near mid-span: 14'-0" long x 7" high up to 6" deep spall with exposed rebar (**Photo 10**).
- At the north end: 2'-0" long x 5" high x 6" deep corner spall (**Photo 10**).

- The previously noted broken base plate weld at the third post from the south has been repaired.
- Rail base, top face, near mid-span: Up to 13'-0" long x up to 1'-6" wide x up to 1-1/2" deep scale (**Photo 10**).
- Rail base, top face, at the north end: 3'-0" long x 11-1/2" high (east face) x full width (top face) edge spall with exposed rebar (**Photo 10**).

**Photo 10: West Curb and Railing. Note: cracks with efflorescence, scale, and spalls with exposed rebar.**

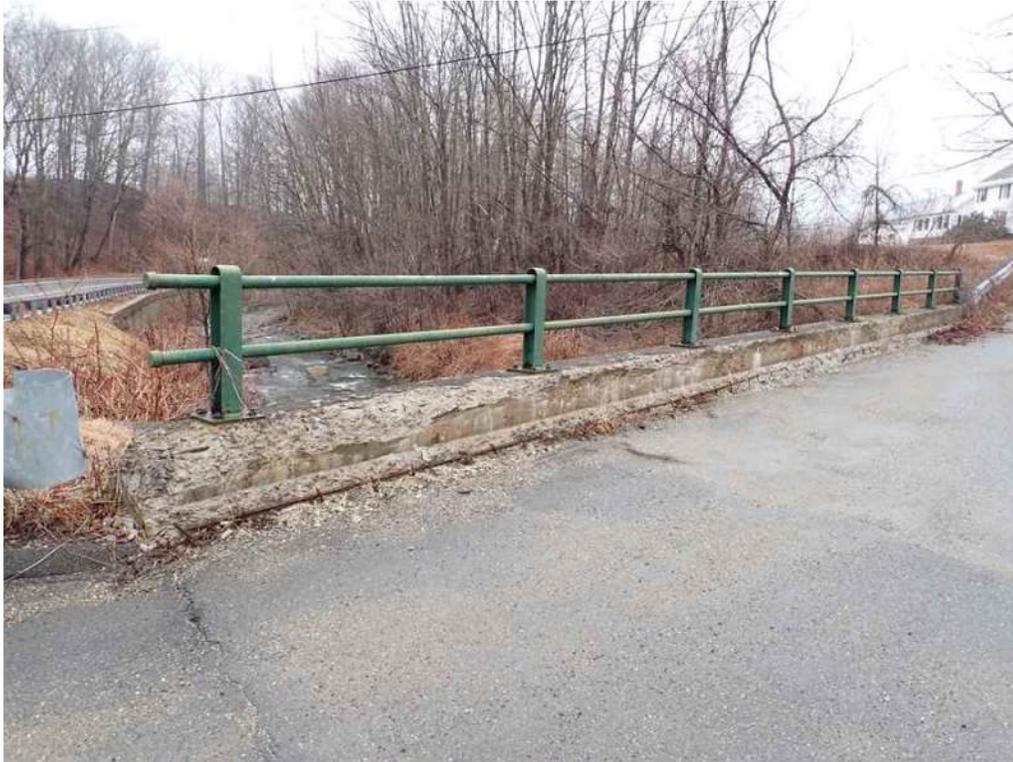
- Rail base, west face, near the south end: 12'-0" long x up to 7" high x up to 5" deep edge spall.
- The previously noted broken base plate welds at the third, fourth and fifth posts from the south have been repaired.
- Rail base, top face, at the north end: 19'-0" long x 1'-0" high (west face) x full width (top face) edge spall with exposed rebar (**Photo 11**).

**Photo 11: East Curb and Railing. Note: cracks with efflorescence and scale / spalls with exposed rebar.**

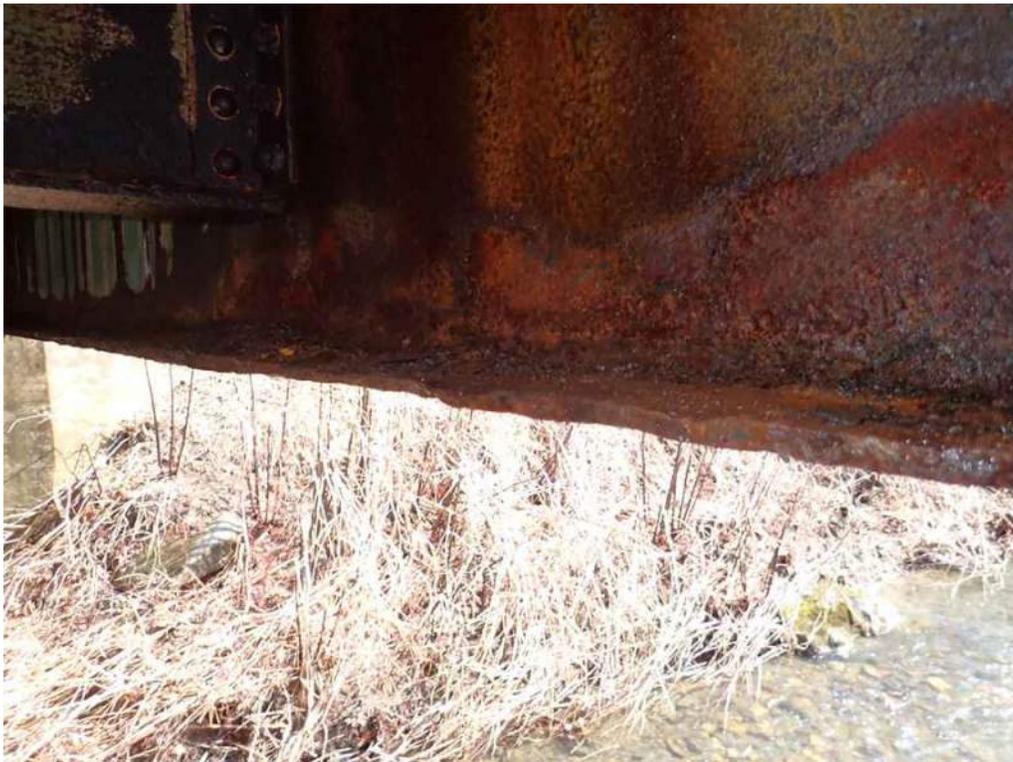
The paint system has failed throughout the entire superstructure (**Photos 8, 9, & 12-17**).

**Photo 12: Beam 1 east bottom flange at mid-span with section loss.**

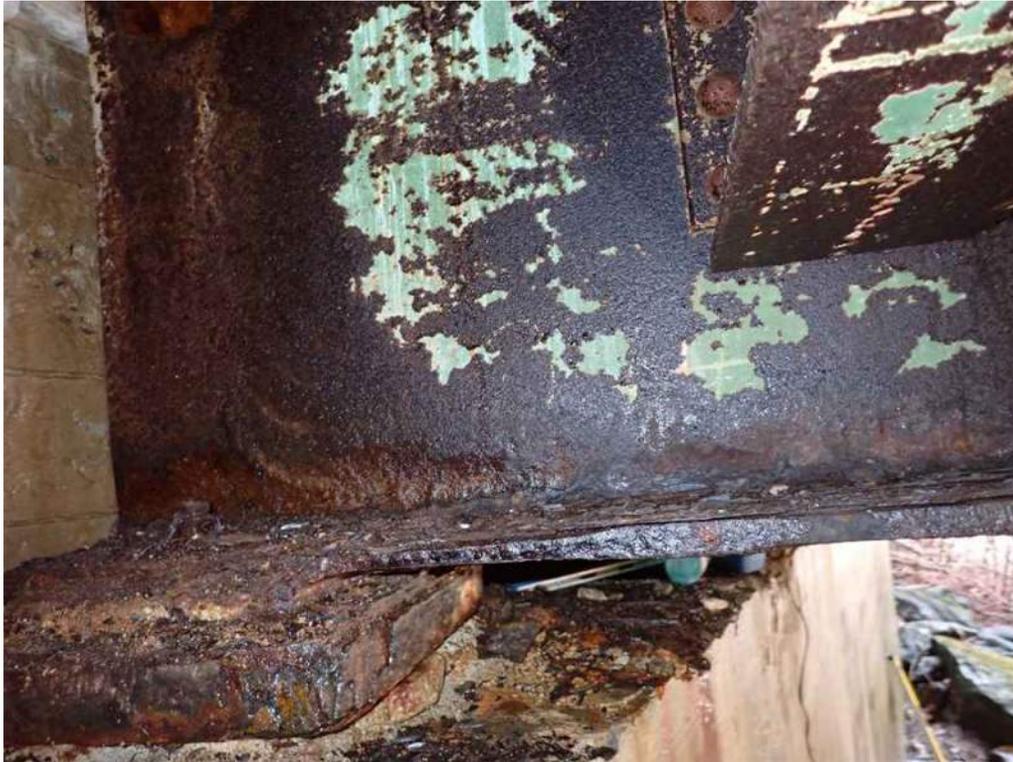
**Photo 13:** Beam 2 west face at north end with section loss.

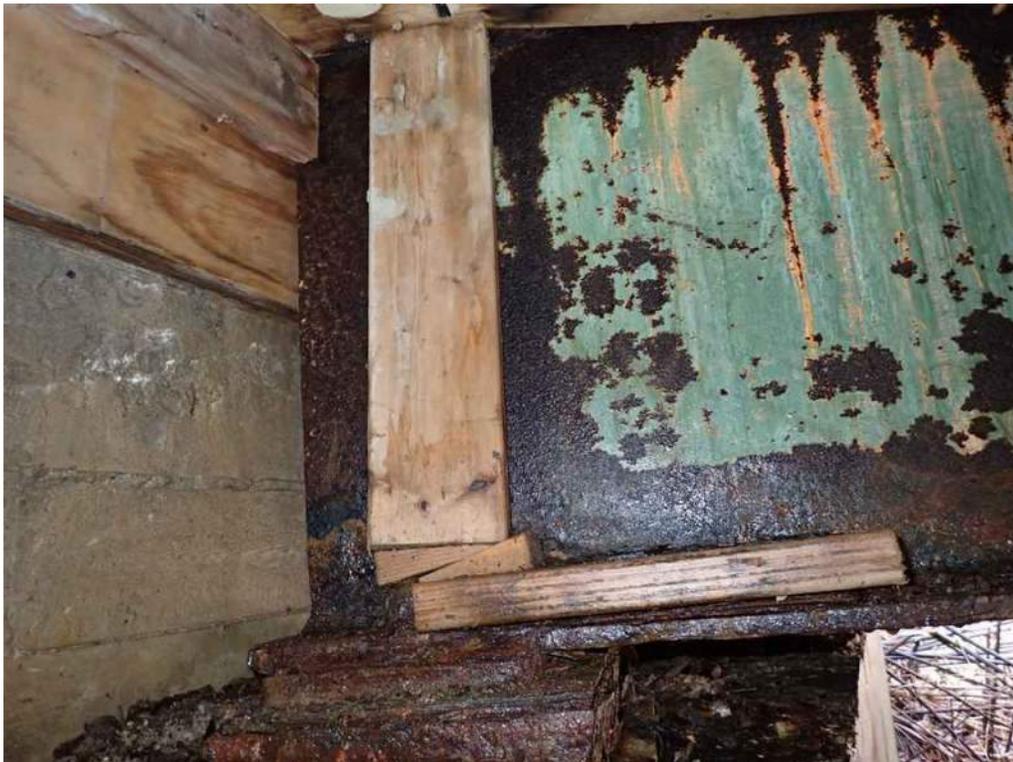
**Photo 14:** Beam 5 west face at north end with section loss. Note: partially hidden by timber formwork.

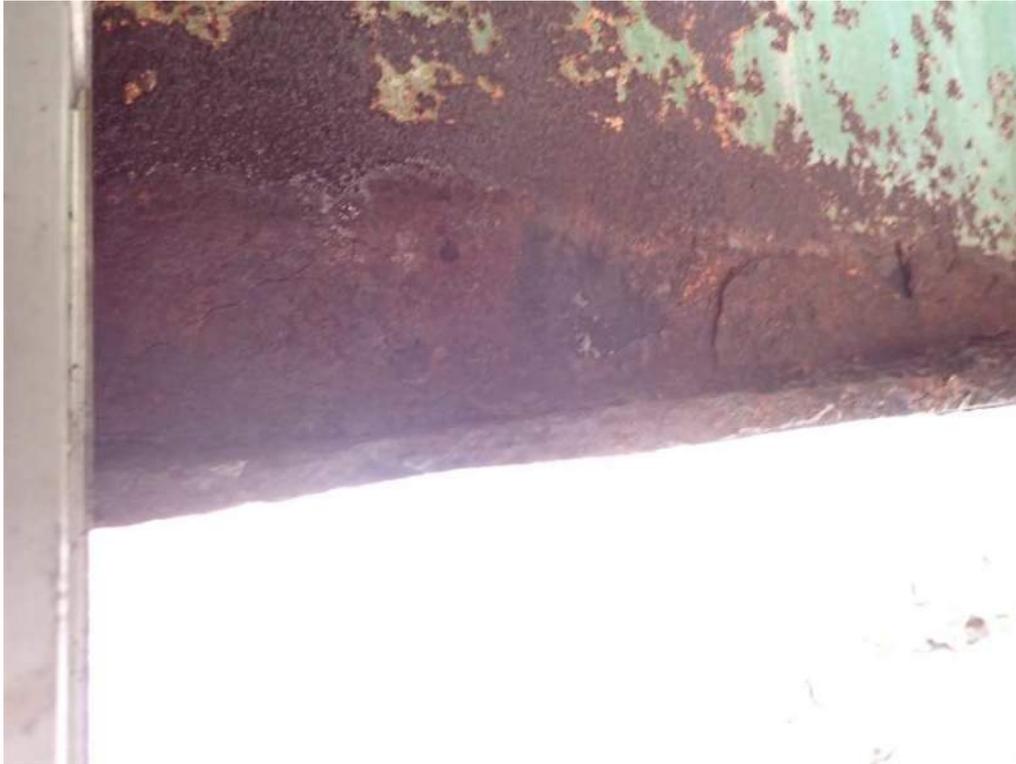
**Photo 15:** Beam 6 west face at mid-span with section loss.

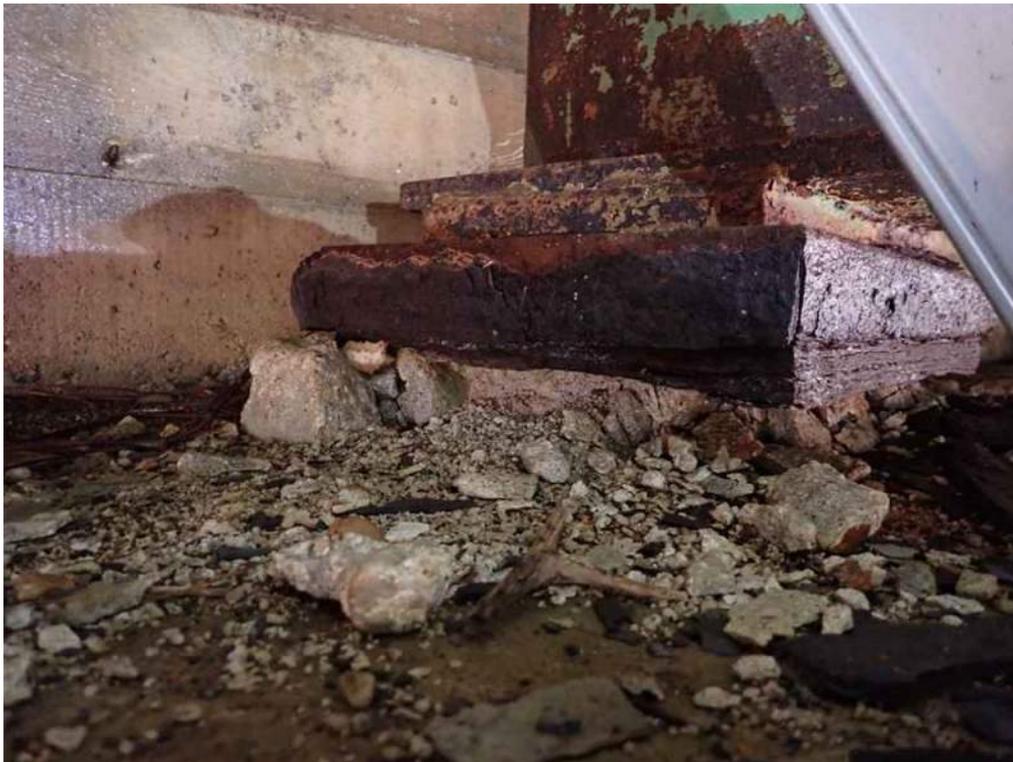
- Beam 5 Bearing: 1/8" thick pack rust between masonry plate and sole plate, and the masonry plate is undermined 11" long x 1/2" deep at the west face, 1'-1" wide x 2" deep at the north face, and full length x 2-1/2" deep at the east face (**Photo 16**).

The South Abutment pedestals typically have spalls up to full width x full height x 2" deep that are undermining the edges of the bearing masonry plates (Photo 16).

**Photo 16:** Beam 5 bearing at South Abutment with undermining of masonry plate due to spalled pedestal.

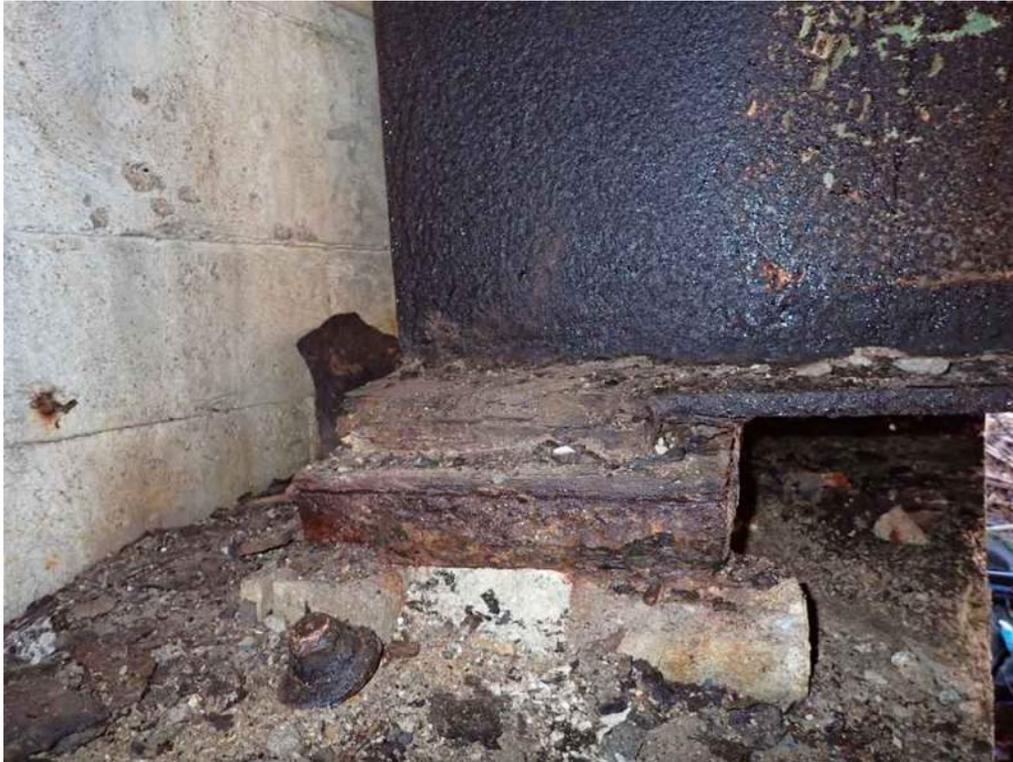
- Beam 1 Bearing: Up to 1/4" thick pack rust between masonry plate and sole plate.
- Beam 2 Bearing: The masonry plate is undermined up to 2" long x 4" deep at the southwest corner.
- Beam 3 Bearing: Missing anchor bolt and nut at the east face and the masonry plate is undermined up to 5" long x 1" deep at the west face.
- Beam 4 Bearing: Missing anchor bolt and nut at the west face and the masonry plate is undermined 5-1/4" long x 1-1/2" deep at the west face, 5-3/4" wide x up to 1" deep at the south face, 6" wide x up to 2" deep at the southeast corner, 4-1/2" long x 1-1/2" deep at the east face, and 3" long x 3/4" deep at the northeast corner (**Photo 17**).

The North Abutment pedestals typically have spalls up to 1'-2" wide x full height x 2" deep that are undermining the edges of the bearing masonry plates (Photo 17).

**Photo 17: Beam 4 bearing at North Abutment with sheared anchor bolt and spalled pedestal.**

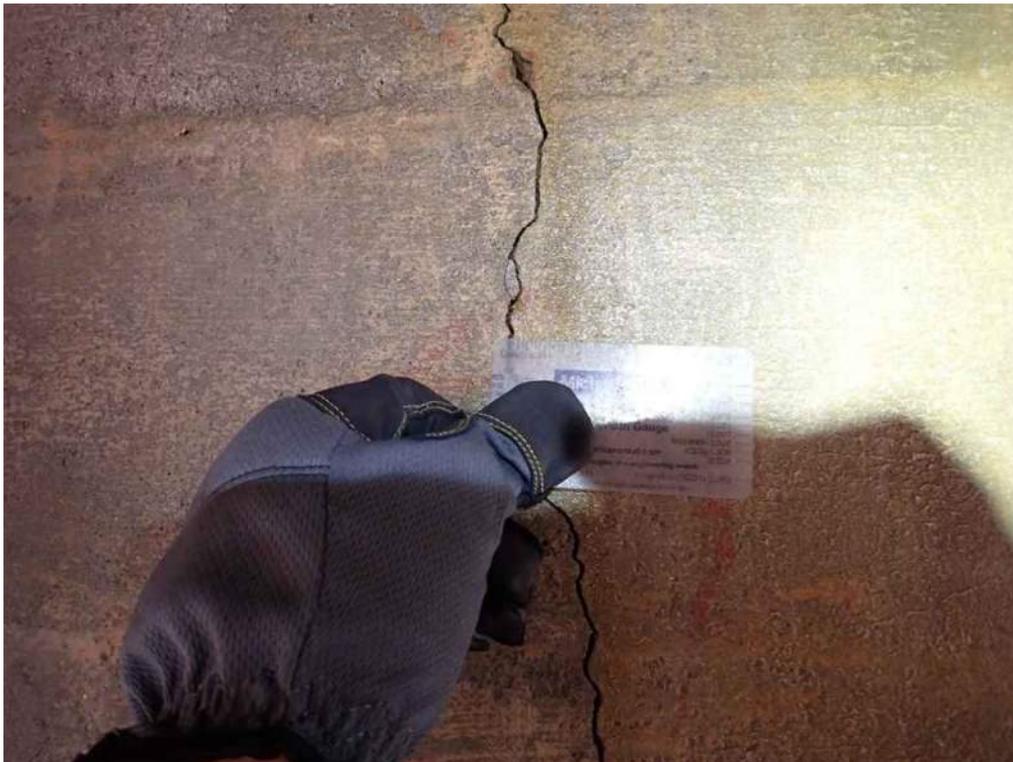
**Photo 18: North Abutment Breastwall below Beam 4 with a full height vertical crack and lateral misalignment.**

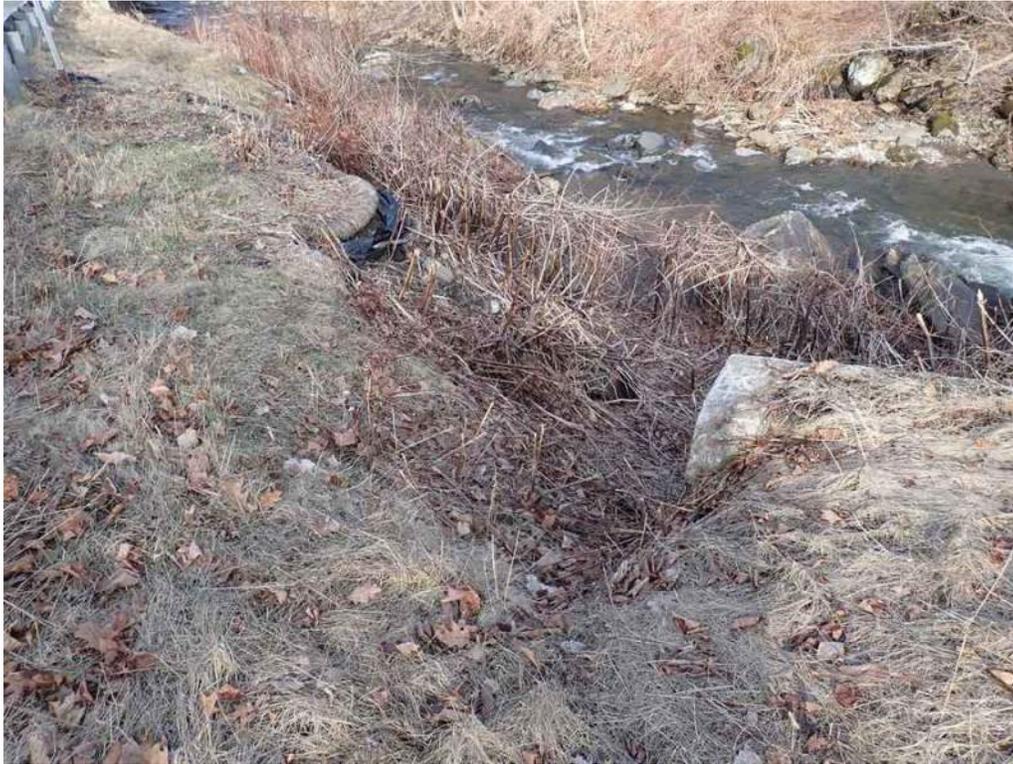
**Photo 19: Left Bank at the east end of the Northeast Wingwall with erosion.**
