STRUCTURES INSPECTION FIELD REPORT

ROUTINE INSPECTION

BR. DEPT. NO.
A-13-025

CITY/TOWN ASHFIELD	8-STRUCTURE NO. A13025-0FJ-MUN-NBI	11-Kilo. POINT 000.000	41-STATUS A:OPEN	90-ROUTINE INSP. DATE MAR 31, 2025
07-FACILITY CARRIED HWY BURTON HLL R	MEMORIAL NAME/LOCAL NAME Br No 5 Burton	27-YR BUILT 1939	106-YR REBUILT 0000	YR REHAB'D (NON 106) 0000
06-FEATURES INTERSECTED WATER SOUTH RIVER	26-FUNCTIONAL CLASS Rural Local	DIST. BRIDGE INSPECTION ENGINEER M. P.E. McCabe <i>Michael P. McCabe</i>		
43-STRUCTURE TYPE 302 : Steel Stringer/Girder	22-OWNER Town Agency	21-MAINTAINER Town Agency	TEAM LEADER K. Trunfio <i>K. Trunfio</i>	PROJ MGR Michael Baker Intl Inc
107-DECK TYPE 1 : Concrete Cast-in-Place	WEATHER P. Cloudy	TEMP. (air) 16°C	TEAM MEMBERS M. MAZZU

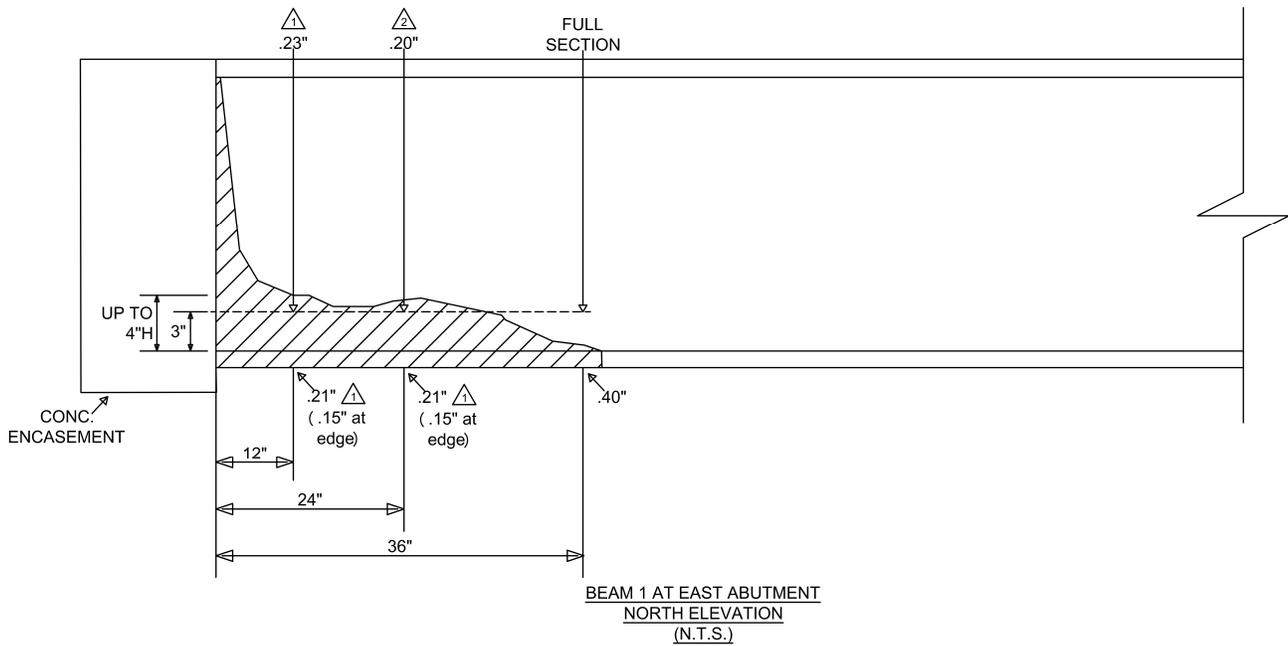
- Web and bottom flange at West Abutment: Up to 1/16" section loss.
- Web and bottom flange at East Abutment: Section loss (**Sketch 5**).

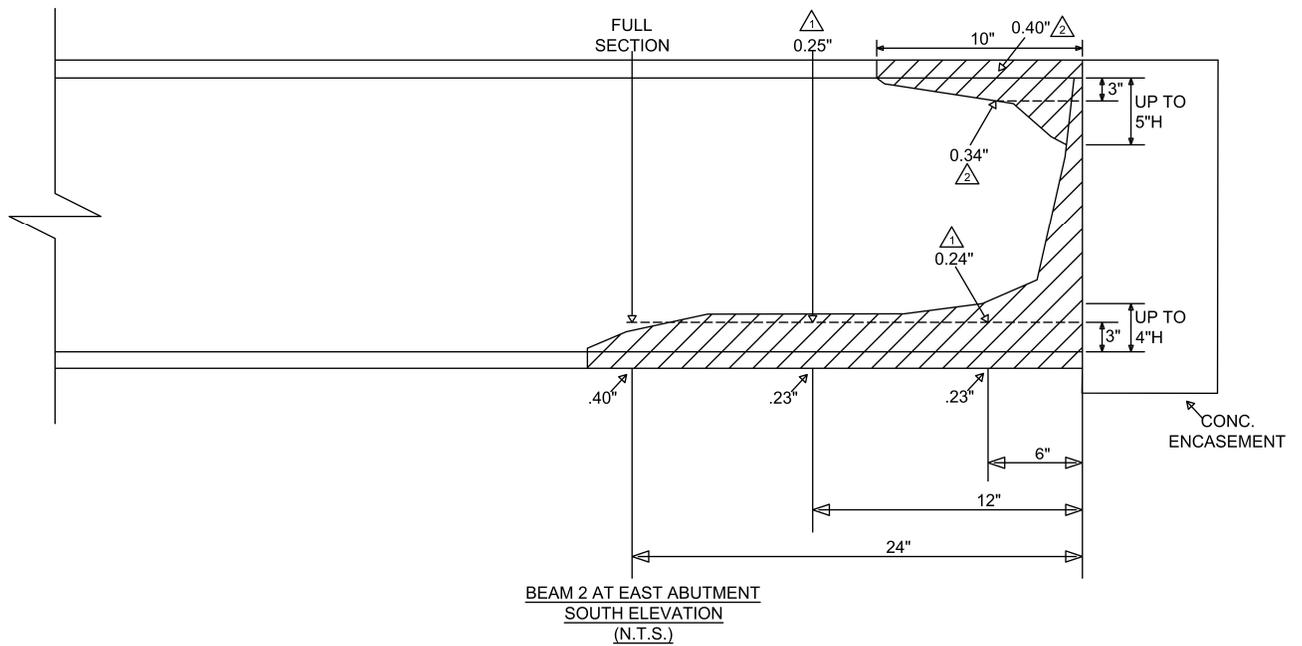
- Web, top flange and bottom flange at East Abutment: Section loss (**Sketch 6 and Photo 12**).

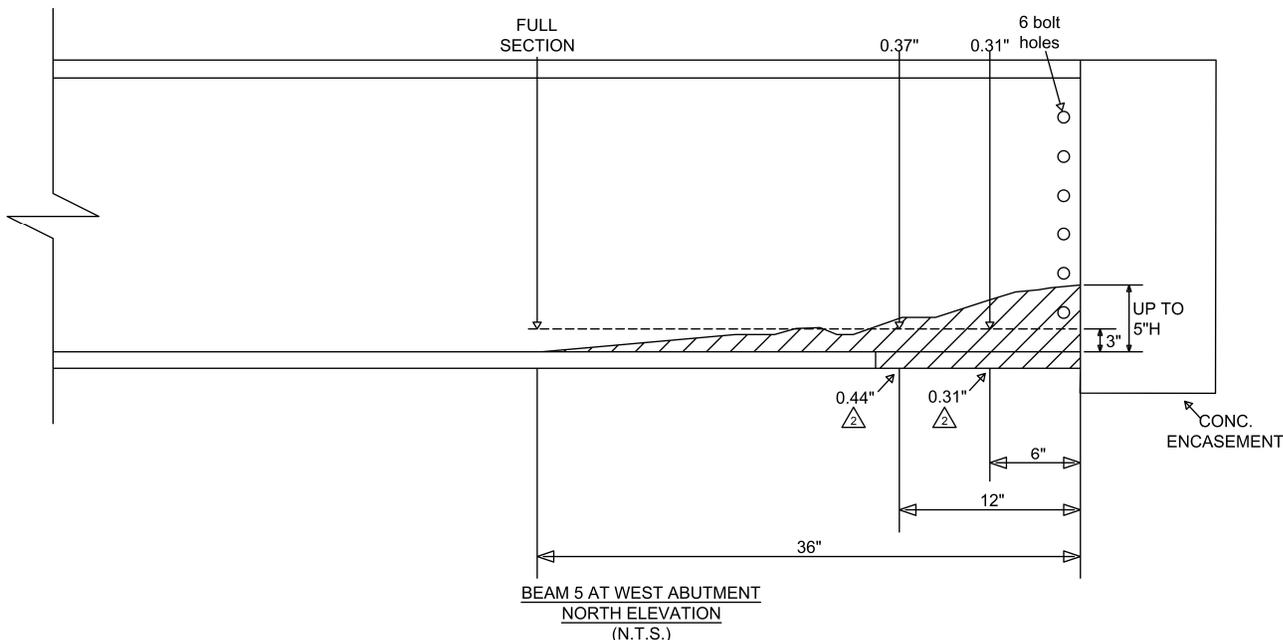
BEAM 5 AT WEST ABUTMENT
NORTH ELEVATION
(N.T.S.)

- Web and bottom flange at West Abutment: Section loss (**Sketch 7 and Photo 13**).

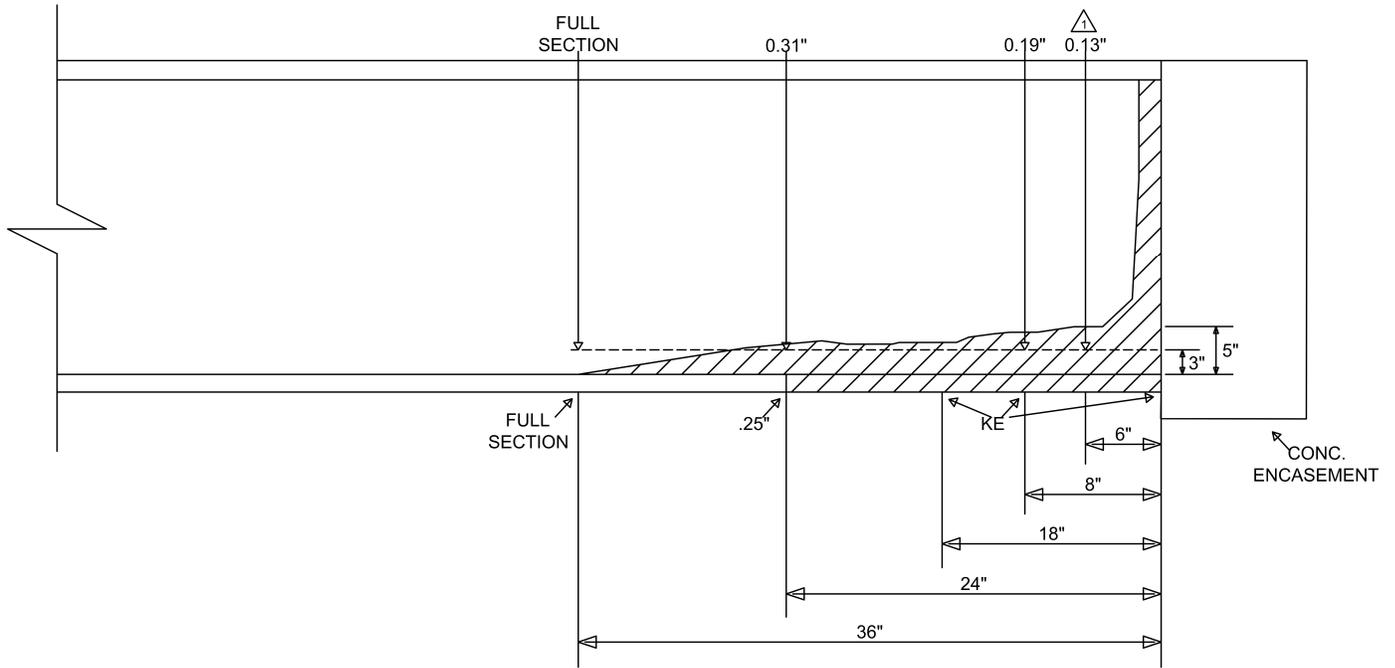
**BEAM 5 AT EAST ABUTMENT
SOUTH ELEVATION
(N.T.S.)**

- Web and bottom flange at East Abutment: Section loss (**Sketch 8**).

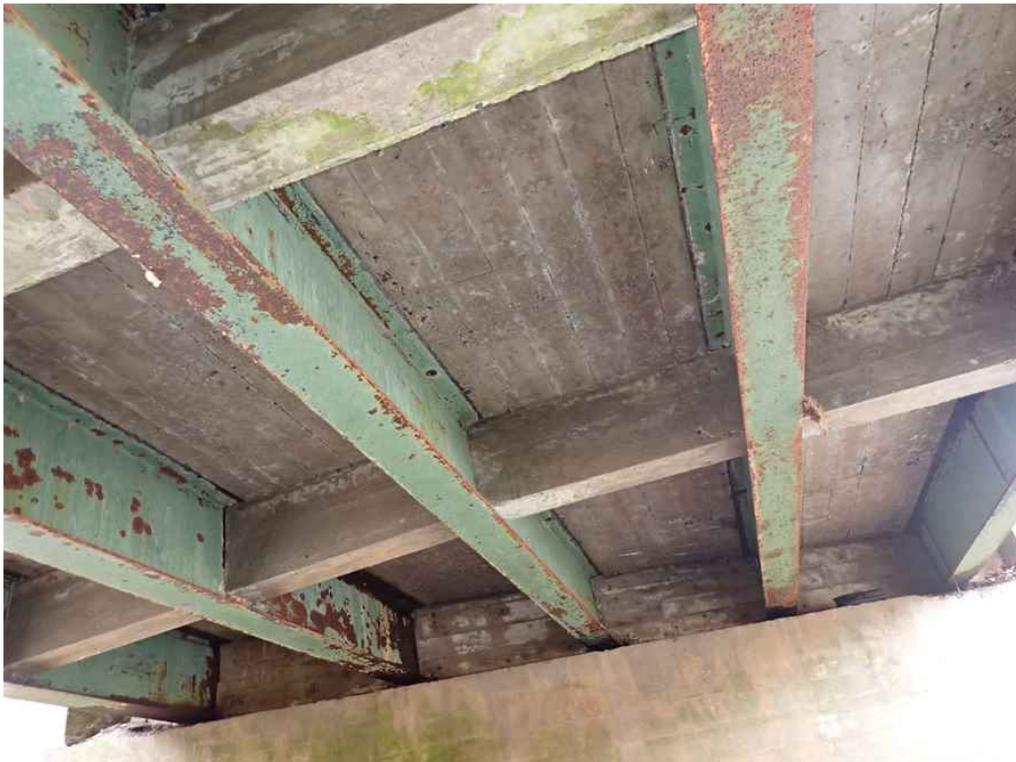
There is typically scattered freckled rust throughout the superstructure with isolated locations of failed paint and section loss to isolated beam ends (**Photos 8, 12 and 13**). All remaining paint is chalked.

Photo 8: Typical Underside, looking east. Scattered freckled rust with isolated locations of failed paint and section loss to isolated beams.

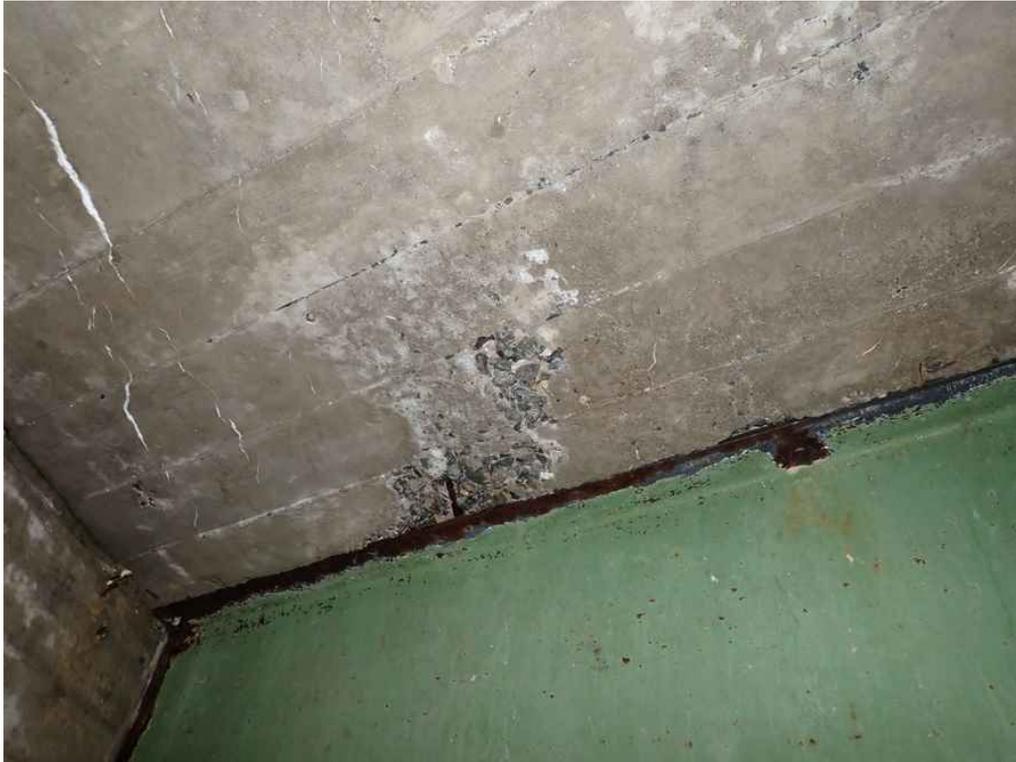
The deck has scattered transverse hairline cracks, with and without efflorescence, typically near the East Abutment. There are isolated spalls and honeycomb, with and without exposed rebar. There are scattered spalls with exposed rebar in the deck overhangs. See the following for specific locations and conditions.

Photo 9: Underside of deck at East Abutment in Bay 3 with honeycombing and hairline cracks with efflorescence.

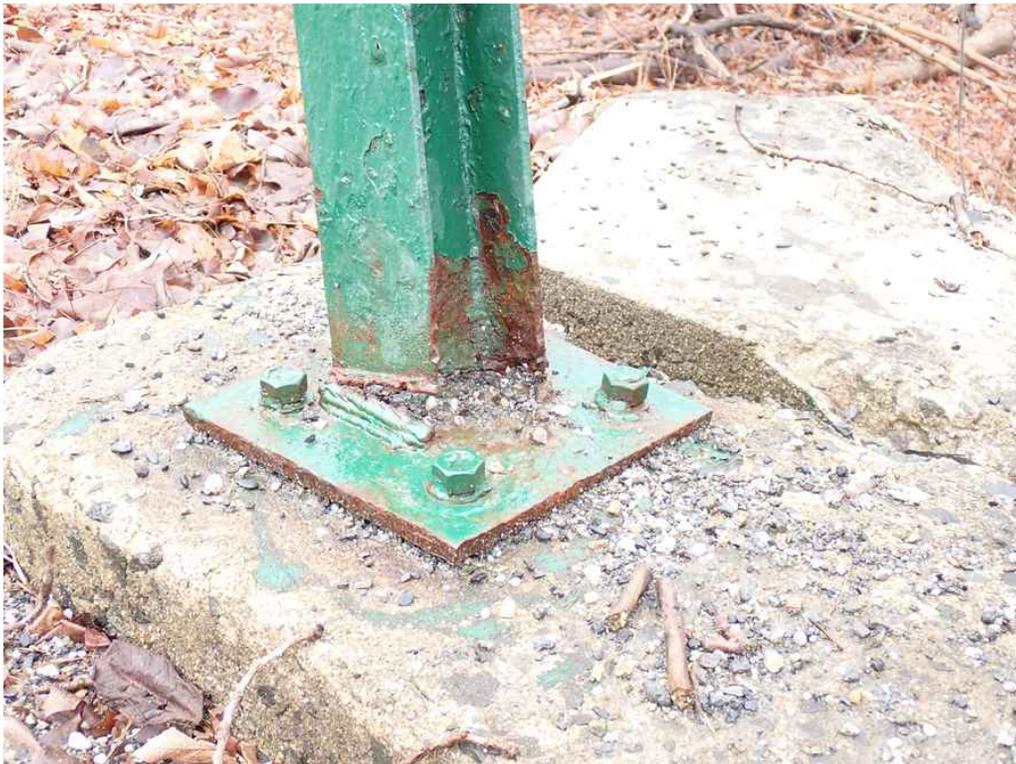
Photo 10: South Bridge Railing at 4th post from west with cracked weld along base plate.

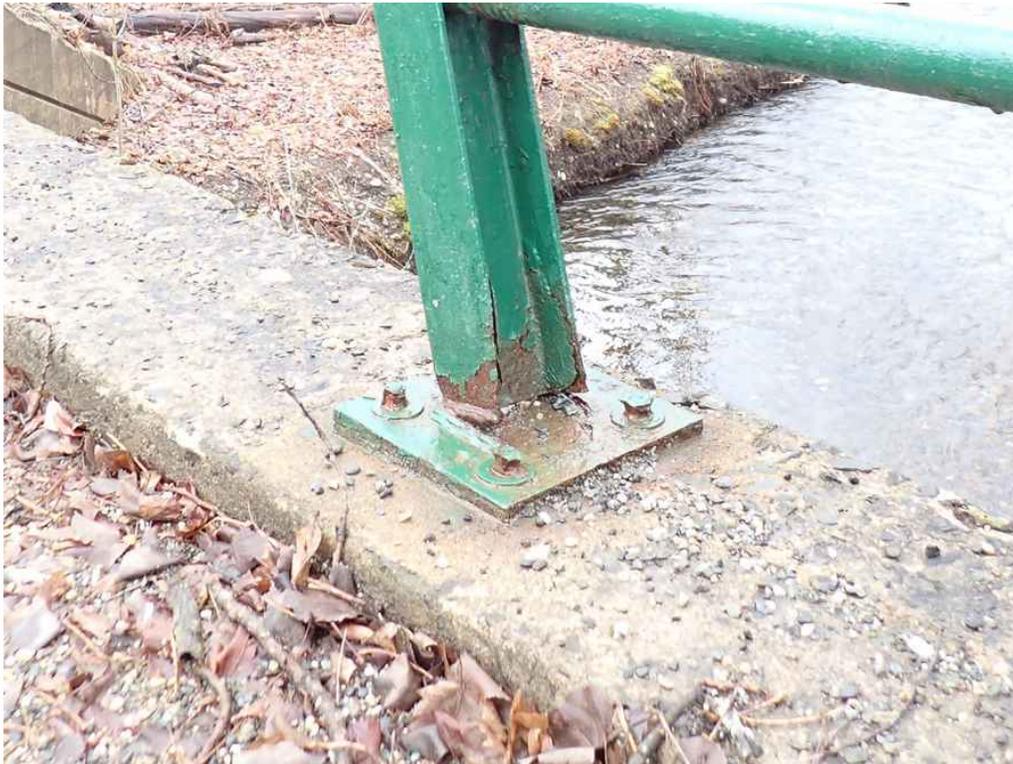
- First post from west: Previously noted cracked weld at base plate repaired.
- **DEF S-A: Second post from west: Tipped to the east and cracked weld along the base plate full length at north and 3-1/4" at south.**
- Third post from west: Tipped to the east. Previously noted cracked weld at base plate repaired.
- **DEF S-A: Fourth post from west: Tipped to the east and cracked weld along the base plate full length at north and 2-1/2" at south (Photo 10).**
- All railings anchor bolt nuts have light to moderate rust. Isolated anchor bolt nuts up to 100% section loss (**Photo 11**).
- East end of railing: Easily moved by hand.

Photo 11: South Bridge Railing at 2nd post from west with anchor bolt nut section loss.

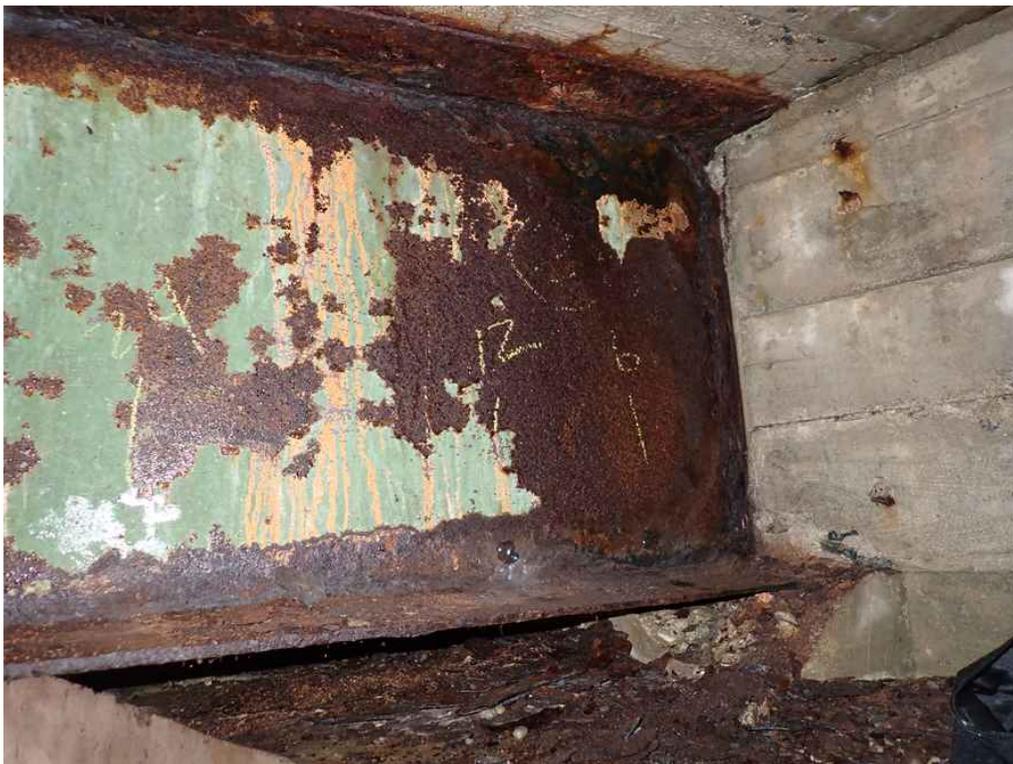
The beams have scattered areas of light rust throughout and isolated locations of heavy rust. The beam ends are partially encased in the concrete backwalls (**Photos 12-13**). The visible portion of the beam ends have isolated locations of up to 5/16" section loss (0.13" remaining). The beam properties vary from 21" WF 59 beams specified in the design plans (**Sketch 4**). There are typically 1" diameter holes in each bottom flange over the abutments. There is an isolated location with six (6) 1" diameter holes in the web near the beam end. See the following for locations and conditions.

Photo 12: Beam 2 South Face at East Abutment with section loss to web, top flange and bottom flange. Note: the beam end is embedded in the concrete backwall.

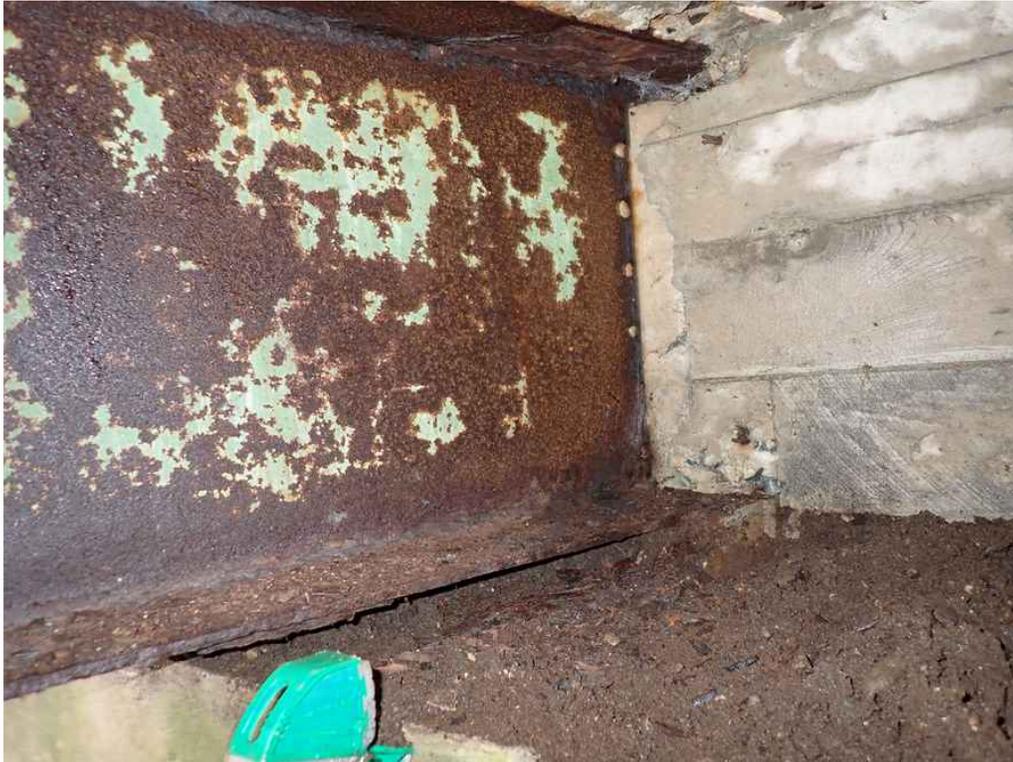
Photo 13: Beam 5 North Face at West Abutment with six (6) holes in the web and section loss to the web and bottom flange. Note: the beam end is embedded in the concrete backwall.

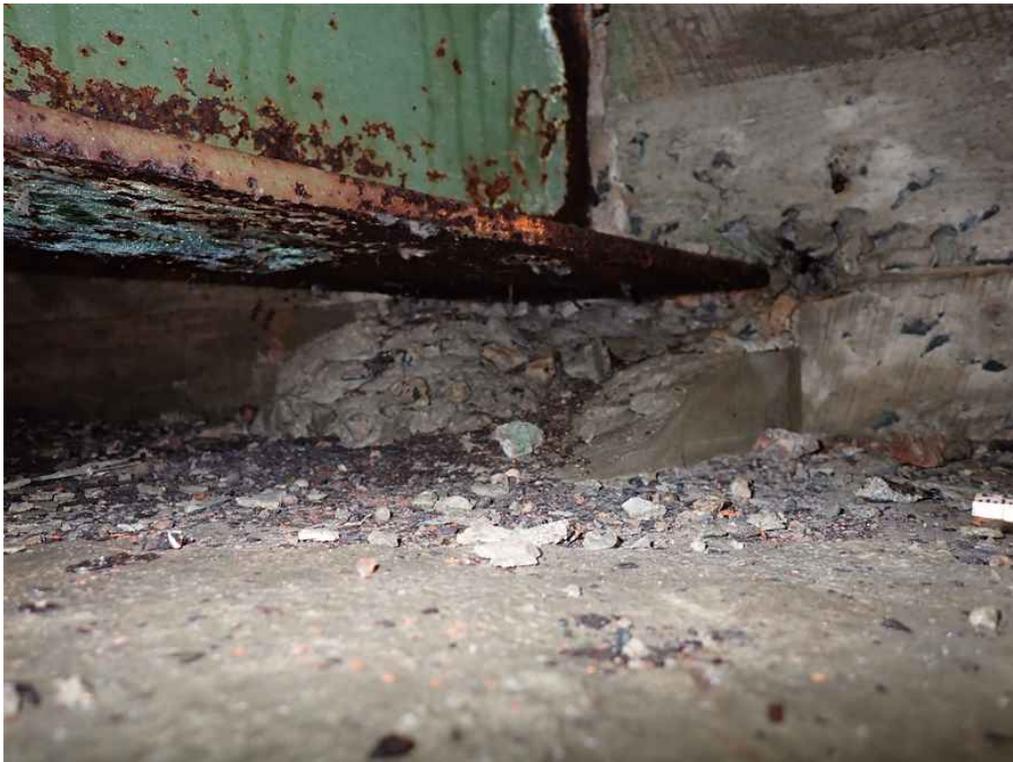
The bearings are not visible and typically embedded in the concrete backwalls (**Photos 14**). This differs from the available plans.

The pedestals are partially embedded in the concrete backwalls (**Photo 14**). The visible portion of the pedestals are typically spalled up to full length x full width x full height. See the following for specific locations and conditions.

- Beam 1: 12" long x up to 5" wide x up to full height spall.
- Beam 2: 7" long x up to 7" wide x up to full height spall.
- Beam 3: 12" long x full width of visible portion x full height spall (**Photo 14**).
- Beam 4: 12" long x up to 5" wide x up to 1-1/4" high spall.
- Beam 5: 12" long x full width of visible portion x full height spall.

Photo 14: Beam 3 Pedestal at East Abutment with spall. Note: the bearing is embedded in the concrete backwall.

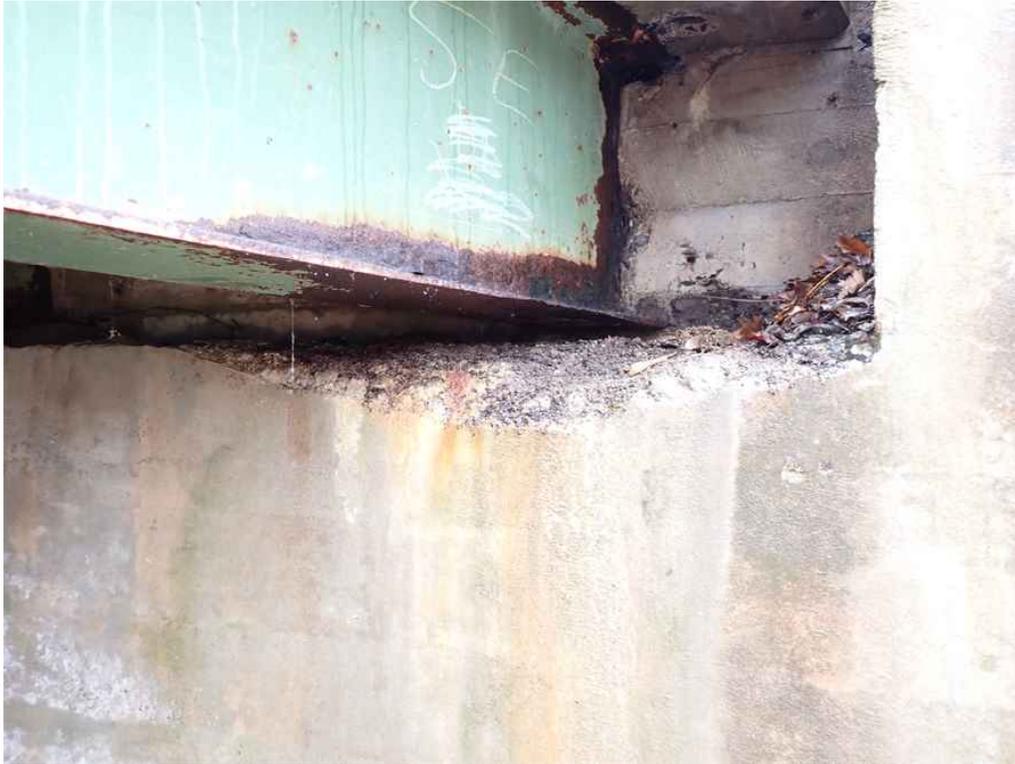
- Below Beam 5 at East Abutment: 3'-0" long x 4" high x up to 6" deep area of scaling that extends onto the breastwall (**Photo 15**).

Photo 15: East Abutment bridge seat below Beam 5 with an area of scale that extends onto the breastwall.

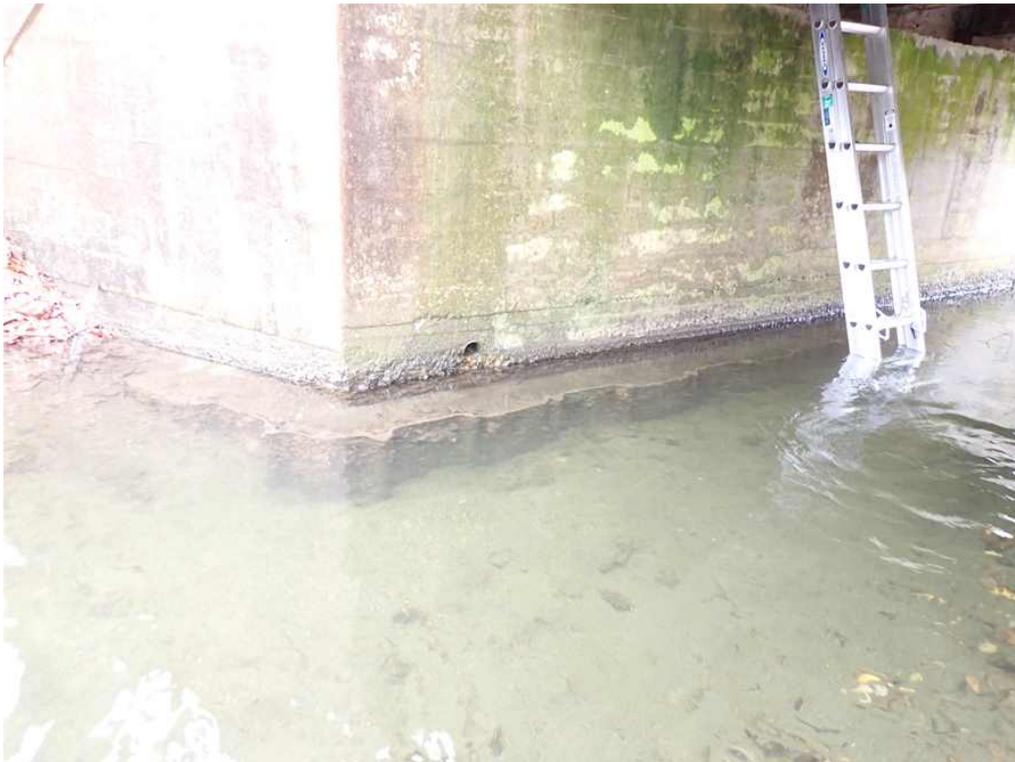
- At the water line: Full length x up to 1'-2" high x 1-1/2" deep area of abrasion, worst at southeast end (**Photo 16**).

There is an exposed steel sheet pile along the West Breastwall, that extends along both wingwalls full length x up to 2'-8" high at north end and 2'-1" high at south end (**Photo 16**).

Photo 16: Abrasion at the waterline along the West Breastwall. Exposed steel sheet pile along Southwest Wingwall and West Breastwall.

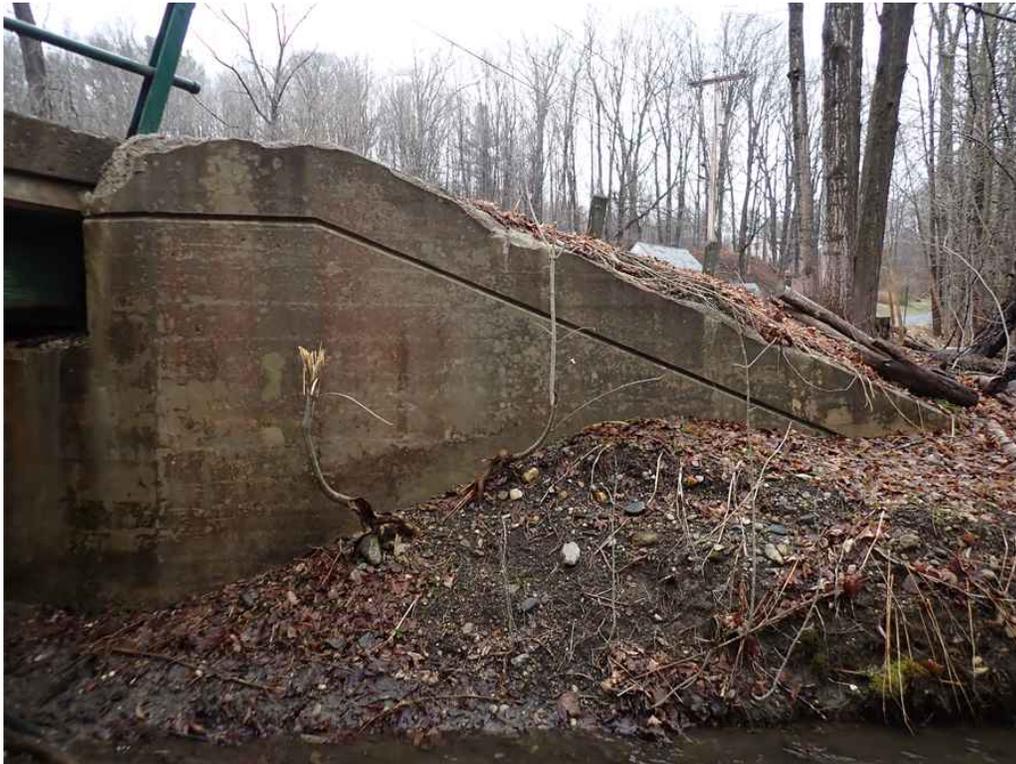
- At the top adjacent to the East Abutment: 1'-0" long x 1'-0" high x up to 4" deep area of scale (**Photo 17**).
- At the top: Up to 13'-0" long x 5" high x up to 8" deep area of scale (**Photo 17**).

Photo 17: Scale along top of Southeast Wingwall.

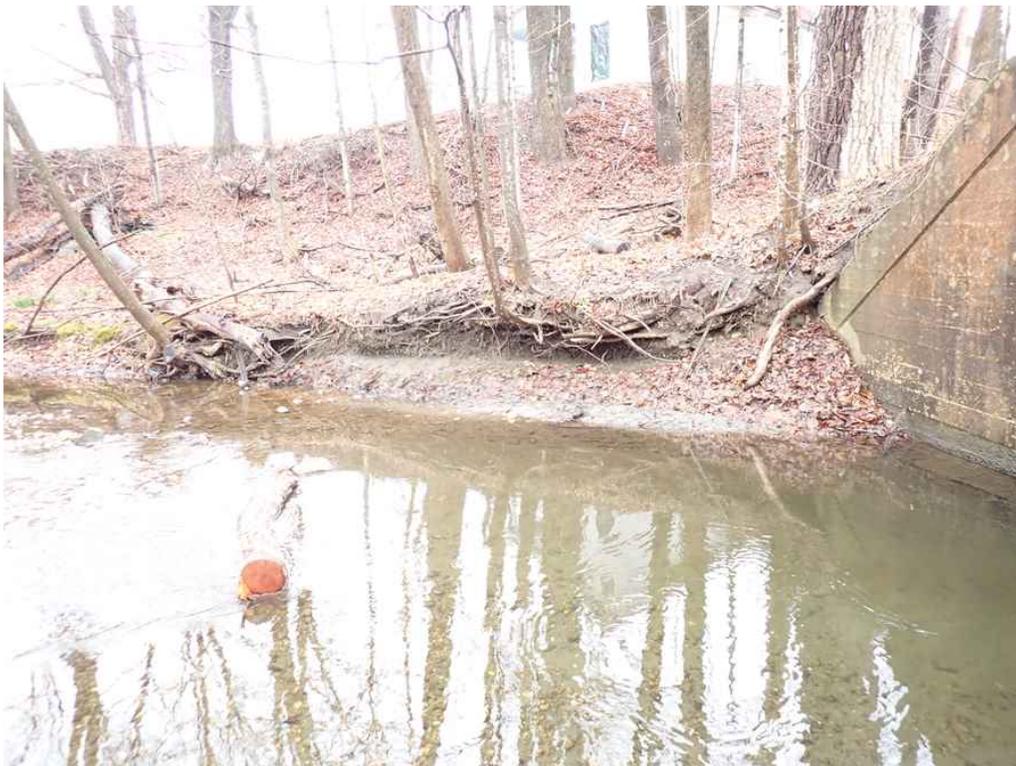
The Southwest Embankment, just downstream from the wingwall has an area of erosion with undercutting and exposed tree roots up to 4'-0" high x 3'-0" deep (**Photo 18**).

Photo 18: Erosion with undercutting and exposed tree roots at Southwest Embankment.

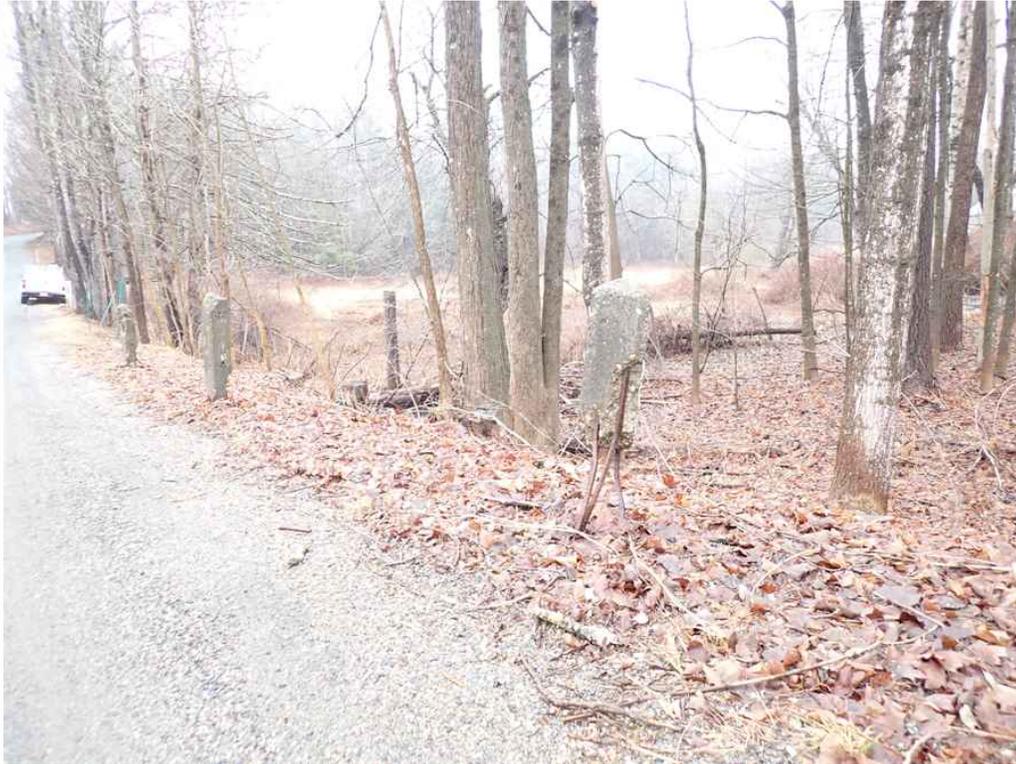
The east transitions consist of single concrete posts. The posts are tipped and severely spalled with no rail in place (**Photo 19**).

The east approach guardrails consist of single concrete posts. The posts are tipped and severely spalled with no rail in place (**Photo 19**).

Photo 19: Southeast Approach Guardrail posts are severely spalled with no rail in place.
