STRUCTURES INSPECTION FIELD REPORT

SPECIAL MEMBER INSPECTION

B.I.N.
5CV

CITY/TOWN ASHFIELD	8-STRUCTURE NO. A13029-5CV-MUN-BRI	11-Kilo. POINT 000.000	90-ROUTINE INSP. DATE Jul 18, 2023	93*-SPEC. MEMB. INSP. DATE Jul 23, 2024
07-FACILITY CARRIED HWY SMITH BR RD	MEMORIAL NAME/LOCAL NAME		27-YR BUILT 1939	106-YR REBUILT 1964
06-FEATURES INTERSECTED WATER SMITH BROOK	26-FUNCTIONAL CLASS Rural Local	DIST. BRIDGE INSPECTION ENGINEER <i>M. P.E. McCabe</i>		
43-STRUCTURE TYPE 302 : Steel Stringer/Girder	22-OWNER Town Agency	21-MAINTAINER Town Agency	TEAM LEADER R. Mancari <i>Reed Mancari</i>	
107-DECK TYPE 1 : Concrete Cast-in-Place	WEATHER Sunny	TEMP. (air) 18°C	TEAM MEMBERS M. RANZONI <i>Matthew Ranzoni</i>

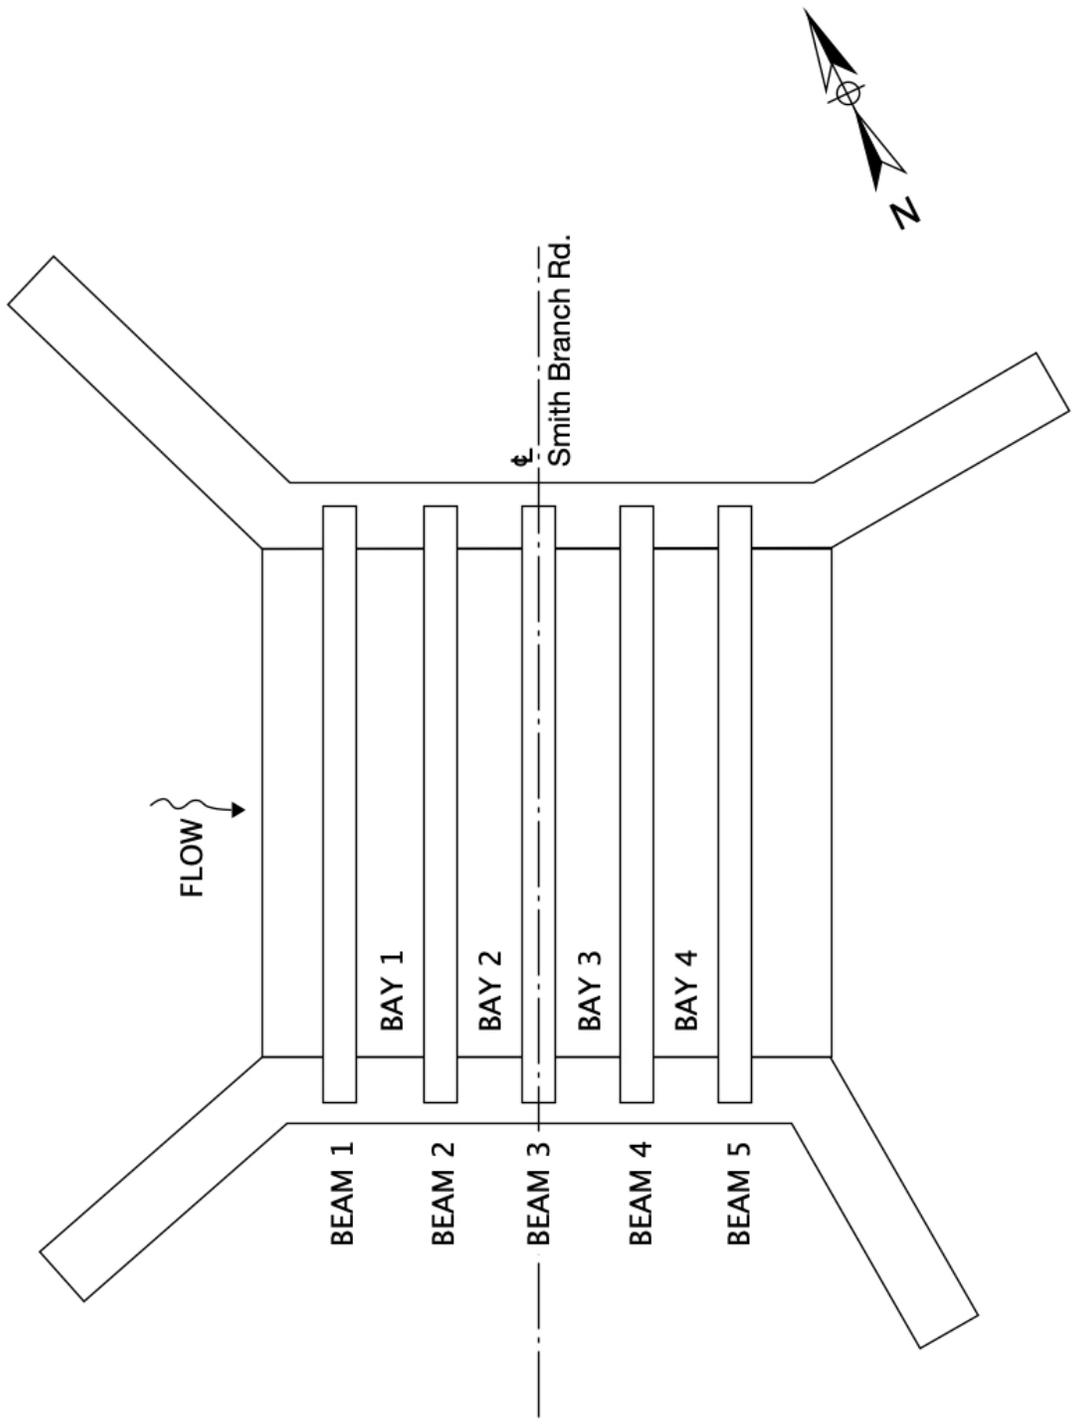
Smith Branch Road travels north and south. Smith Brook flows west to east. This single span structure consists of five steel beams supporting a reinforced concrete deck with a gravel wearing surface. The beams and bays are numbered west to east, upstream to downstream, in accordance with the 2015 Bridge Inspection Handbook. See sketch 1 and photos 1 & 2.

Sketch 1: Framing plan.

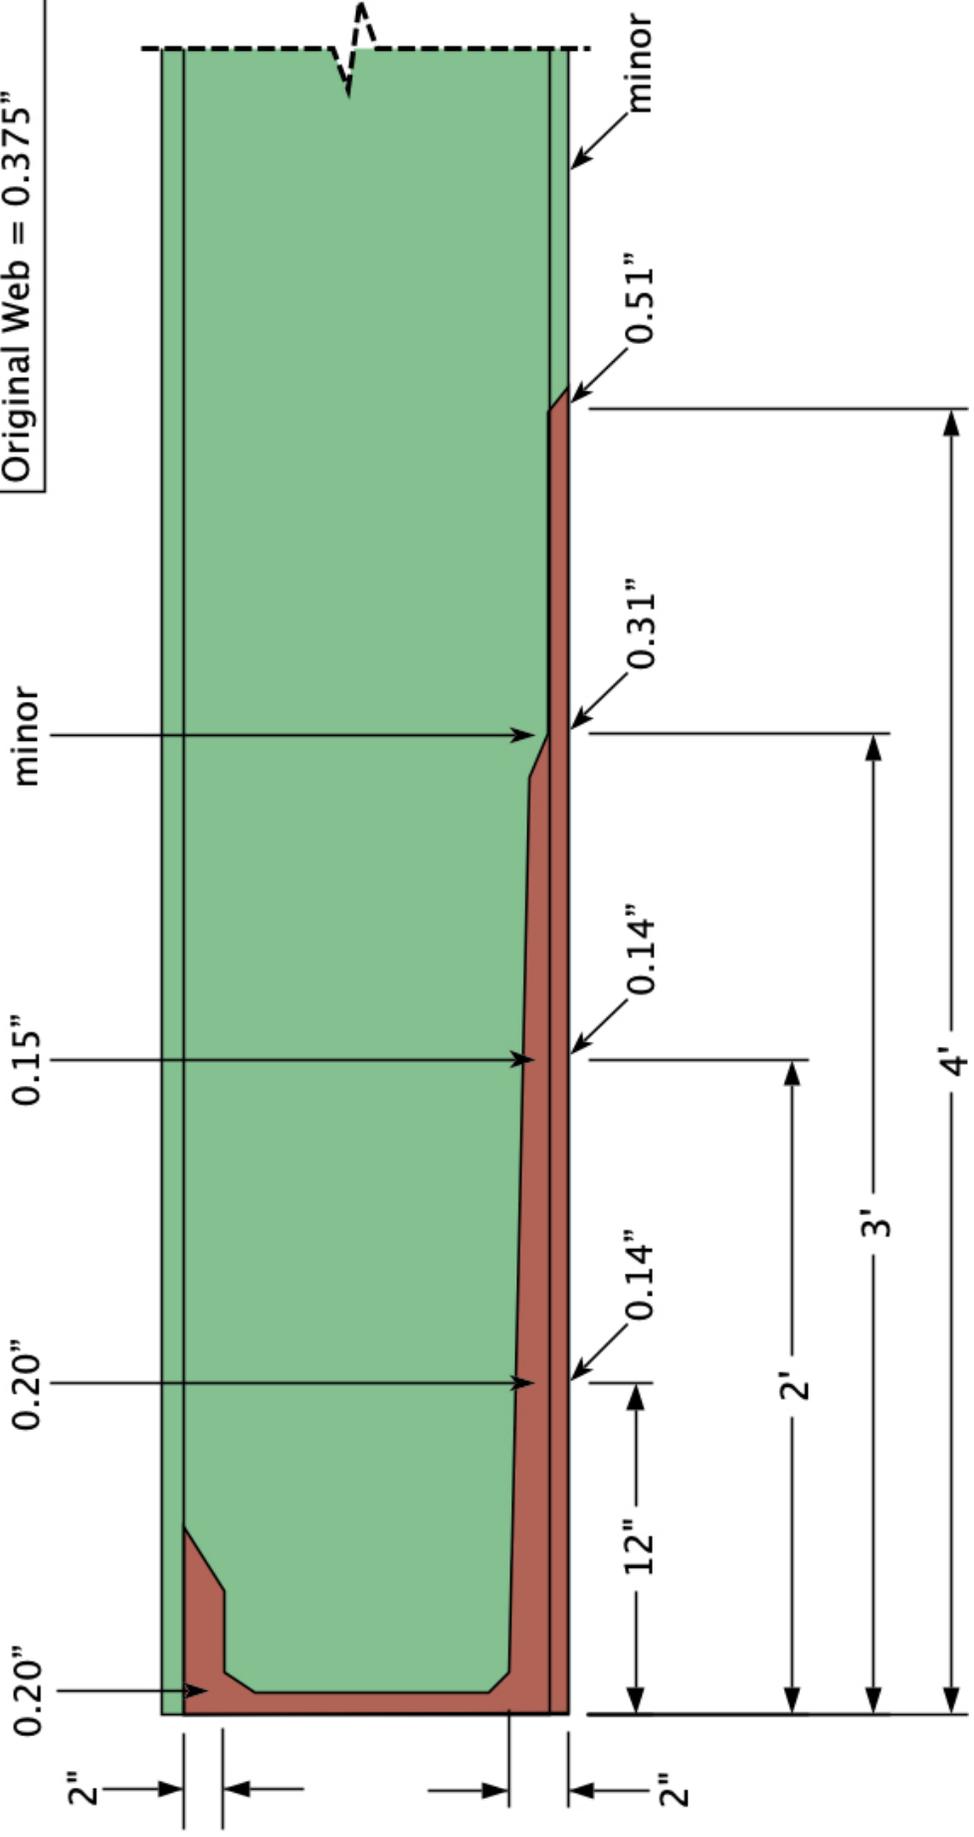
Beam 1 – North End (West Elevation)

Beams 1, 2, 4 and 5, at the north ends, have moderate to severe rusting, with up to 100% section loss. See sketches 2 - 5 and photos 3 - 6.

Original Section: 16" WF 50#
Original Flange = 0.625"
Original Web = 0.375"

Sketch 2: Beam 1 section loss.

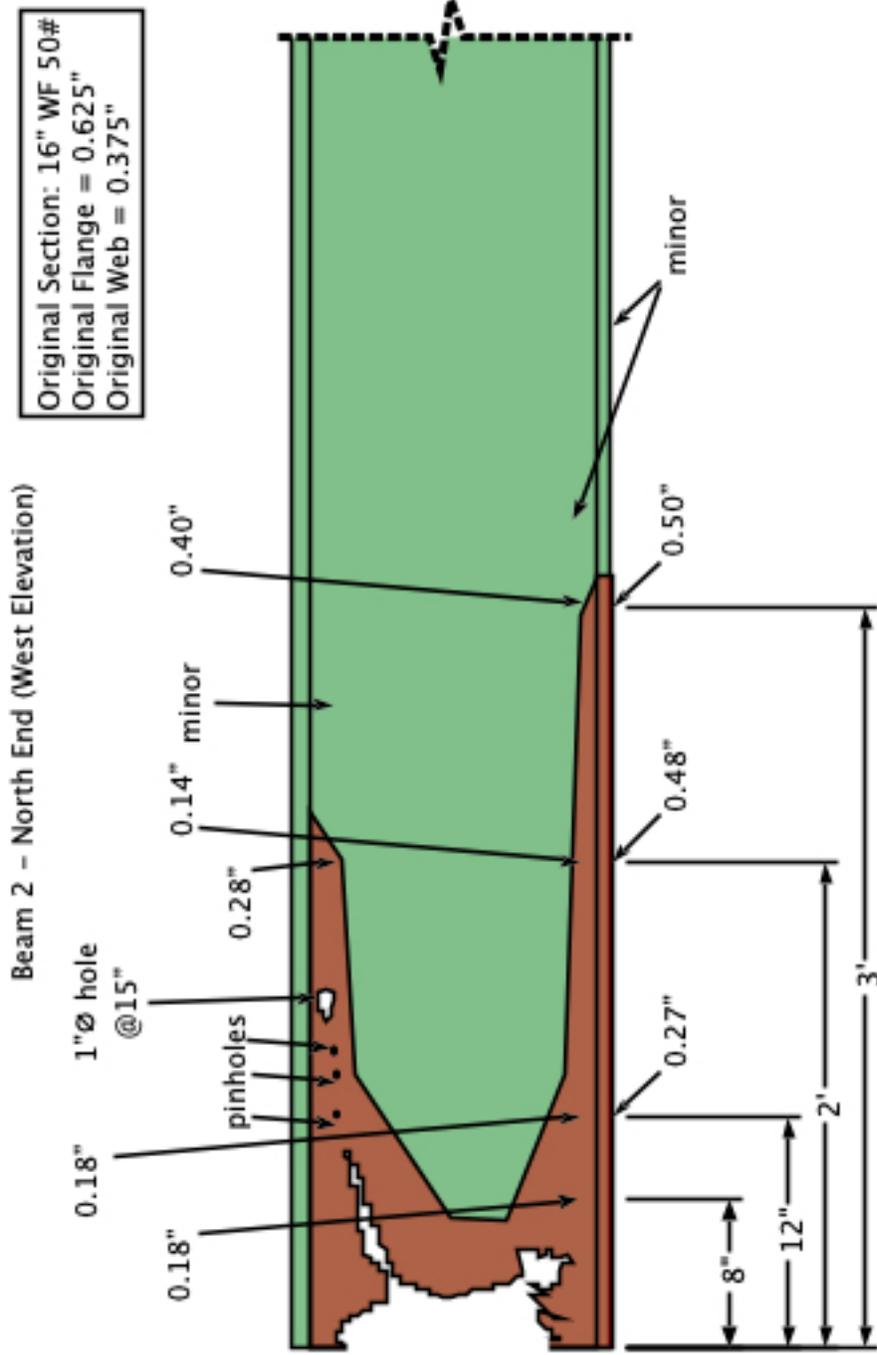
Sketch 3: Beam 2 section loss.

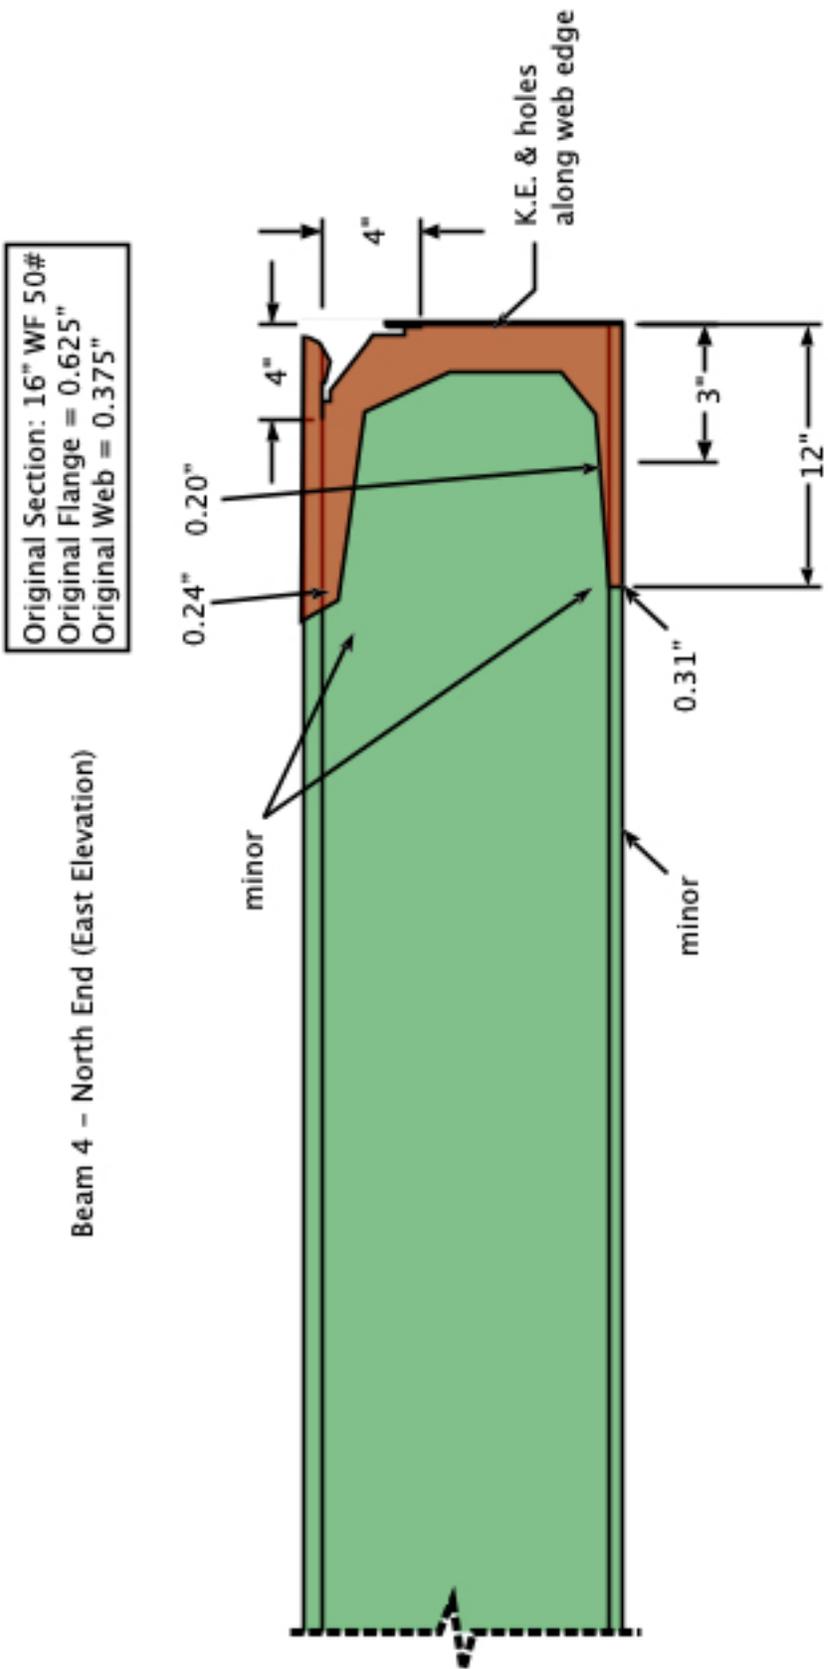
Beam 4 – North End (East Elevation)

Sketch 4: Beam 4 section loss.

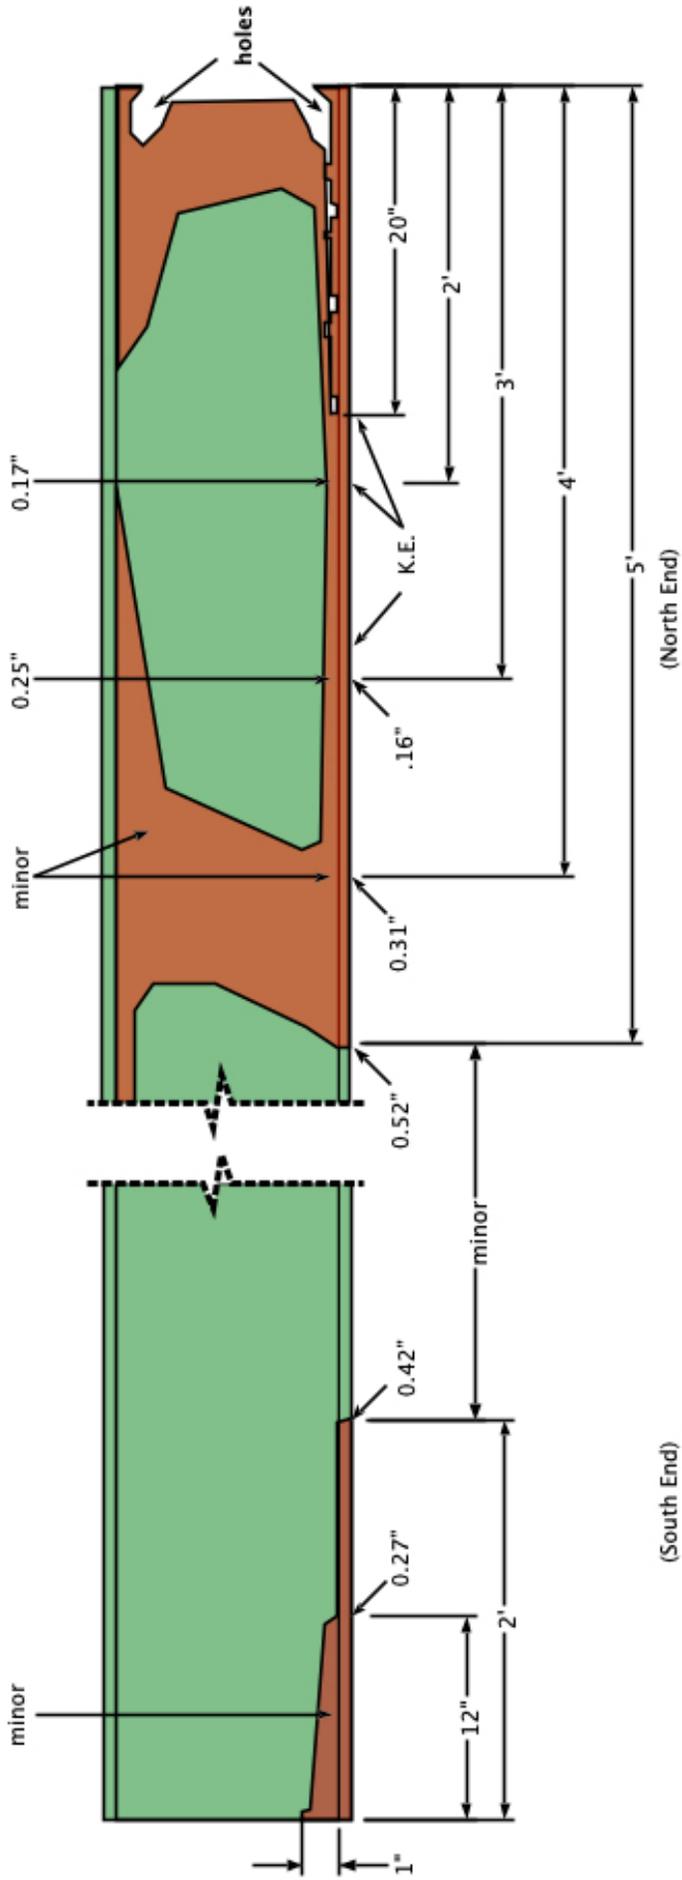
Beam 5 - East Elevation

Original Section: 16" WF 50#
 Original Flange = 0.625"
 Original Web = 0.375"

Sketch 5: Beam 5 section loss.

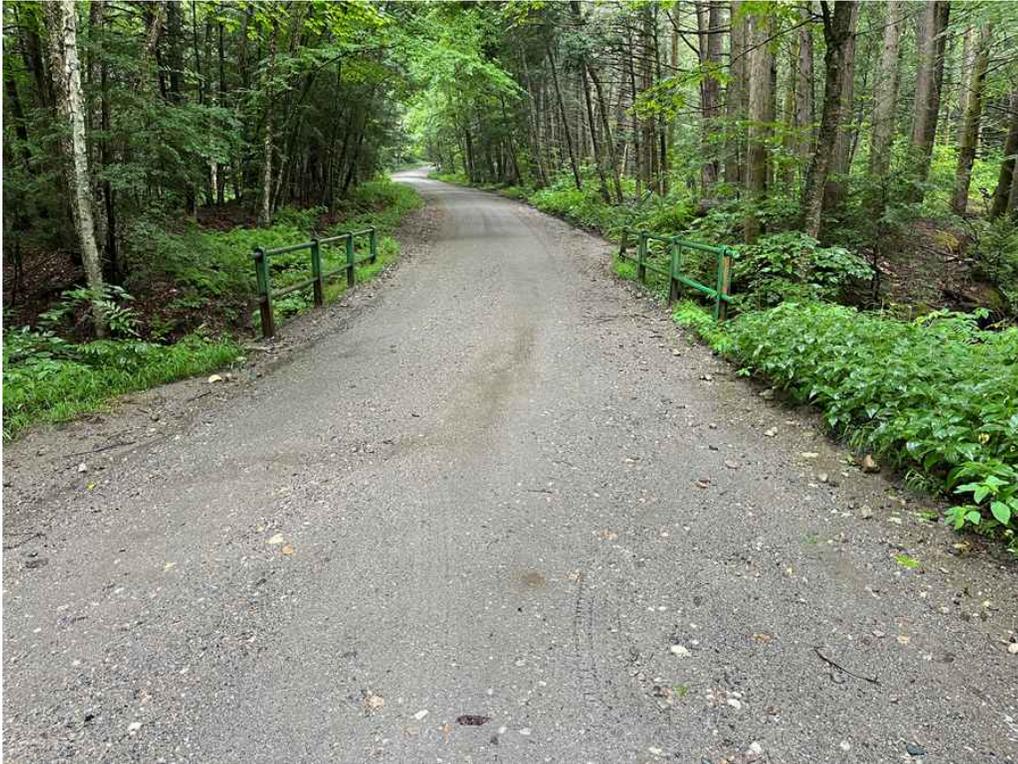
Photo 1: General topside, looking south.

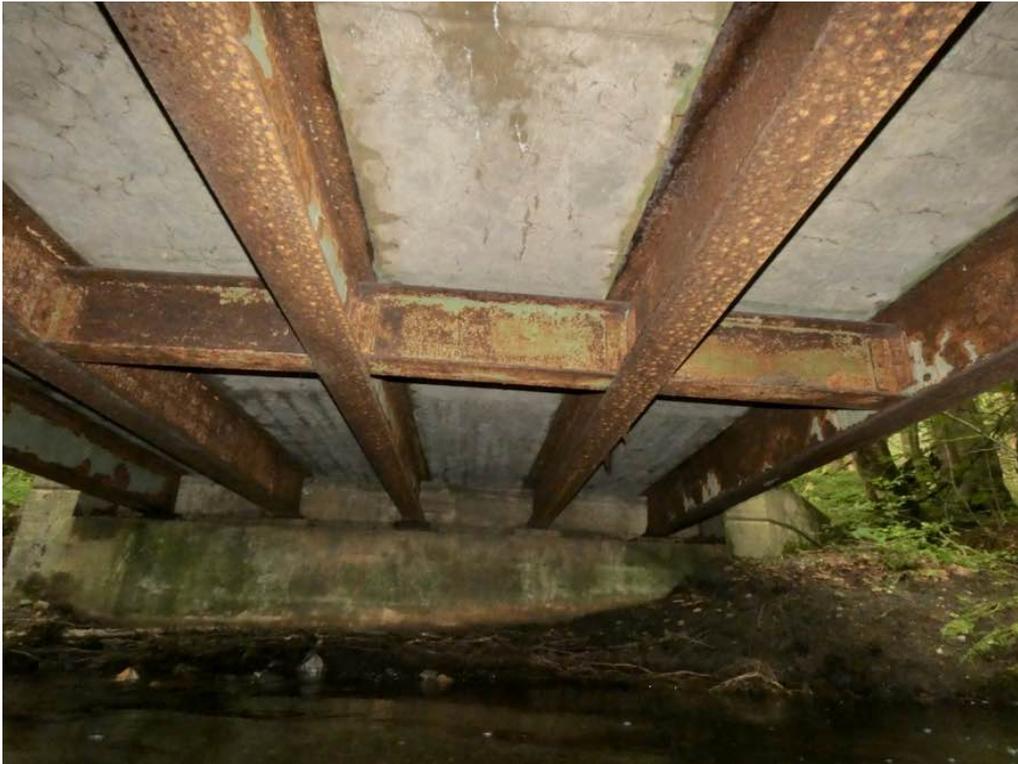
All beams have widespread rusting with random bird nests on the bottom flanges. See photo 2.

Photo 2: General underside, looking south.

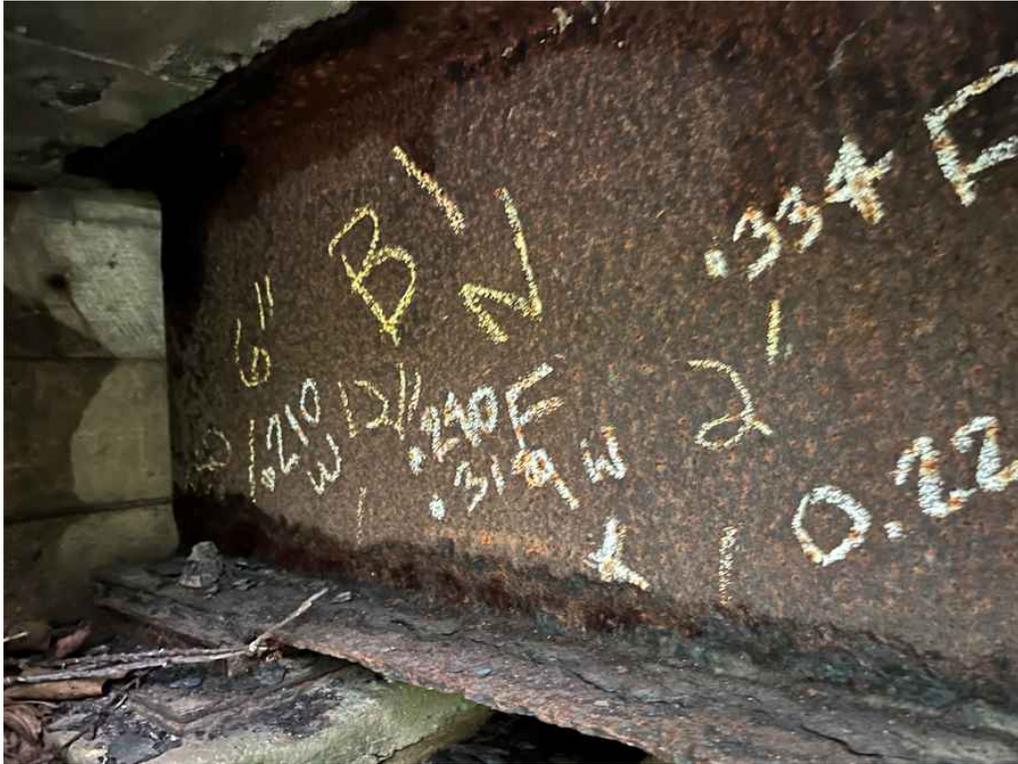
Photo 3: Beam 1 north end section loss.

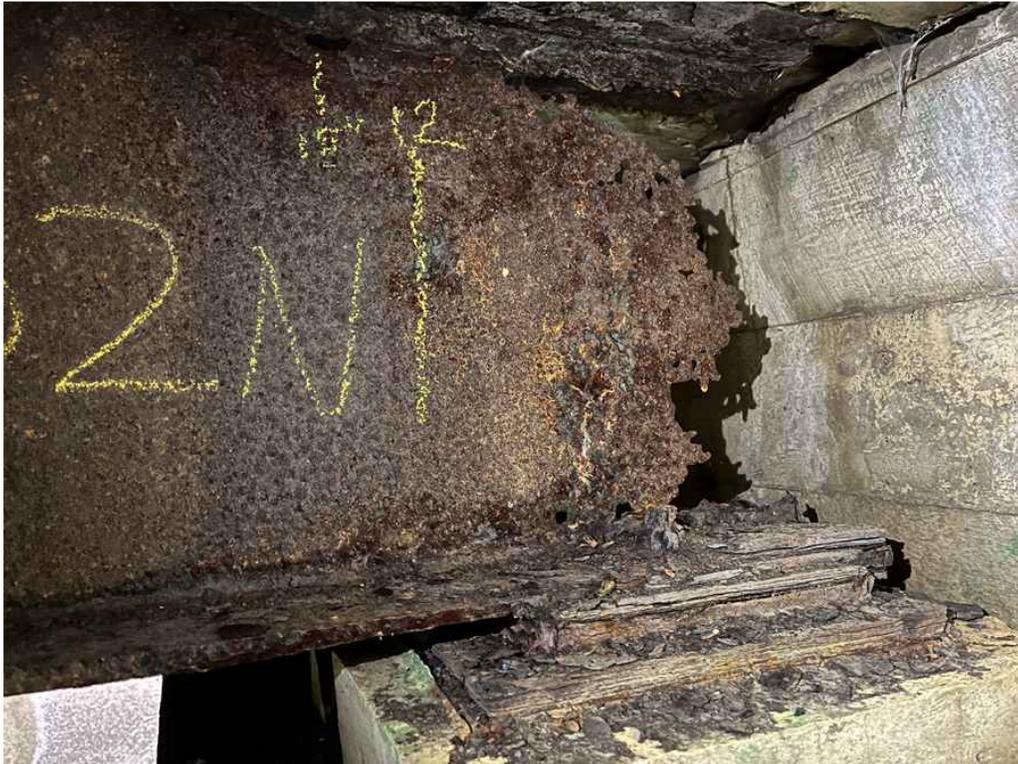
Beams 2 and 5, at the north ends, have minor out of plane bending. See photos 4 & 6.

Photo 4: Beam 2 north end section loss.

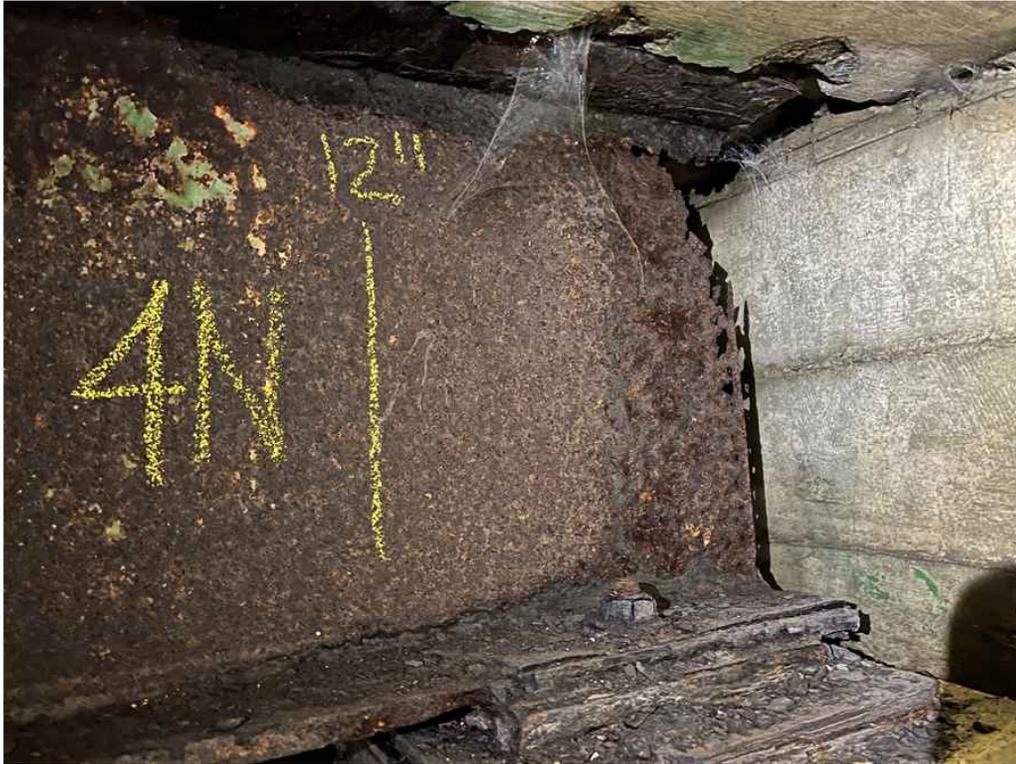
Photo 5: Beam 4 north end section loss.

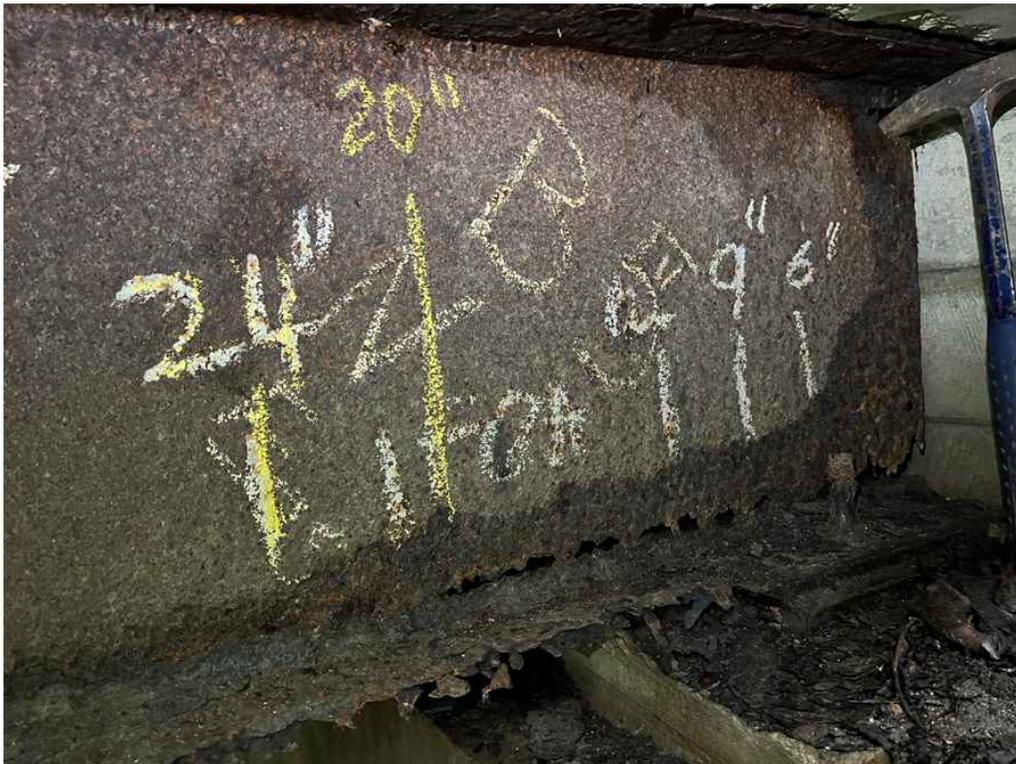
Photo 6: Beam 5 north end section loss.
