STRUCTURES INSPECTION FIELD REPORT

B.I.N.
C6V

ROUTINE INSPECTION

CITY/TOWN ASHFIELD	8.-STRUCTURE NO. A13028-C6V-MUN-NBI	11-Kilo. POINT 000.000	41-STATUS A:OPEN	90-ROUTINE INSP. DATE JUL 8, 2025
07-FACILITY CARRIED HWY WATSON RD	MEMORIAL NAME/LOCAL NAME	27-YR BUILT 2021	106-YR REBUILT 0000	YR REHAB'D (NON 106) 0000
06-FEATURES INTERSECTED WATER SWIFT RIVER	26-FUNCTIONAL CLASS Rural Local	DIST. BRIDGE INSPECTION ENGINEER M. P.E. McCabe <i>Michael P.E. McCabe</i>		
43-STRUCTURE TYPE 107 : Concrete Frame	22-OWNER Town Agency	21-MAINTAINER Town Agency	TEAM LEADER R. Mancari <i>Reed Mancari</i>	
107-DECK TYPE 2 : Concrete Precast Panels	WEATHER Cloudy	TEMP. (air) 24°C	TEAM MEMBERS E. GEMINDER <i>E. Geminder</i>

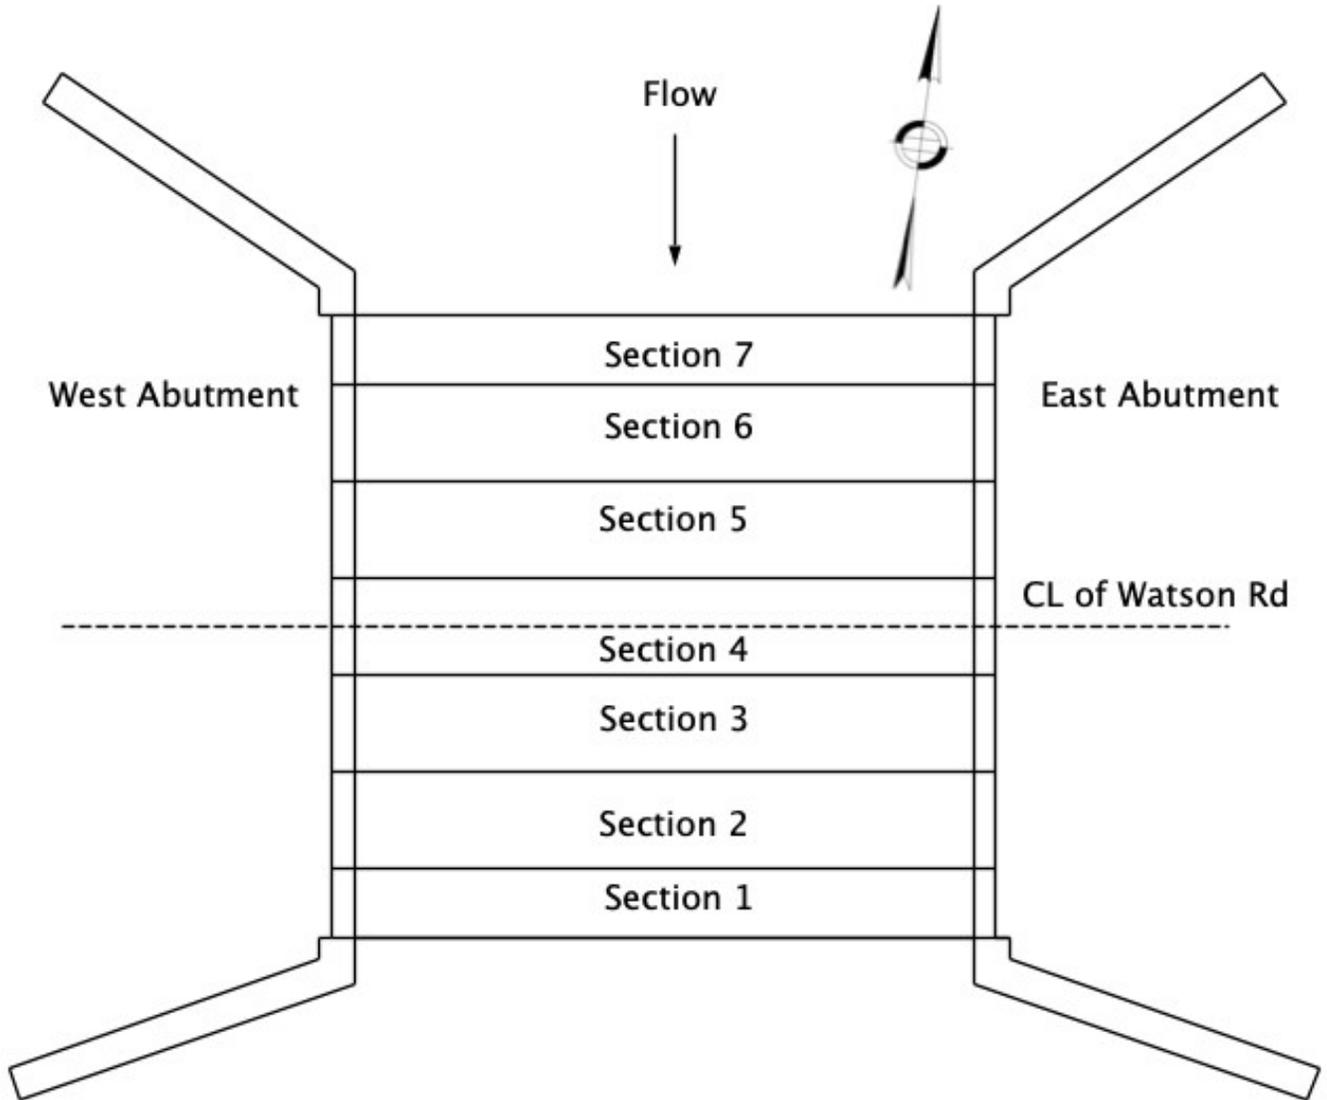
Sketch 1: Framing plan.

Watson Road travels east and west. Swift River flows from north to south. This structure consists of seven precast concrete rigid frame sections supporting fill with an asphalt wearing surface. The sections are numbered from south to north, downstream to upstream, in accordance with the 2015 Bridge Inspection Handbook. **See Sketch 1 and Photos 1 & 2.**

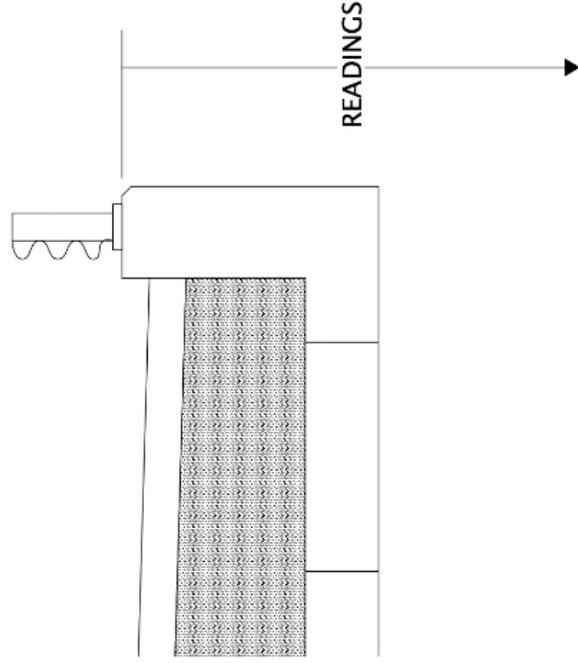
Chart 1: Channel profile readings

For channel profile readings, refer to Chart 1.

A13028 Channel Profile Readings (ft.x)										
DATE	North Fascia					South Fascia				
	East Abutment	Post	Post	West Abutment	Post	East Abutment	Post	Post	West Abutment	Post
7/18/2023	11.2	13.3	14.8	12.8	11.3	11.3	13.1	15.0	14.1	11.5
7/8/2025	11.0	12.7	14.5	12.4	10.8	11.3	13.4	14.8	13.8	11.3

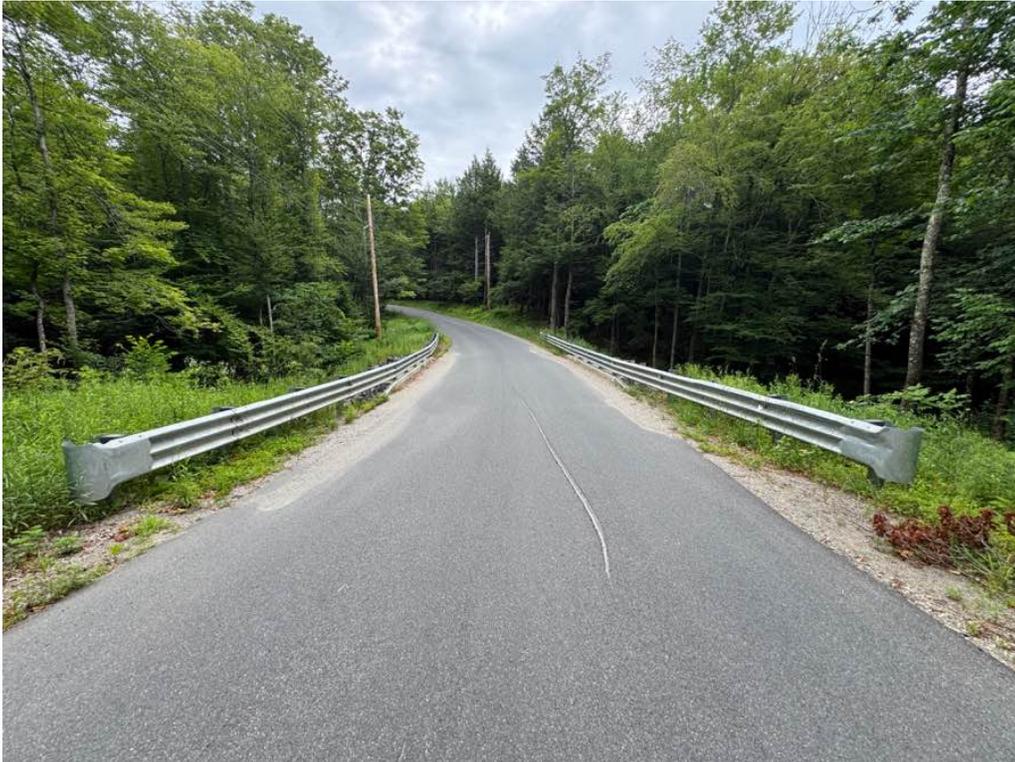
Starting in the west approach, there is a deep plow scrape along the centerline, 35' long x 3" wide x 1" deep. **See Photo 1.**

Photo 1: General topside, looking east. Note scrape in roadway.

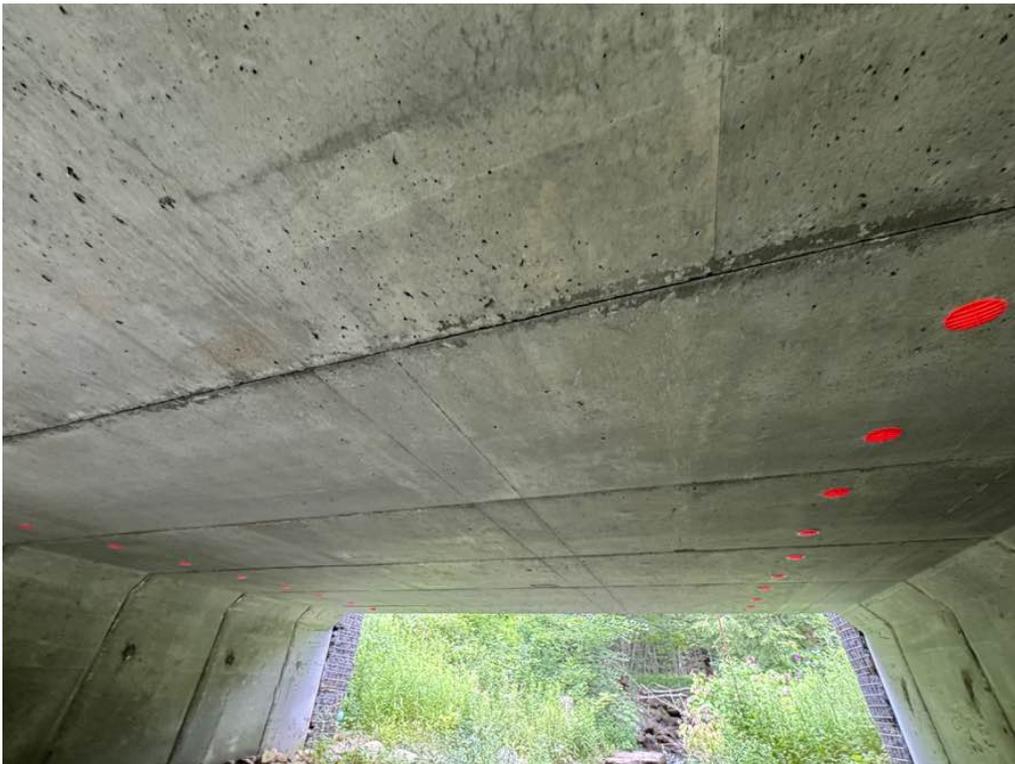
All section joints, at the walls, have evidence of leakage with light efflorescence.

All plastic void plugs are still in place. **See Photo 2.**

Photo 2: General underside, looking south. Note the void plugs left in place.

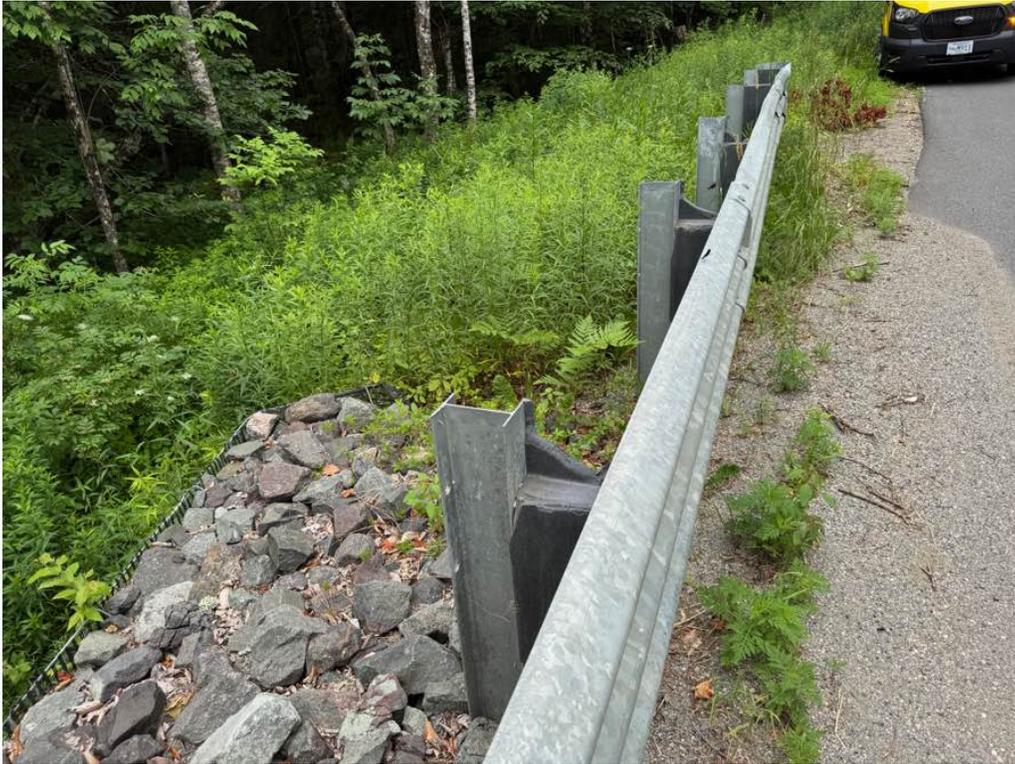
In both south approaches, there are several broken blockouts. **See Photo 3.**

Photo 3: Southwest approach with broken blockouts.

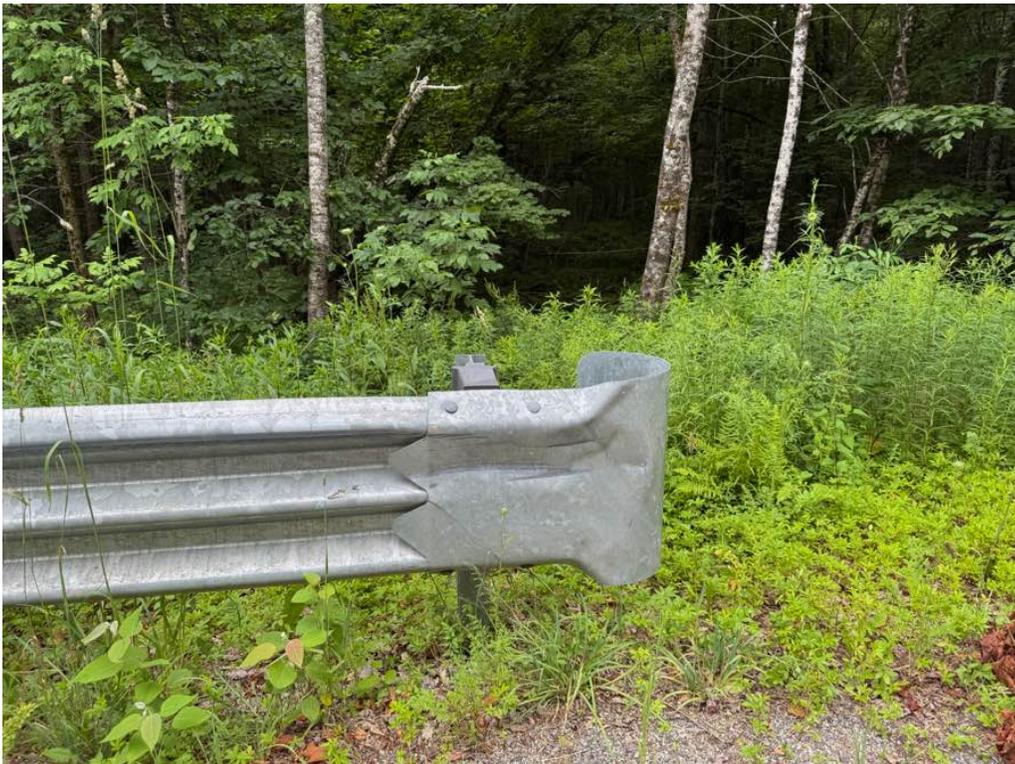
In the southwest steel terminal end, there is minor collision damage. **See Photo 4.**

Photo 4: Southwest terminal end with collision damage.
