STRUCTURES INSPECTION FIELD REPORT

B.I.N.  
0EF

BR. DEPT. NO.  
A-13-024

CITY/TOWN <b>ASHFIELD</b>	8.-STRUCTURE NO. <b>A13024-0EF-MUN-NBI</b>	11-Kilo. POINT <b>000.000</b>	90-ROUTINE INSP. DATE <b>Mar 21, 2025</b>	INSPECTION DATE <b>Jul 8, 2025</b>
07-FACILITY CARRIED <b>HWY WILLIAMSBURG</b>	MEMORIAL NAME/LOCAL NAME	27-YR BUILT <b>1938</b>	106-YR REBUILT <b>0000</b>	*YR REHAB'D (NON 106) <b>0000</b>
06-FEATURES INTERSECTED <b>WATER CREAMERY BROOK</b>	26-FUNCTIONAL CLASS <b>Major Collector</b>	DIST. BRIDGE INSPECTION ENGINEER <i>M. P.E. McCabe</i>		
43-STRUCTURE TYPE <b>302 : Steel Stringer/Girder</b>	22-OWNER <b>Town Agency</b>	21-MAINTAINER <b>Town Agency</b>	TEAM LEADER R. Mancari <i>Reed Mancari</i>	
107-DECK TYPE <b>1 : Concrete Cast-in-Place</b>	WEATHER <b>Cloudy</b>	TEMP. (air) <b>25°C</b>	TEAM MEMBERS <b>E. GEMINDER</b> <i>E. Geminder</i>

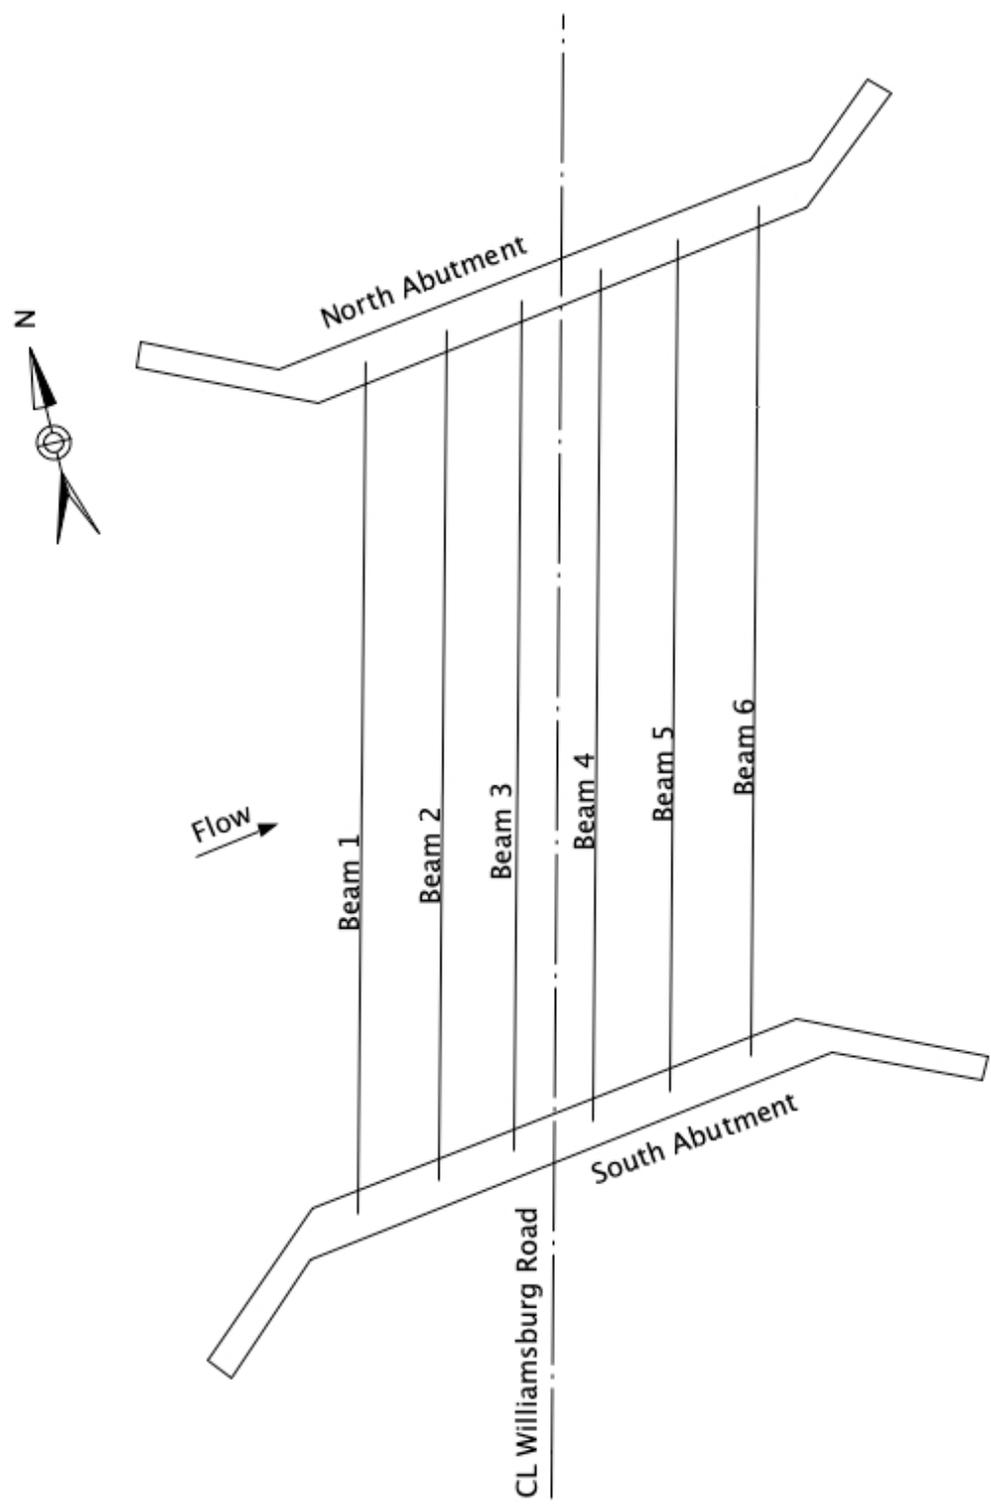
Sketch 1: Framing plan.

Williamsburg Road travels north and south. Creamery Brook flows from west to east. This single span structure consists of six steel beams, supporting a concrete deck, with an asphalt wearing surface. The beams and bays are numbered from west to east, upstream to downstream, in accordance with the 2004 Rating Report. **See Sketch 1 & Photos 1 & 2.**

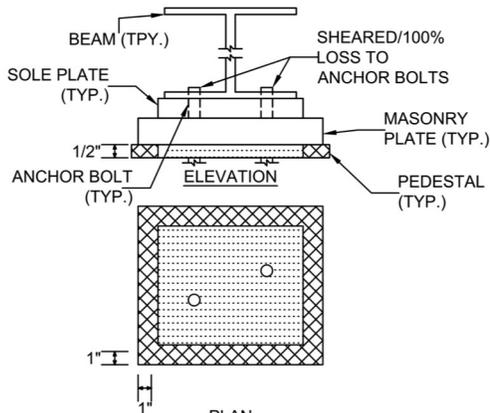
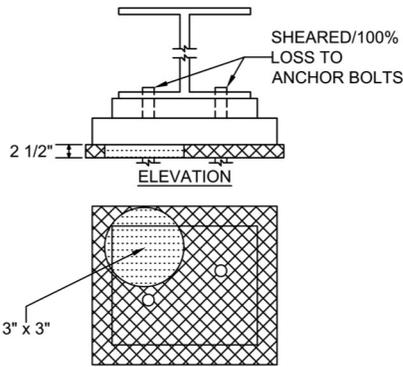
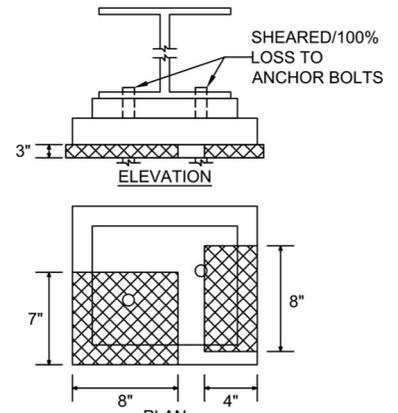
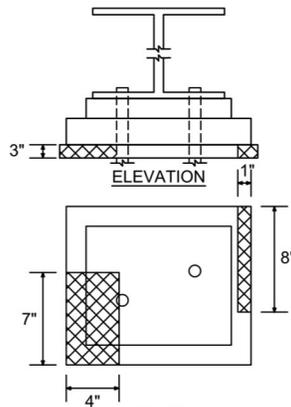
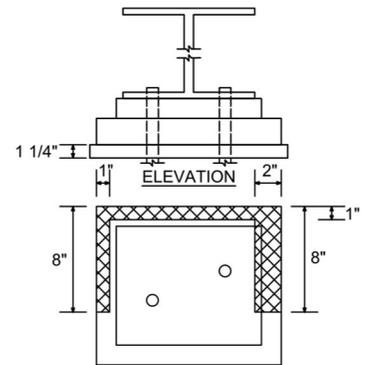
**Sketch 3: Bearings 1 – 5, south abutment. From Routine & Special Member Report, dated 3/21/25.**

At the south abutment, the pedestals are cracked and spalled, with up to 90% loss of bearing area (beam 2 bearing). **See Sketch 3 and Photos 3 – 7.**

**BEARINGS WITH BEARING AREA LOSS**

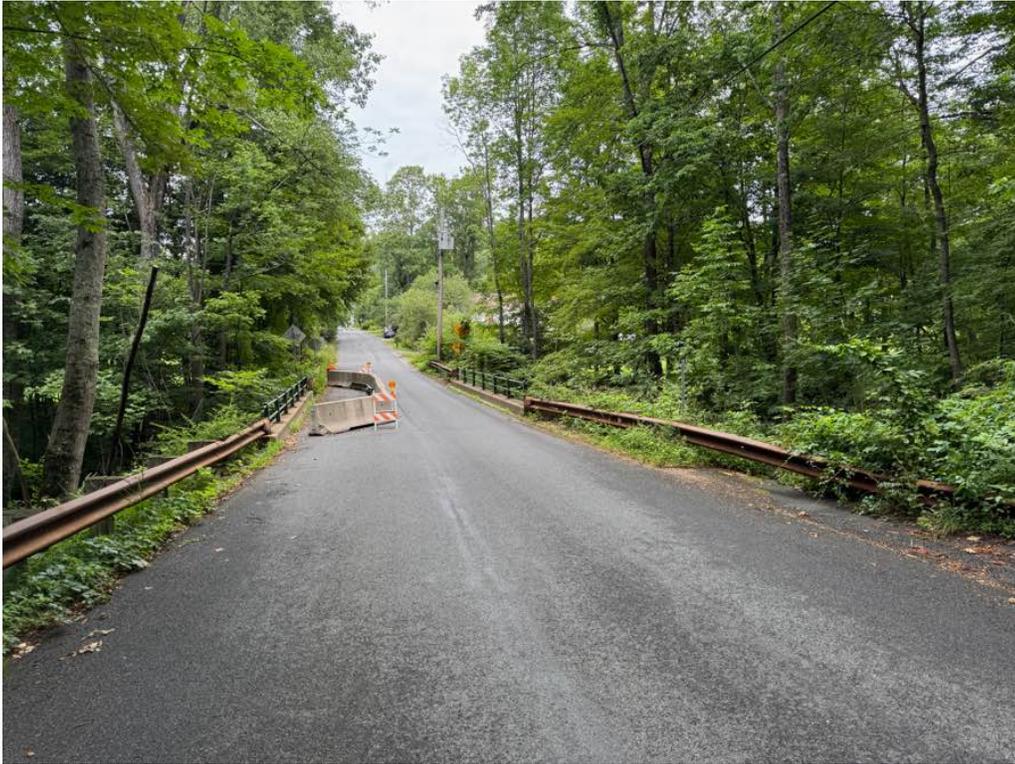
Photo 1: General topside, looking north.

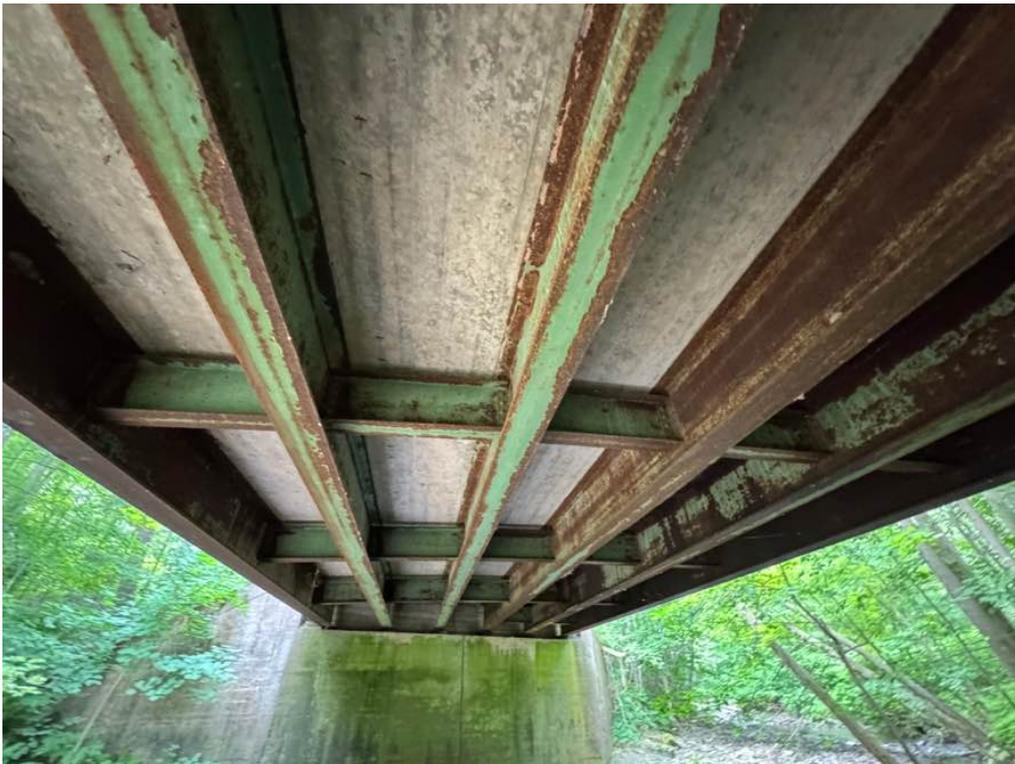
Photo 2: General underside, looking south.

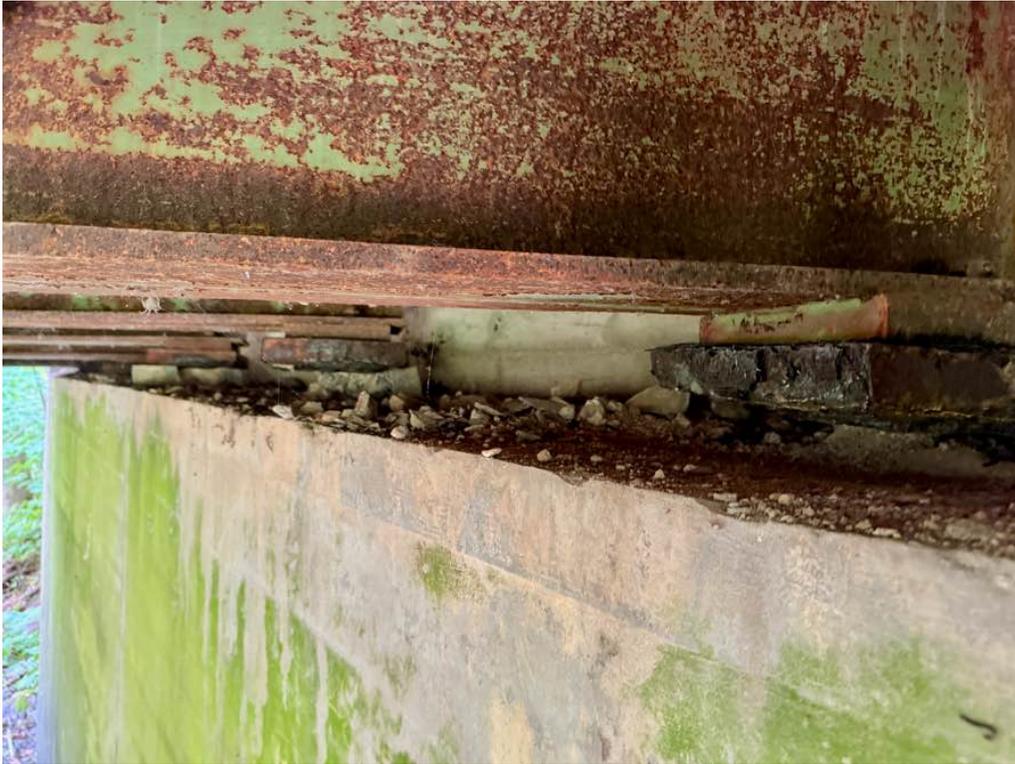
Along the south abutment, the bearings are severely undermined, with deteriorated pedestals. Refer to Item 60.1.a - Pedestals.

**Photo 3: South bridge seat, with deteriorated pedestals and bearings.**

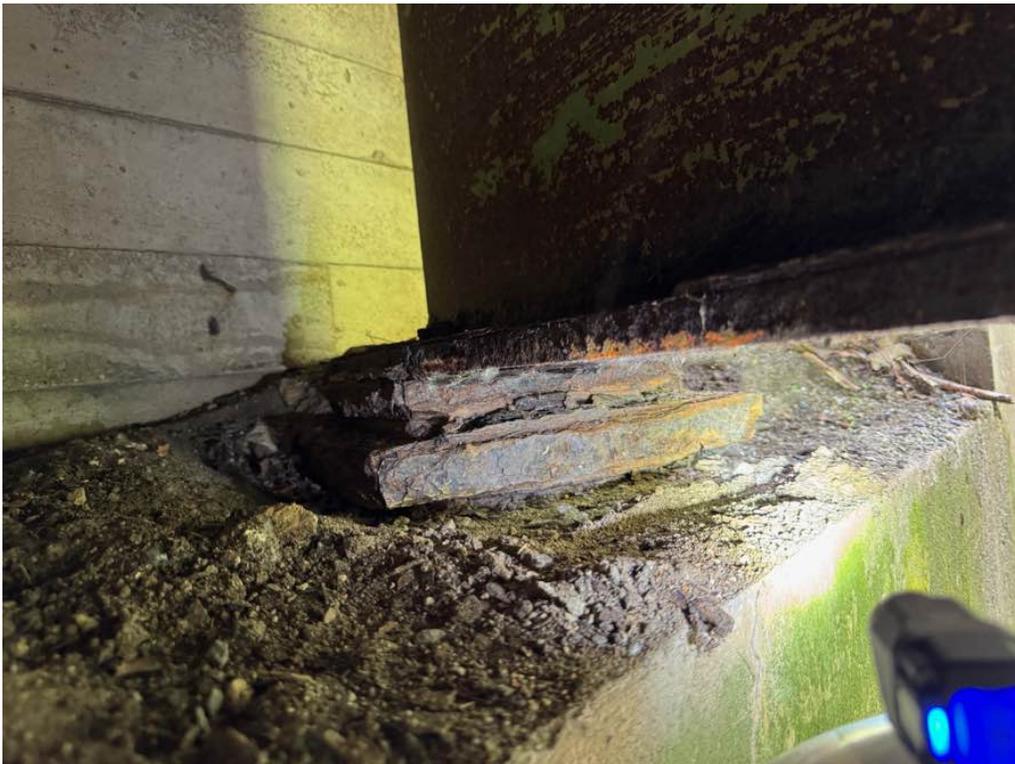
**Photo 4: South abutment, beam 1 bearing.**

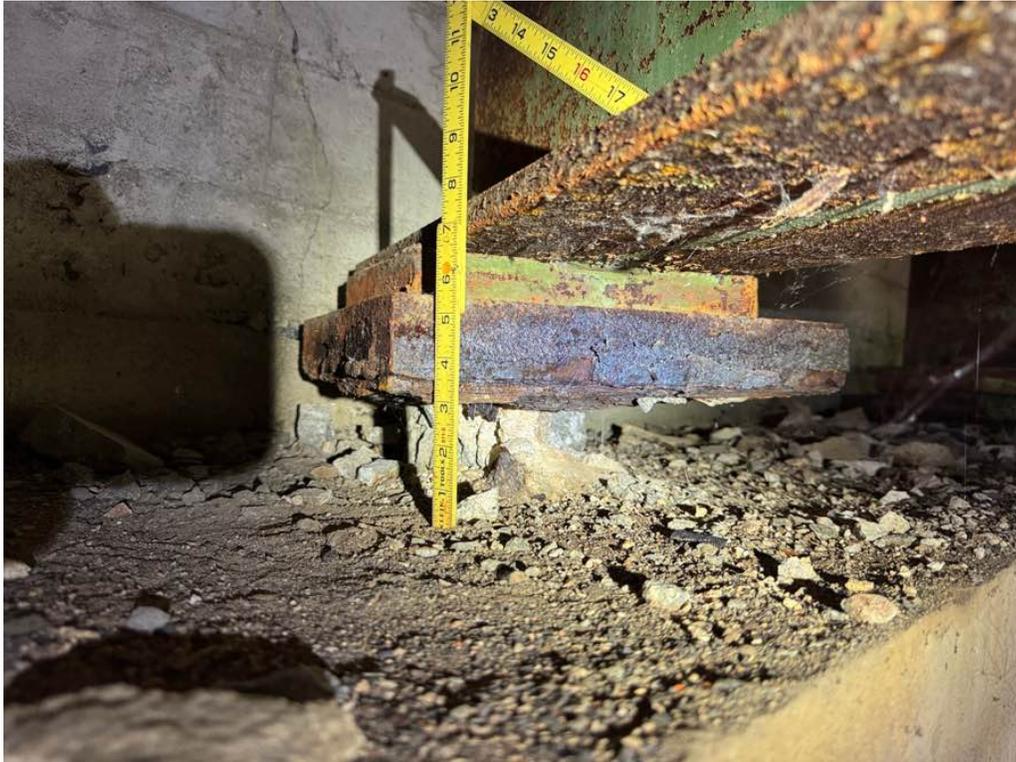
**Photo 5: South abutment, beam 2 bearing.**

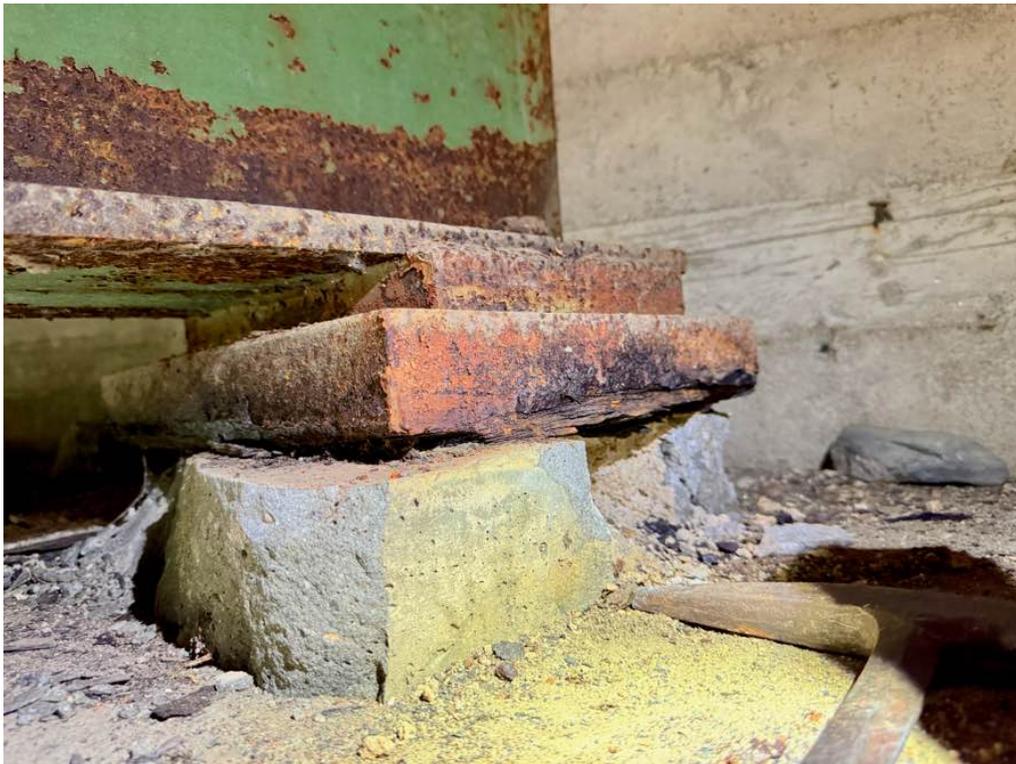
**Photo 6: South abutment, beam 4 bearing.**

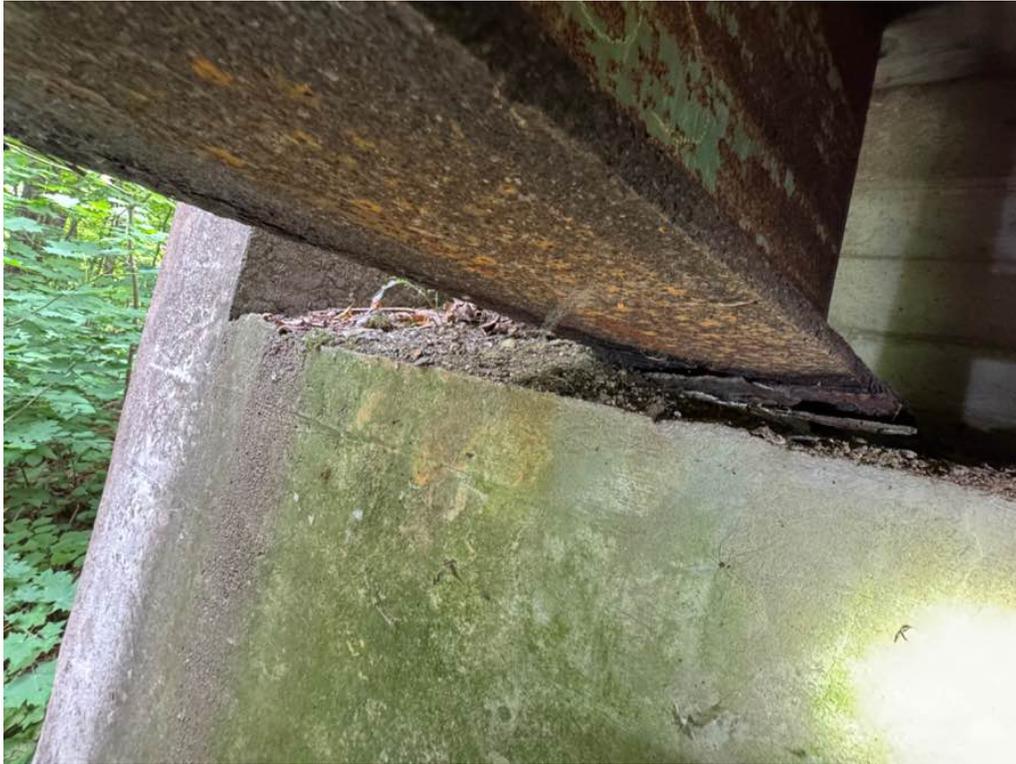
**Photo 7: South abutment, beam 6 bearing.**
