STRUCTURES INSPECTION FIELD REPORT

SPECIAL MEMBER INSPECTION

B.I.N.
0FM

CITY/TOWN ASHFIELD	8.-STRUCTURE NO. A13020-0FM-MUN-NBI	11-Kilo. POINT 000.000	90-ROUTINE INSP. DATE Jul 18, 2023	93*-SPEC. MEMB. INSP. DATE Jul 23, 2024
07-FACILITY CARRIED HWY APPLE VALLEY	MEMORIAL NAME/LOCAL NAME SCHOOLHOUSE NO. 13	27-YR BUILT 1939	106-YR REBUILT 0000	*YR REHAB'D (NON 106) 0000
06-FEATURES INTERSECTED WATER U BR CLESSON BK	26-FUNCTIONAL CLASS Rural Local	DIST. BRIDGE INSPECTION ENGINEER <i>M. P.E. McCabe</i>		
43-STRUCTURE TYPE 302 : Steel Stringer/Girder	22-OWNER Town Agency	21-MAINTAINER Town Agency	TEAM LEADER R. Mancari <i>Reed Mancari</i>	
107-DECK TYPE 1 : Concrete Cast-in-Place	WEATHER Sunny	TEMP. (air) 21°C	TEAM MEMBERS M. RANZONI <i>Matthew Ranzoni</i>

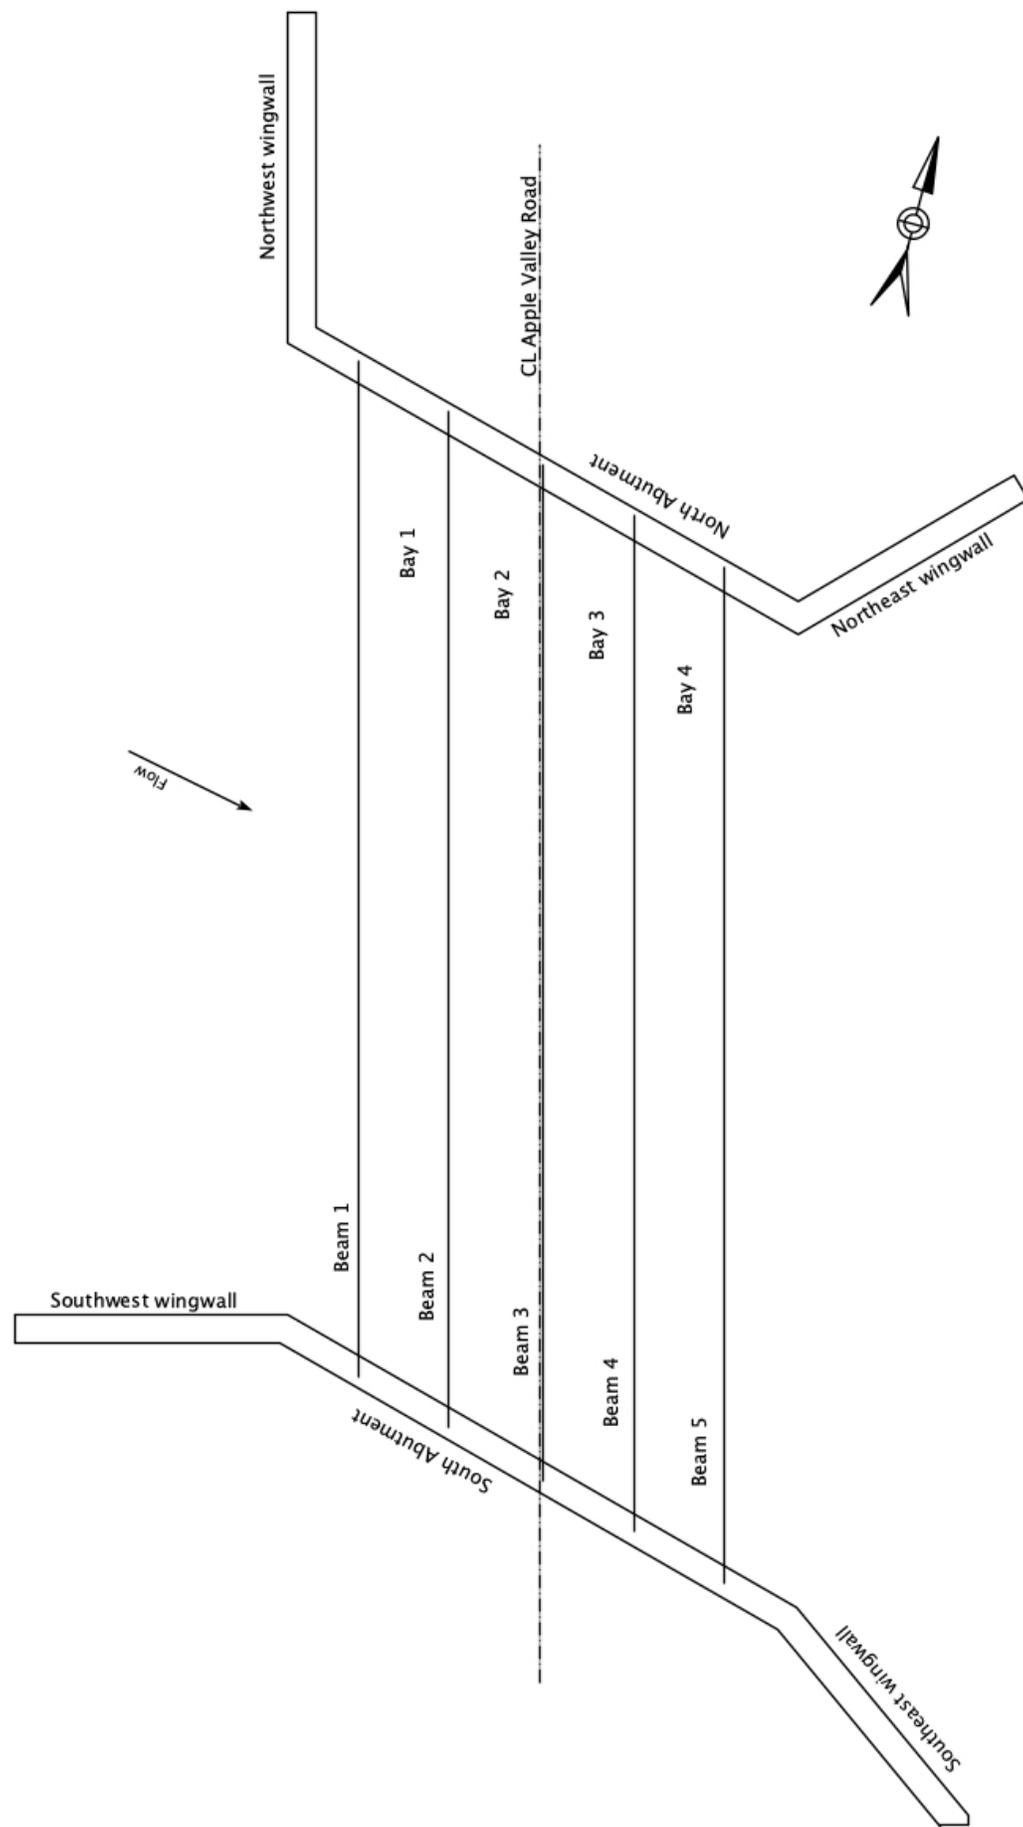
Sketch 1: Framing plan.

Apple Valley Road travels north and south. Upper Branch of the Clesson Brook flows from west to east. This single span structure consists of five steel beams, supporting a reinforced concrete deck, with an asphalt wearing surface. The beams and bays are numbered from west to east, upstream to downstream, in accordance with the 2018 Repair Plans and the 2020 Rating Report. See sketch 1 and photos 1 & 2.

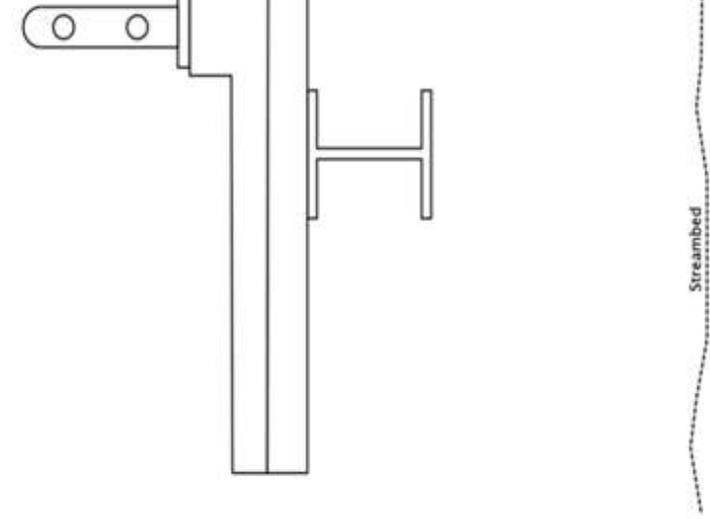
Chart 1: Channel profile readings.

The south footing is exposed, full length with isolated areas of undermining. Most of the previously noted undermining has been filled in since the previous Routine Inspection Report, dated 7/18/2023. Refer to charts 1 - 3 and photos 2 & 3.

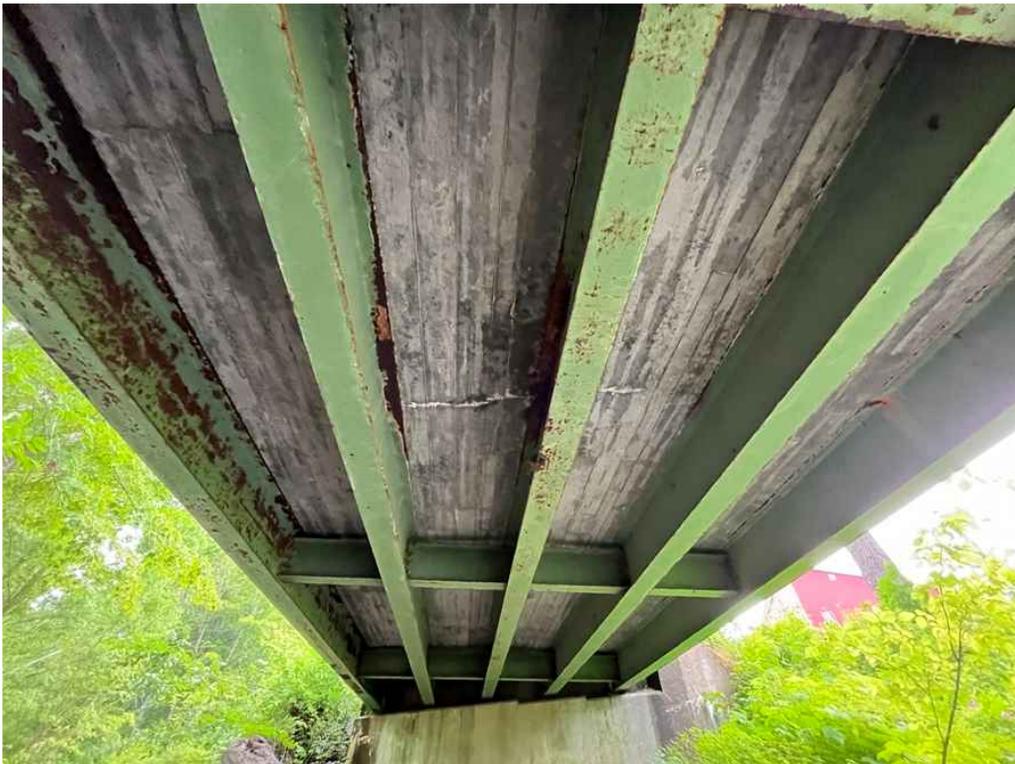
Photo 2: Typical underside, looking north.

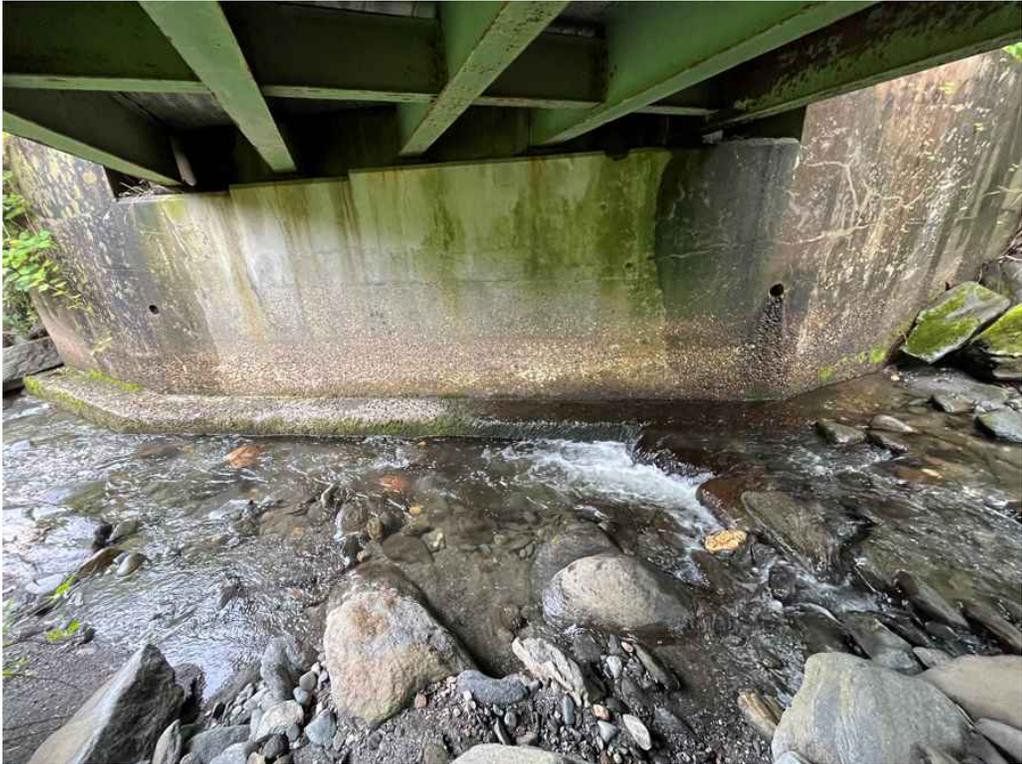
The abutment condition is controlled by the severe scour.

The southeast wingwall footing is exposed, full length. The previously noted undermining has been filled in since the previous Routine Inspection Report, dated 7/18/2023. See photo 3.

Photo 3: Exposed south footing.
