STRUCTURES INSPECTION FIELD REPORT

ROUTINE INSPECTION

BR. DEPT. NO.
A-13-015

CITY/TOWN ASHFIELD	8-STRUCTURE NO. A13015-0FK-MUN-NBI	11-Kilo. POINT 000.000	41-STATUS P:POSTED	90-ROUTINE INSP. DATE MAR 21, 2025
07-FACILITY CARRIED HWY BELDNGVIL RD	MEMORIAL NAME/LOCAL NAME Br.No. 15 Leon Hall	27-YR BUILT 1940	106-YR REBUILT 0000	YR REHAB'D (NON 106) 0000
06-FEATURES INTERSECTED WATER BEAR RIVER	26-FUNCTIONAL CLASS Rural Local	DIST. BRIDGE INSPECTION ENGINEER <i>Michael P. McCabe</i> M. P.E. McCabe		
43-STRUCTURE TYPE 302 : Steel Stringer/Girder	22-OWNER Town Agency	21-MAINTAINER Town Agency	TEAM LEADER M. Estrada <i>Mark J. Estrada</i>	PROJ MGR Michael Baker Intl Inc <i>[Signature]</i>
107-DECK TYPE 1 : Concrete Cast-in-Place	WEATHER Cloudy	TEMP. (air) 2°C	TEAM MEMBERS R. YOUSSEF

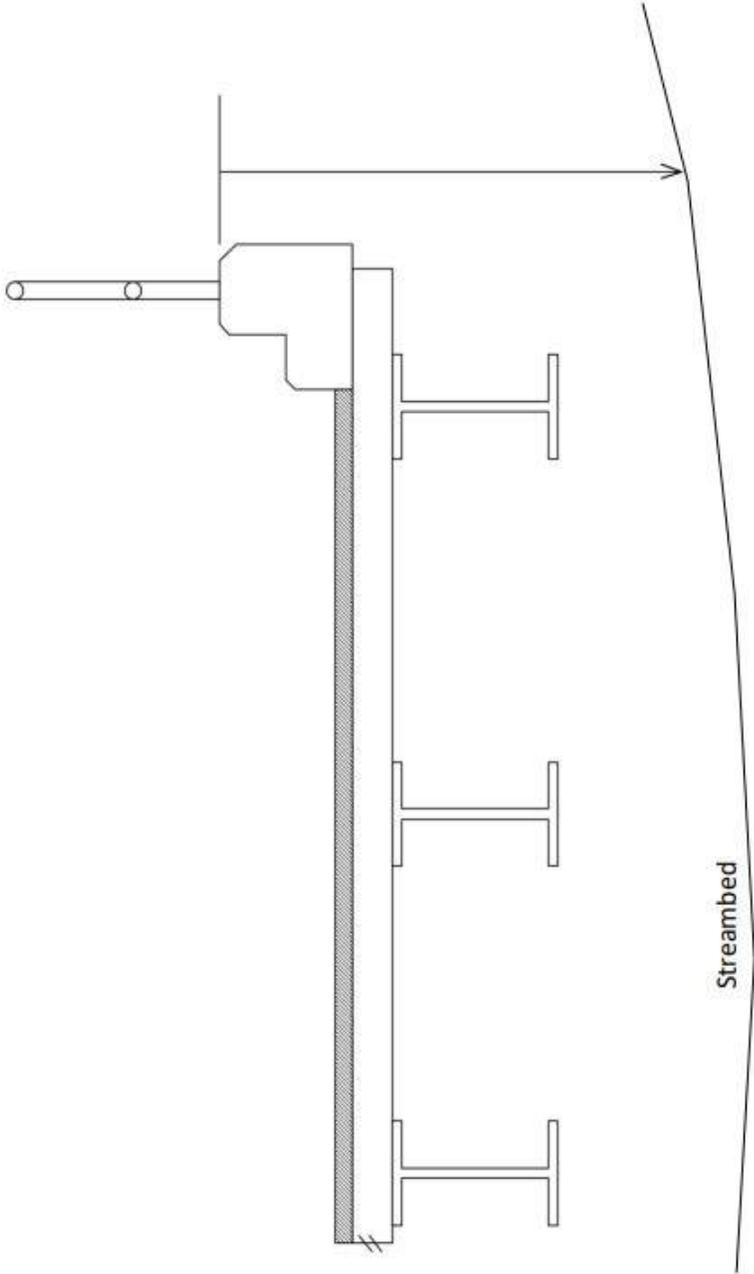
Sketch 3: Channel Profile Measurements.

BIN OFK - Channel Profile Readings										
	West Fascia					East Fascia				
DATE	S. Abut.	1/4 span	1/2 span	3/4 span	N. Abut.	S. Abut.	1/4 span	1/2 span	3/4 span	N. Abut.
3/21/2025	7.1'	9.8'	14.0'	10.3'	4.8'	7.0'	9.5'	15.6'	12.8'	6.8'

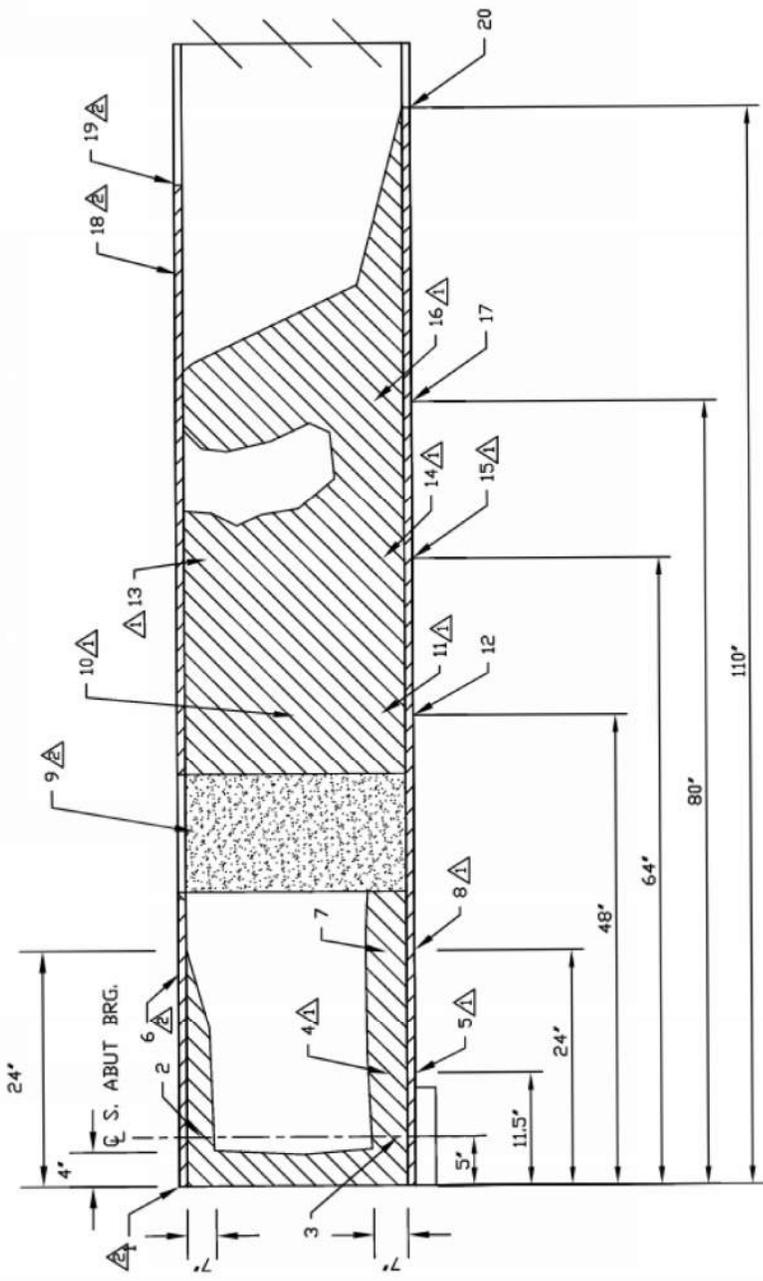
BEAM 4 AT SOUTH ABUTMENT
EAST ELEVATION
(N.T.S.)

- 1. WEST LEG TOP FLANGE: 110'L x FW x 0.44 REMAINING
- 2. 0.41' REMAINING
- 3. 0.21' REMAINING
- 4. 0.28' REMAINING
- 5. 3.5'L x FW x 0.20' REMAINING
- 6. 30'L x FW x 0.75' REMAINING
- 7. 0.32' REMAINING
- 8. 0.30' REMAINING
- 9. WEST ELEVATION: DIAPHRAGM CONNECTION HARDWARE HAS HEAVY RUST
- 10. 0.42' REMAINING
- 11. 0.23' REMAINING (UP TO 4"H)
- 12. 0.61' REMAINING
- 13. 0.38' REMAINING (INCLUDES 86"L x 5"H AVERAGE AT WEST ELEVATION)
- 14. 0.42' REMAINING (UP TO 4"H)
- 15. 0.54' REMAINING
- 16. 0.49' REMAINING
- 17. 0.62' REMAINING
- 18. 56"L x FW x 0.70' REMAINING
- 19. NEGLIGIBLE LOSS
- 20. NEGLIGIBLE LOSS

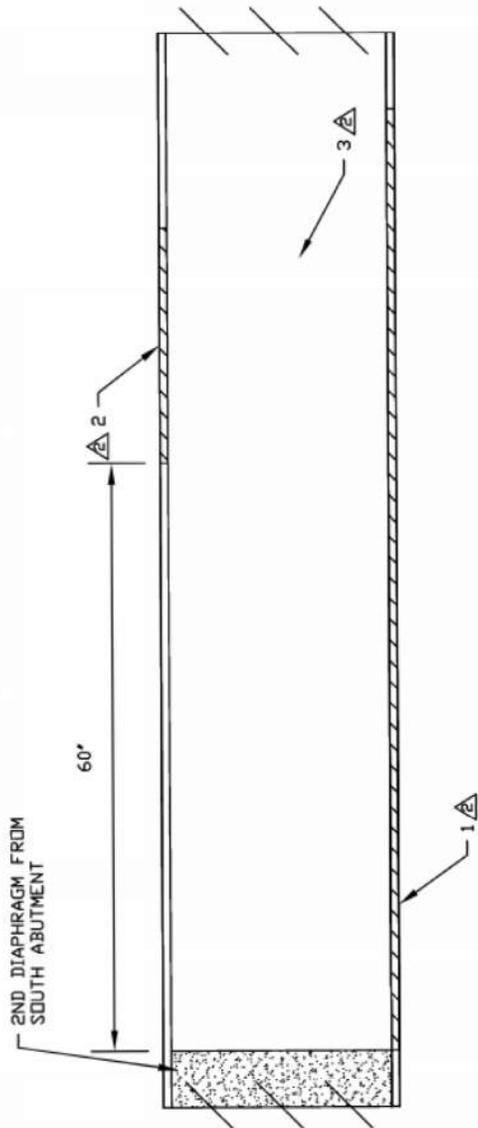
BEAM 4 AT MID-SPAN
EAST ELEVATION
(N.T.S.)

DEFECTS (NOTE, MEASURED AT EAST ELEVATION UNLESS OTHERWISE NOTED):
 1. 8'-0"L x FULL LEG WIDTH x 0.80" REMAINING
 2. 2'-0"L x FULL LEG WIDTH x 0.72" REMAINING
 3. NEGLIGIBLE LOSS

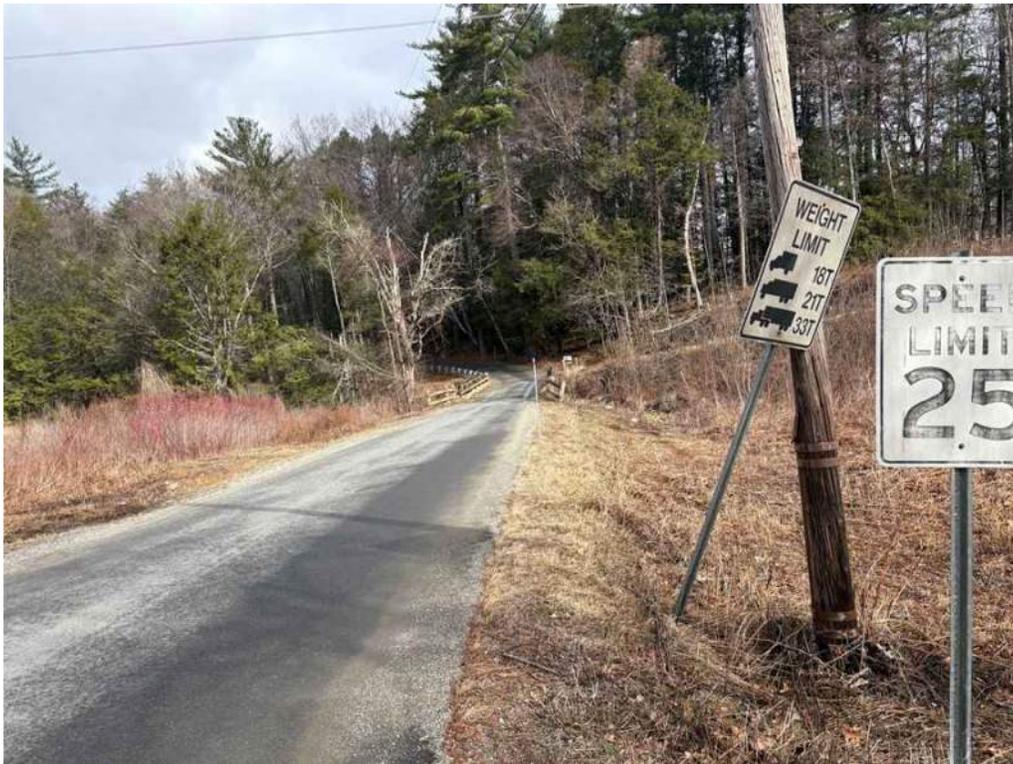
The bridge has two (2) At-Bridge and two (2) Advanced weight posting signs posted for 18 tons on two axles, 21 tons on three axles, and 33 tons on five axles, with the exception of the Advanced weight posting sign at the South Approach, which is incorrectly posted as 18 tons on two axles, 21 tons on three axles, and 31 tons on five axles (**Photo 9**). The At-Bridge weight posting sign at the South Approach is tilted to the east away from the roadway (**Photo 10**).

Photo 10: South Approach At-Bridge weight posting sign, looking north, rotated away from the roadway.

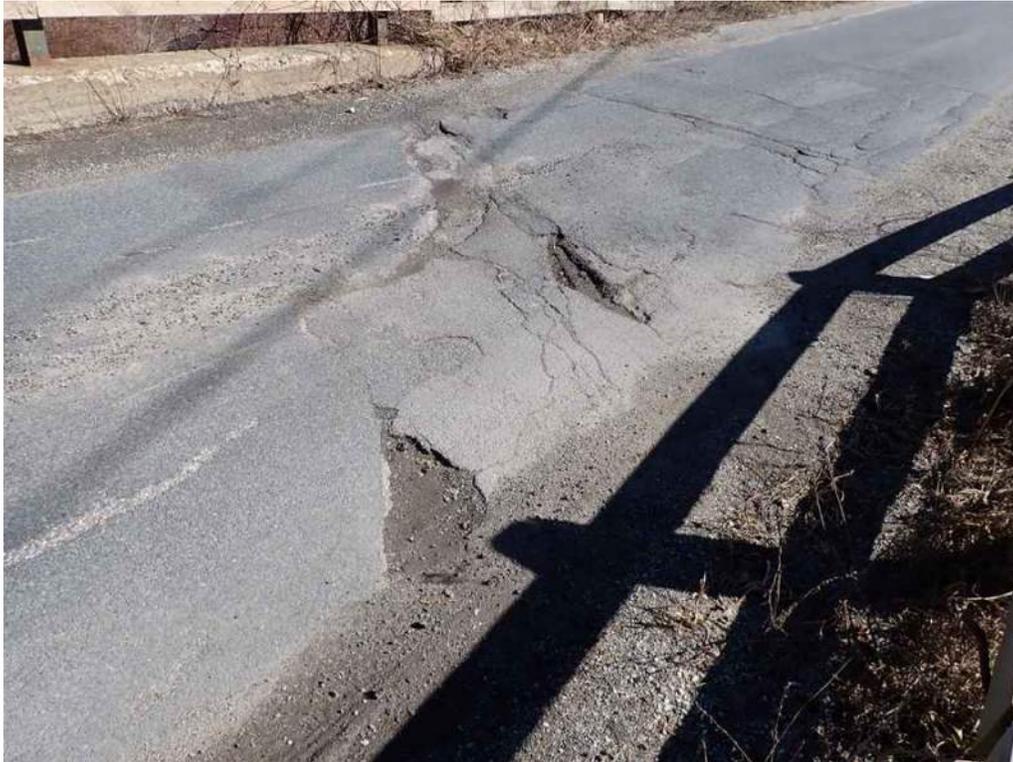
There are random gouges up to 3'-8" long x 3" wide x 1/4" deep and moderate sand accumulation. The South Deck End has isolated potholes, patches, and cracks (**Photo 11**). See the following for specific locations and conditions:

Photo 11: Wearing Surface, at South Deck End and South Approach, with gouges, potholes, patches, and map cracks.

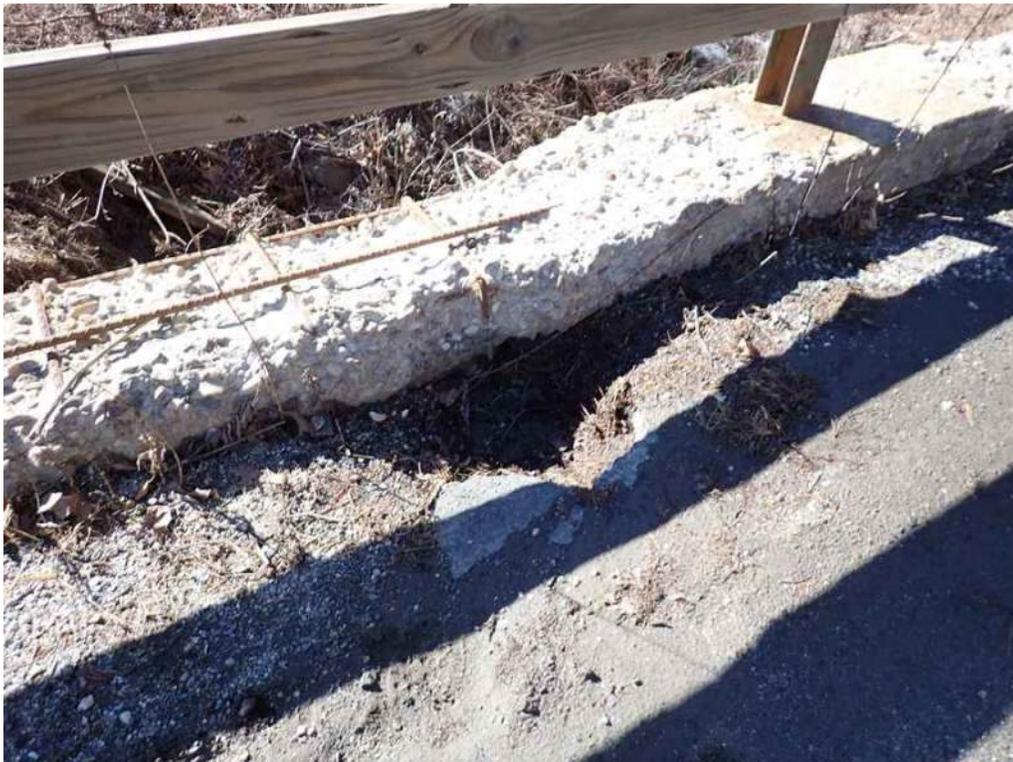
- Southwest corner: 2'-6" long x 4'-0" wide area of alligator cracks open up to 1/4" wide.
- Near the centerline of the roadway at the South Deck: 9" long x 3'-0" wide x 2" deep pothole, 10" long x 1'-4" wide x 3/4" deep pothole, and adjacent patches with cracks up to 1'-4" long x 3'-4" wide.
- Along the West Curb, near the South Deck End, at the drain pipe: 2'-0" long x 1'-2" wide x 5" deep pothole (**Photo 12**).

- South end: 9'-0" long x full width x full height x 3" deep spall with exposed and debonded rebar (**Photo 12**).
- Near midspan: 18'-0" long x full width x full height x 2" deep spall with exposed rebar.
- Near north end: 8'-0" long x full width x full height x 1" deep spall with exposed rebar.

Photo 12: Wearing Surface near South Deck End along West Curb with potholes at drain pipe, West Curb at south end with spall with exposed and debonded rebar.

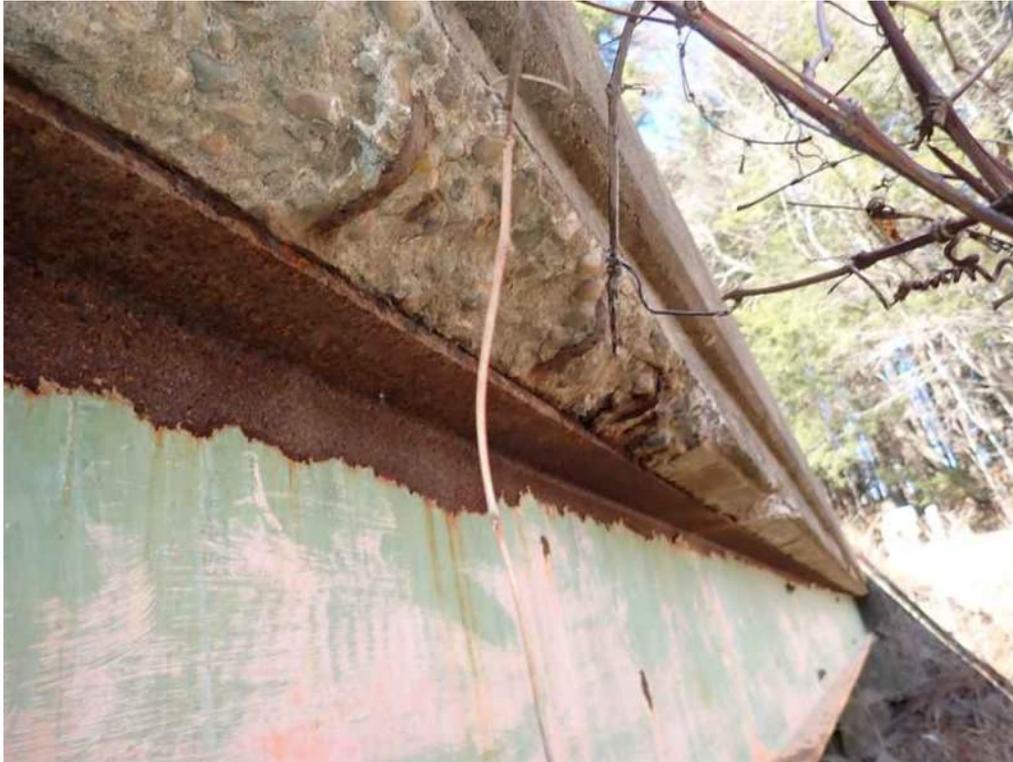
- East Deck Overhang, south end (from south to north): 6'-0" long x 6" wide x 3" deep spall with exposed rebar, 2'-4" long x 6" wide x full height delamination, and 2'-0" long x 6" wide x 2" deep spall with exposed rebar (**Photo 13**).

Photo 13: East Deck Overhang at south end with spalls with exposed rebar and delamination.

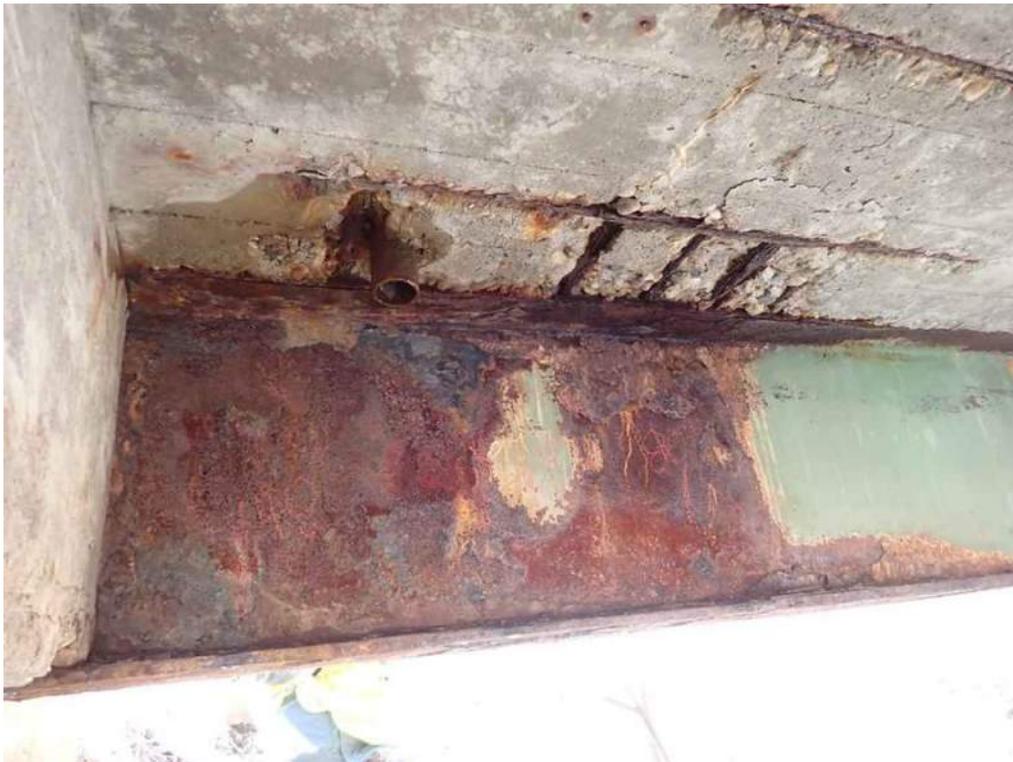
- The deck drain pipe in Bay 3 adjacent to the 1st Diaphragm from the South Abutment is short and leaking onto Beam 4 (**Photo 14**).
- The previously noted remaining short deck drain pipes in Bay 3 have been repaired (**Photo 19**).

There is heavy rust with section loss throughout Beam 4 (**Sketches 5 - 7 and Photos 14, 15, 18, & 19**).

At Beam 4, below the drain pipes and at the south end, the paint has failed (**Photos 14 & 15**). At the remainder of the structure, the paint is chalky with areas of light rust (**Photo 8**).

Photo 14: Bay 3 Panel 2 with spalls with exposed rebar with moderate section loss and leaking drain pipe, and Beam 4, East Elevation north of 1st Diaphragm from the South Abutment with rust and section loss.

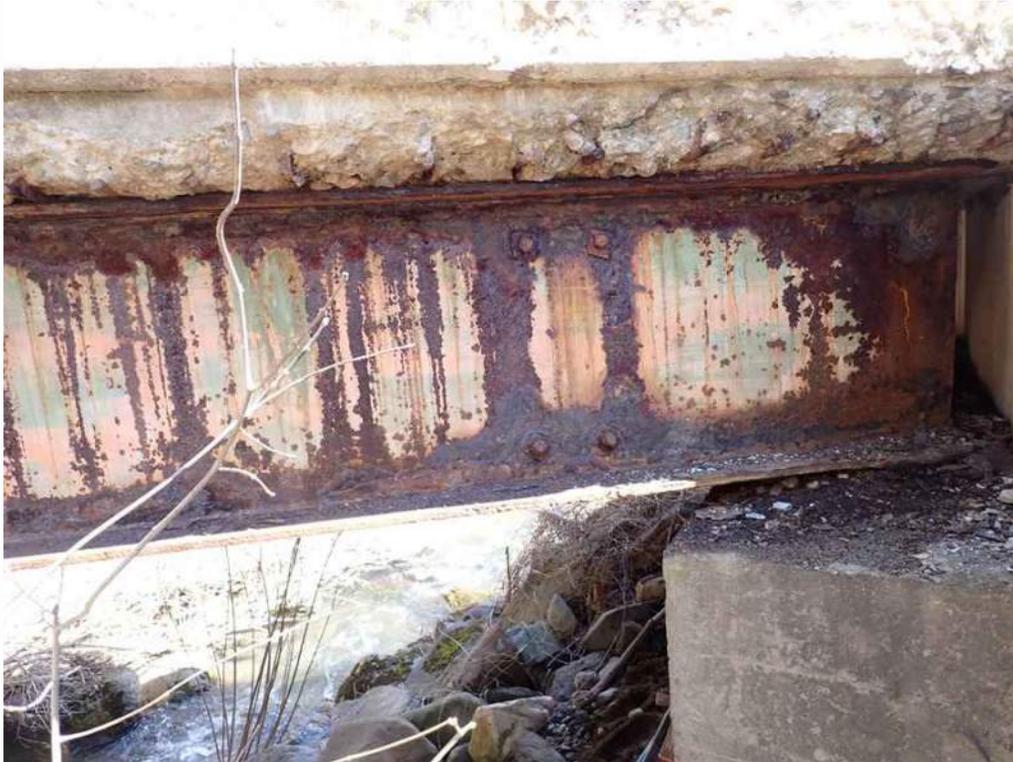
- Bay 1, Panel 2: 7'-0" long x 4" wide delamination.
- Bay 3, Panel 1: 4'-0" long x 3'-0" wide area of spalls with exposed rebar up to 1" deep and a 3'-0" long x 1'-0" wide x 1/2" deep spall / delamination along Beam 3.
- Bay 3, Panel 2: Two (2) spalls up to 1'-0" long x 7" wide x up to 1" deep along Beam 3, 5'-0" long x 1'-6" wide x up to 2" deep spall with exposed rebar with heavy rust and negligible section loss along leaking drain pipe, and scattered spalls with exposed rebar up to full length x 6" wide x 1/2" deep (**Photo 14**).
- Bay 3, Panel 4: 6'-0" long x 1'-6" wide x 1" deep spall with exposed and corroded rebar.
- West Deck Overhang, south end: 7'-0" long x 6" wide x up to 5" deep spall with exposed rebar (**Photo 15**).

Beam 4, West Elevation, the diaphragm connection hardware near the south end has heavy rust (**Photo 15**).

Photo 15: West Deck Overhang at south end with spall with exposed rebar, and Beam 4 West Elevation at the south end with rust and section loss.

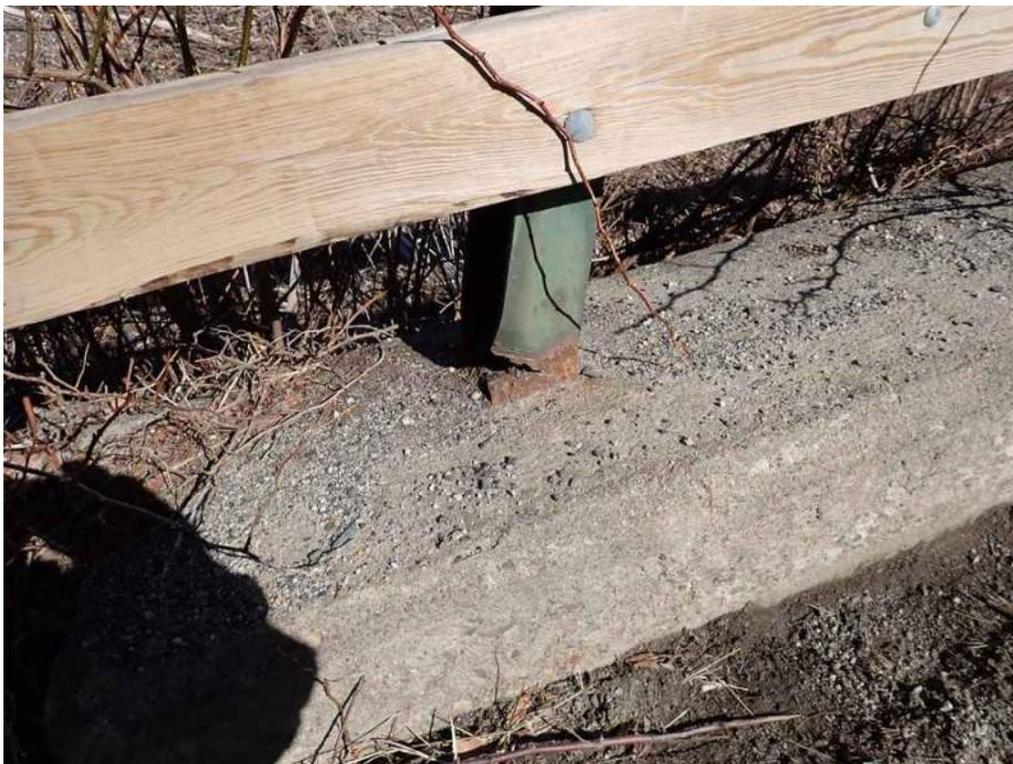
Photo 16: East Railing at 7th post from south end.

- The previously noted several rotted rails have been repaired.
- 7th post from south end: 2'-6" long tear at the bottom of west face (**Photo 16**).

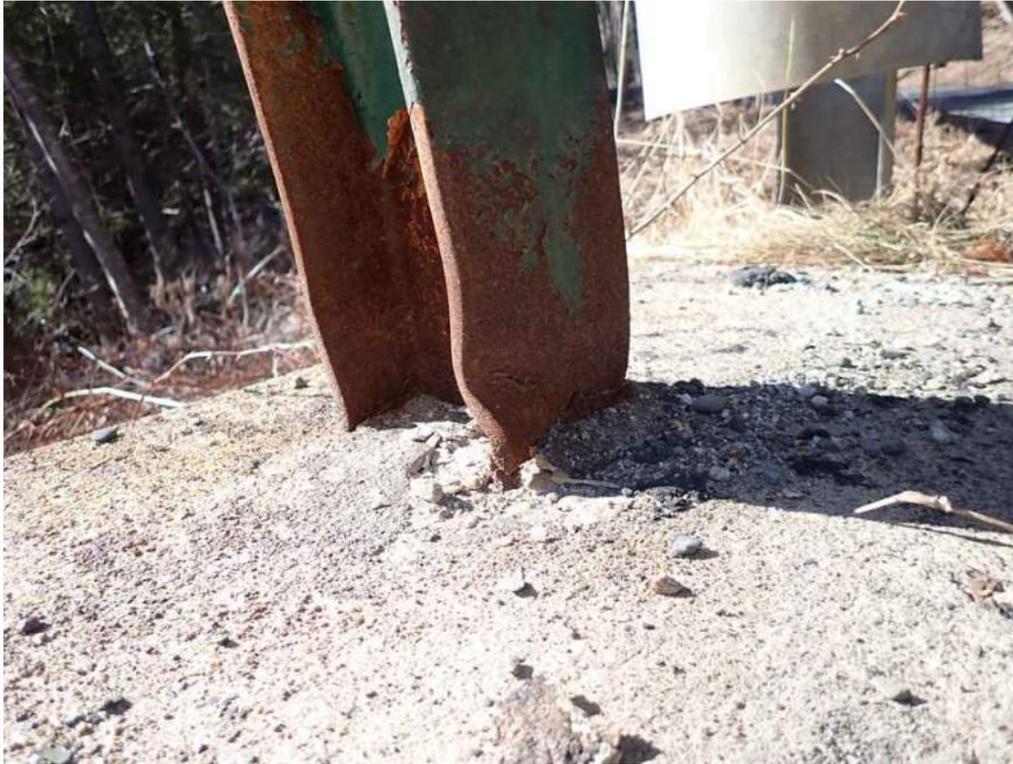
Photo 17: West Railing at 7th post from south end.

- The previously noted rotted rails at the north end have been repaired.
- 1st post from south end: 2" long tear at bottom of east face.
- 3rd post from south end: Sloppy weld at bottom of east face.
- 7th post from south end: Crack at bottom of east face and warped at bottom of west face (**Photo 17**).

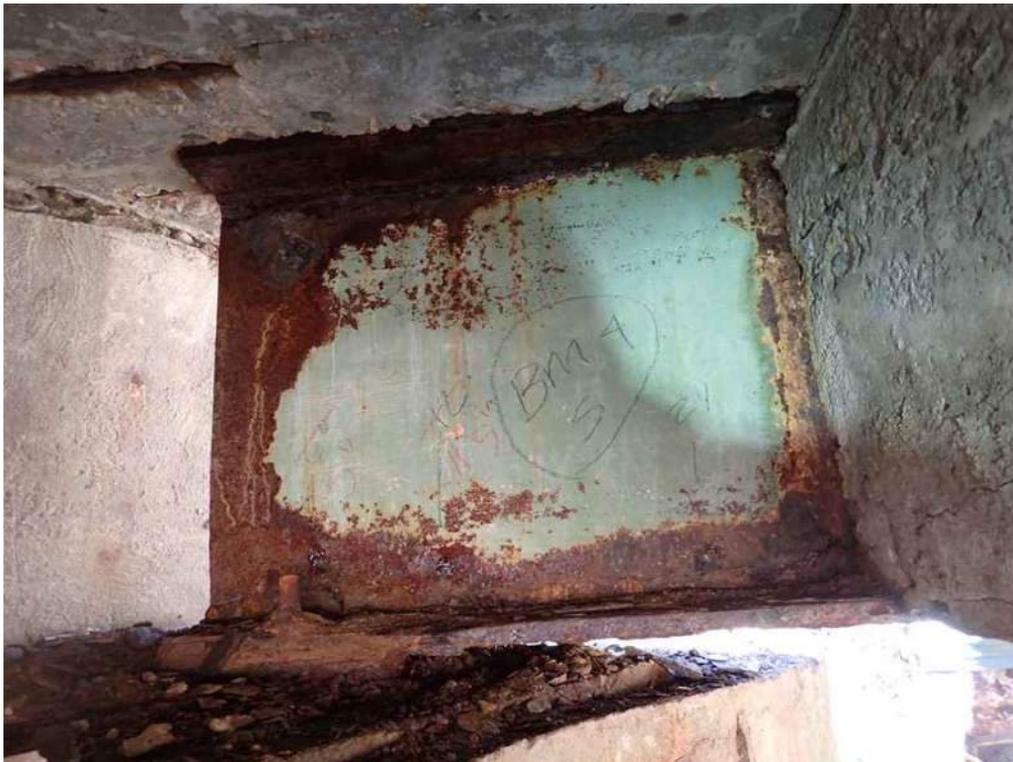
Photo 18: Beam 4 East Elevation at south end with rust and section loss.

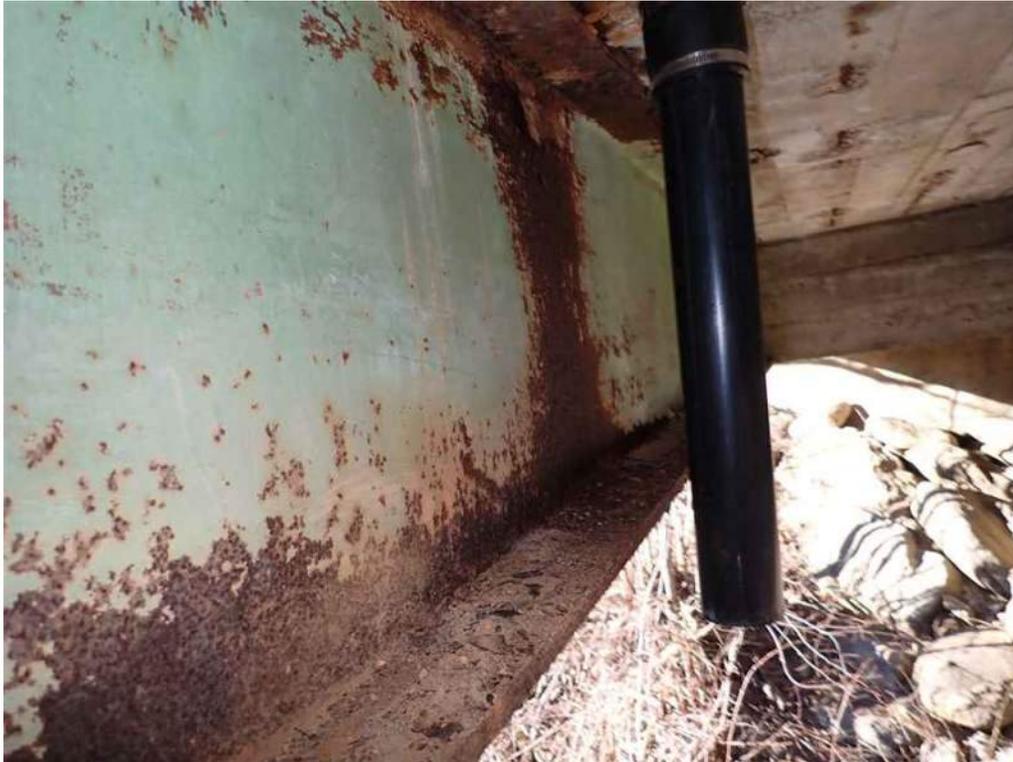
Photo 19: Beam 4 East Elevation at midspan with rust and section loss.

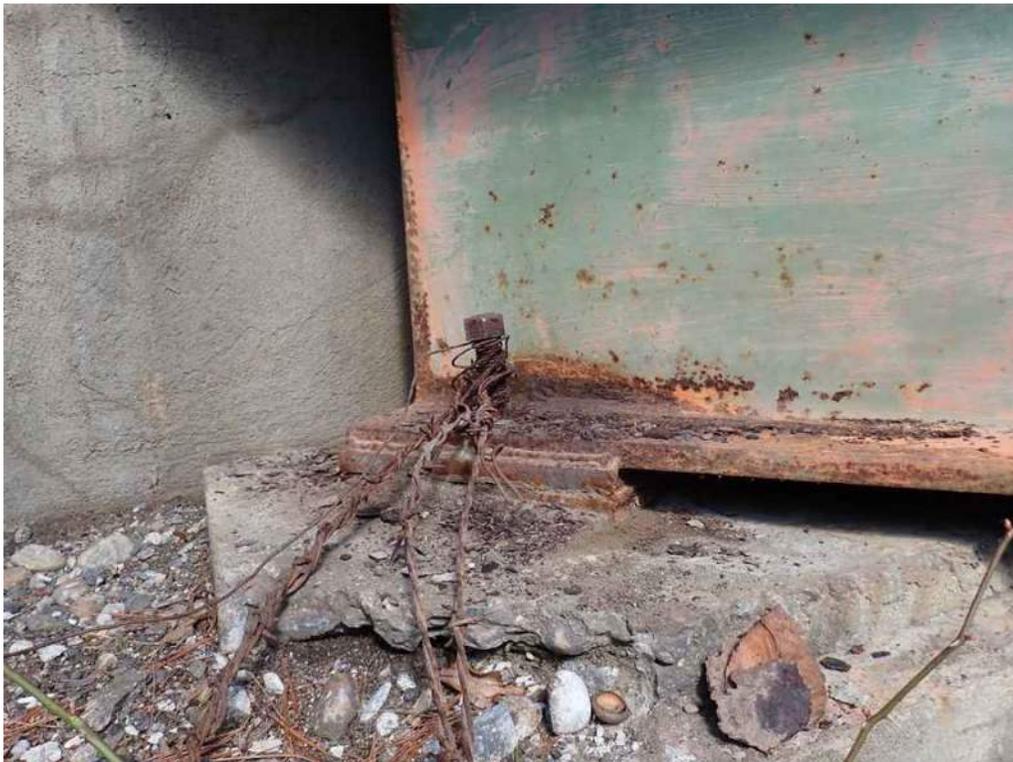
- Beam 1 Bearing: Up to 1/4" thick pack rust between masonry and sole plates.
- Beam 3 Bearing: West side anchor bolt has two (2) square washers.
- Beam 4 Bearing: Both anchor bolt nuts have up to 100% section loss and the west anchor bolt has 7/16" diameter remaining.

Photo 20: Beam 4 Bearing at North Abutment with backed off anchor bolt nut and wrapped with barbed wire.

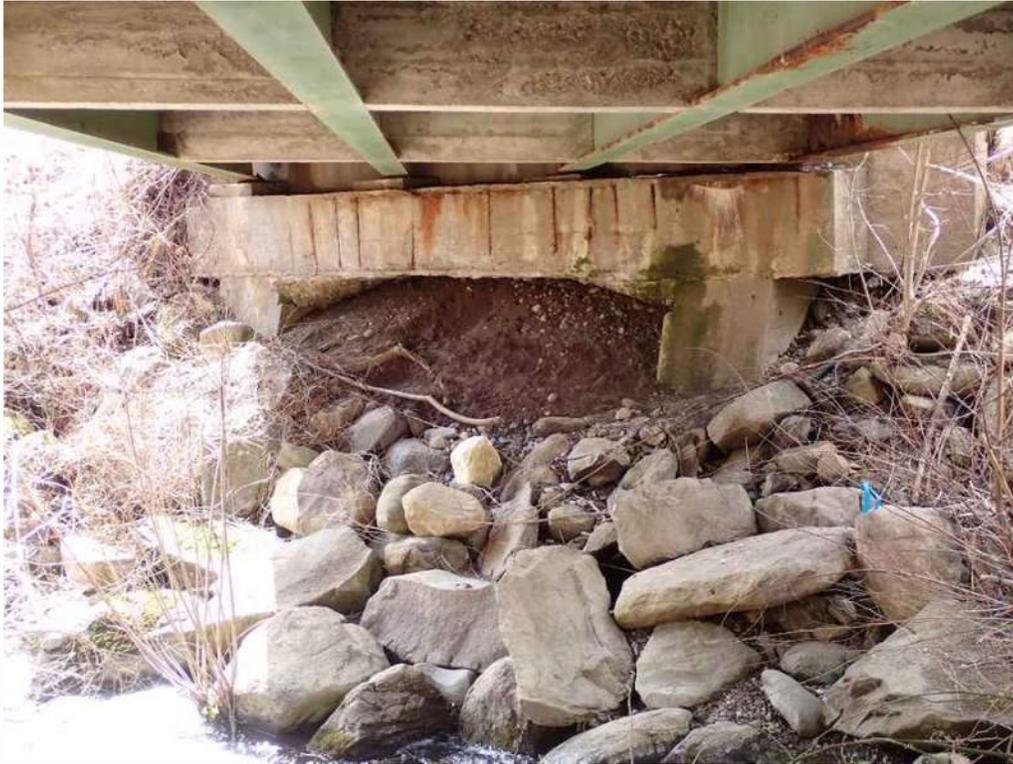
There is a 5'-0" long x 14'-0" wide area of missing rip rap below the bridge at the top of the Right Bank (**Photo 21**).

Photo 21: South Abutment with spalls with exposed rebar, delaminations, scale, cracks with efflorescence, rust, and dampness, and void below Cap Beam, and Right Bank with missing rip rap.

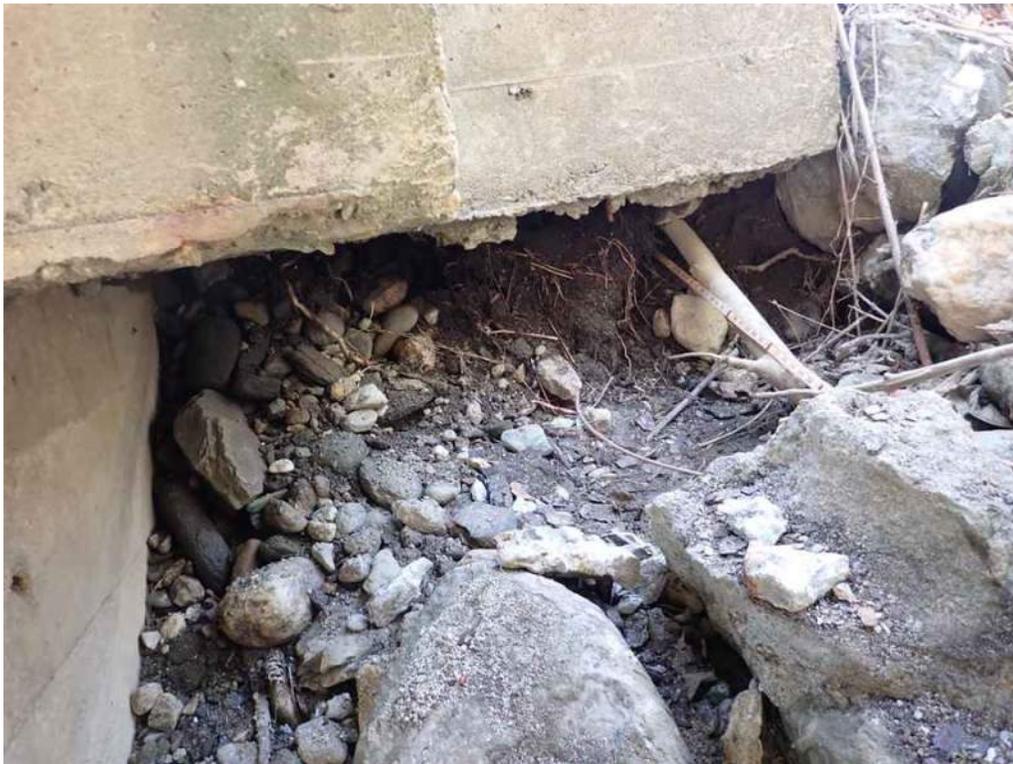
- The Southeast Wingwall has heavy vegetation and vine growth and an isolated 5" wide x 6" high x 1" deep spall at the top of the west end.
- The Southwest Wingwall is undermined 4'-4" wide x 1'-5" high x 2'-0" deep (**Photo 22**).
- The Northeast Wingwall is undermined 4'-3" wide x 7" high x 1'-1" deep.

Photo 22: Southwest Wingwall with undermining.

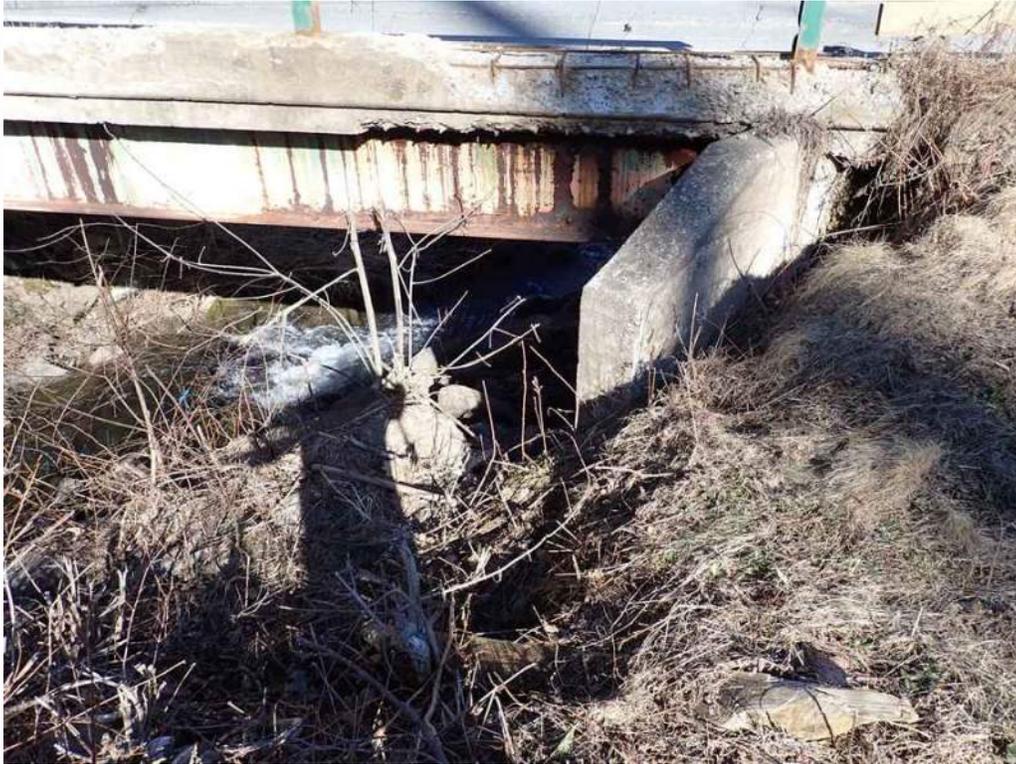
Photo 23: Embankment at South Face of Southwest Wingwall with erosion.

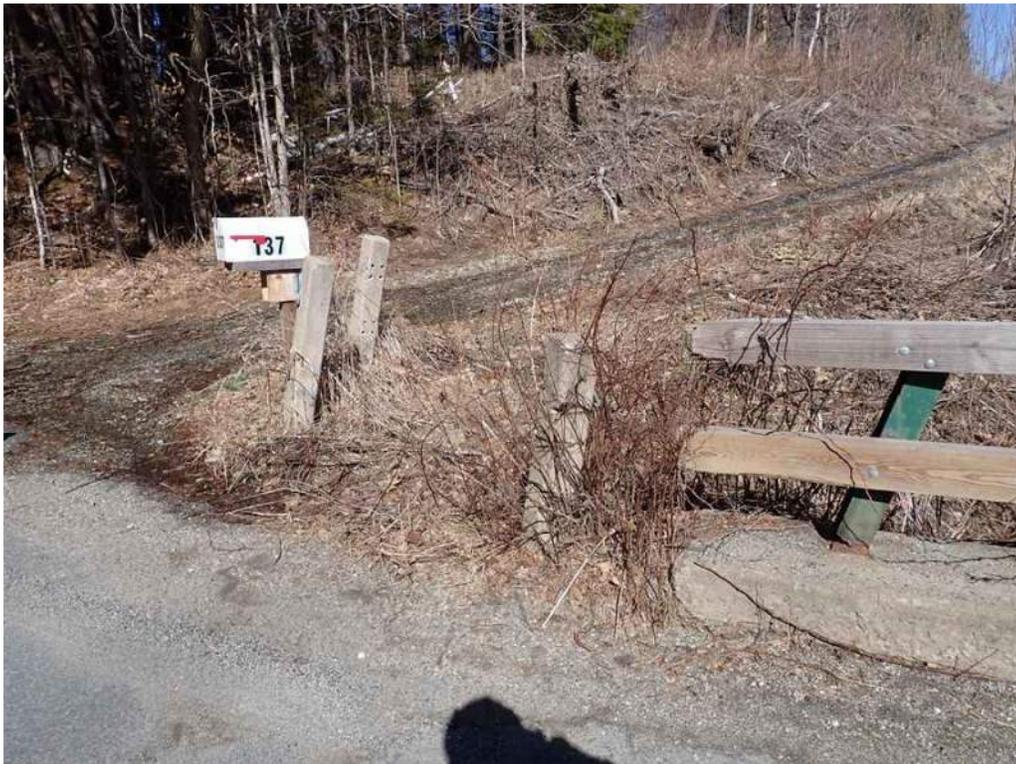
The Northeast Transition is missing both timber rails (**Photo 24**).

Photo 24: Northeast transition with missing rails.
