STRUCTURES INSPECTION FIELD REPORT

CLOSED/REHABILITATION INSPECTION

CITY/TOWN ASHFIELD	8-STRUCTURE NO. A13037-5CY-MUN-BRI	11-Kilo. POINT 000.000	90-ROUTINE INSP. DATE NOV 21, 2023	93*- INSPECTION DATE NOV 18, 2024
07-FACILITY CARRIED HWY APPLE VAL RD	MEMORIAL NAME/LOCAL NAME	27-YR BUILT 1960	106-YR REBUILT 0000	YR REHAB'D (NON 106) 0000
06-FEATURES INTERSECTED WATER SMITH BROOK	26-FUNCTIONAL CLASS Rural Local	DIST. BRIDGE INSPECTION ENGINEER M. P.E. McCabe <i>Michael P.E. McCabe</i>		
43-STRUCTURE TYPE 319 : Steel Culvert	22-OWNER Town Agency	21-MAINTAINER Town Agency	TEAM LEADER M. Ranzoni <i>Matthew Ranzoni</i>	
107-DECK TYPE N : Not applicable	WEATHER Sunny	TEMP. (air) 0°C	TEAM MEMBERS Eli Geminder <i>Eli Geminder</i>

CITY/TOWN ASHFIELD	B.I.N. 5CY	BR. DEPT. NO. A-13-037	8.-STRUCTURE NO. A13037-5CY-MUN-BRI	INSPECTION DATE NOV 18, 2024
------------------------------	----------------------	----------------------------------	---	--

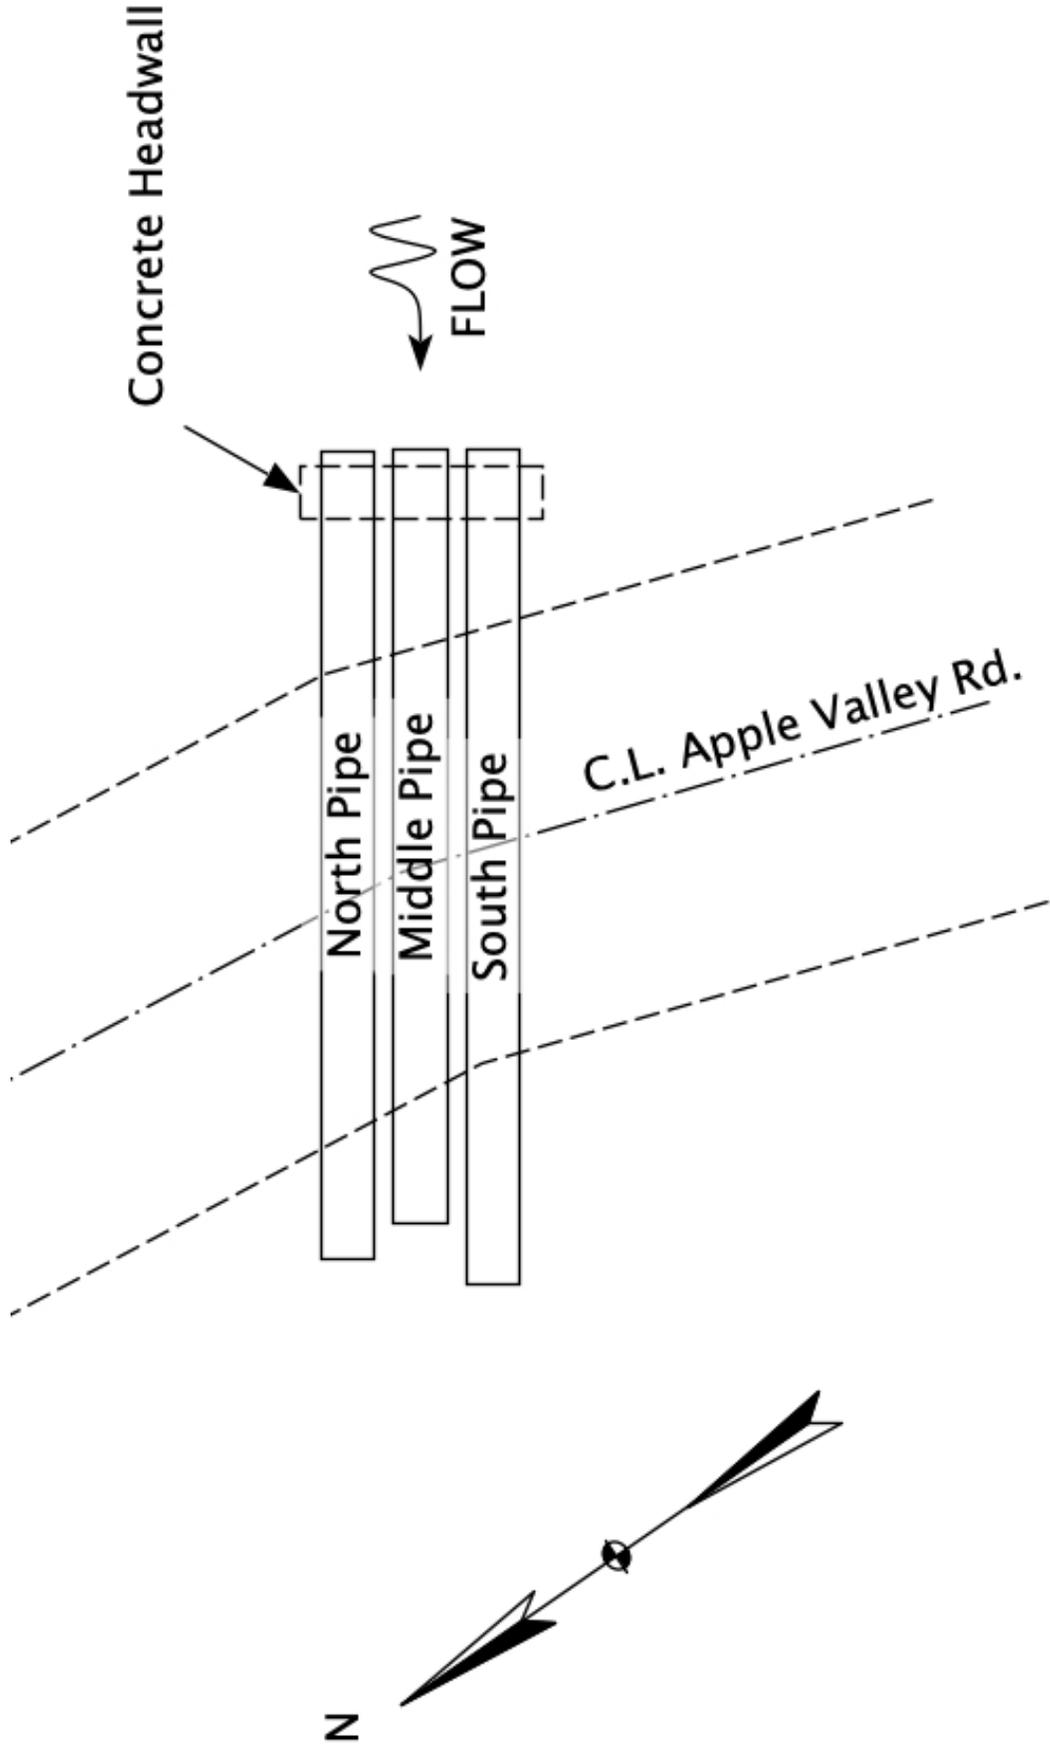
Sketch 1: Framing plan (temporary structure).

The new temporary culvert consists of three plastic pipes, supporting fill with a gravel wearing surface. Pipes are labeled north, middle and south. Report notes are taken from west to east, downstream to upstream, in accordance with the 2015 Bridge Inspection Handbook. **See Sketch 1 and Photos 1 – 7.**

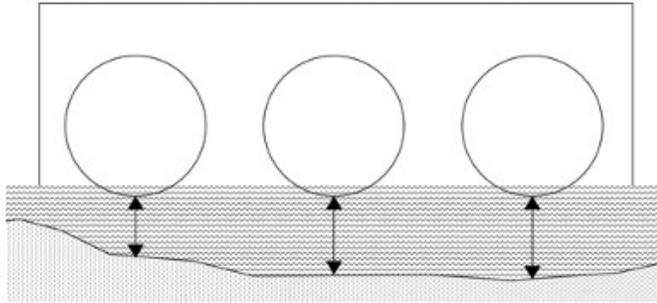
Chart 1: Channel profile readings.

For channel profile readings, refer to Chart 1.

Date	A13037 Channel Profile Readings (ft)											
	West End						East End					
	South		Middle		North		South		Middle		North	
	S	U	S	U	S	U	S	U	S	U	S	U
11/18/24	0.3	1.7	0	0	1.3	2.5	0.0	0.0	0.0	0.0	0.0	0.0

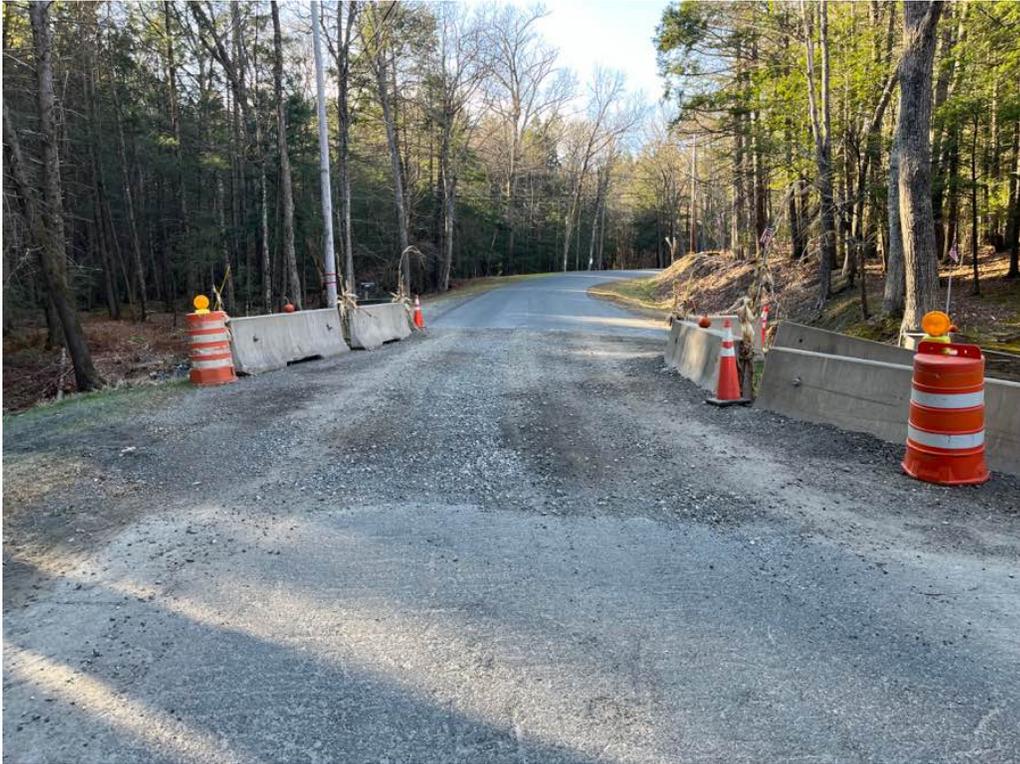
Photo 1: North approach.

The north approach has widespread moderate mapcracking and wear. **See Photo 1.**

There are no approach guardrail end devices in place. **See Photos 1 & 2.**

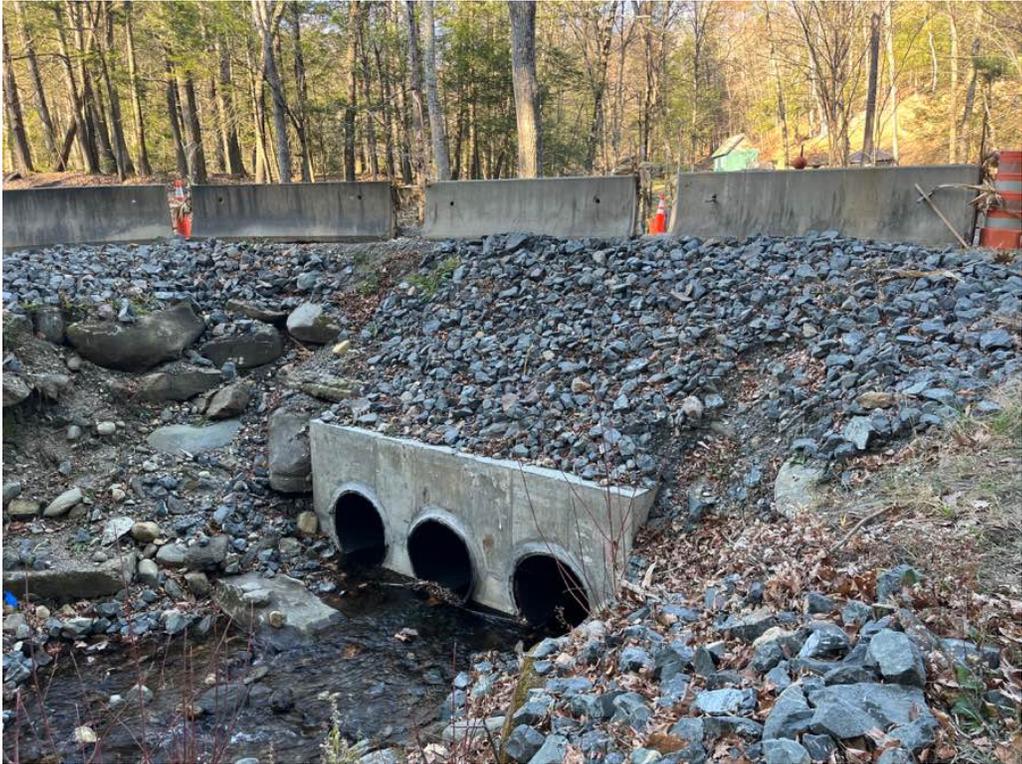
Photo 3: East elevation.

The east embankment has minor missing rip-rap. **See Photo 3.**

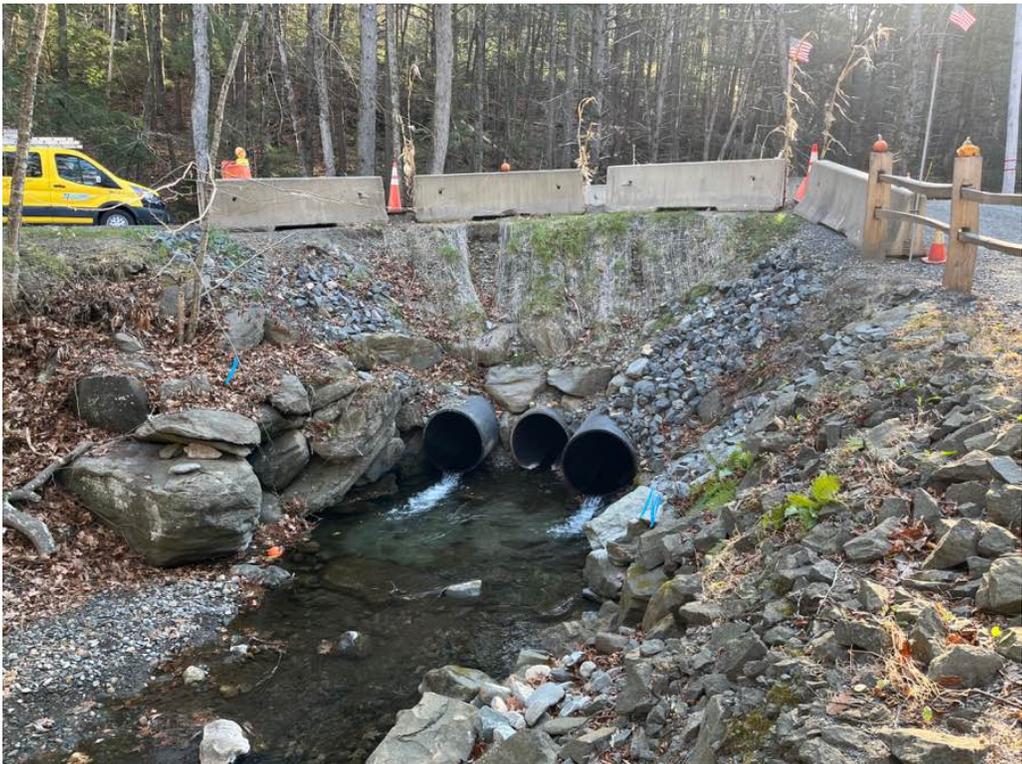
Photo 4: West elevation.

The west embankment has widespread missing rip-rap, with exposed geo-textile underlayment. **See Photo 4.**

At the downstream outfall, there is minor scouring of the channel. **See Photo 4.**
