STRUCTURES INSPECTION FIELD REPORT

ROUTINE INSPECTION

BR. DEPT. NO.  
A-13-023

Structure A-13-023 (OFL) carries Bullitt Road over the South River in the town of Ashfield (**Sketch 1**). The bridge is a single-span structure comprised of six (6) rolled-shaped steel beams (30WF108 per plans) with a Cast-in-Place concrete deck overlaid with an asphaltic wearing surface. The beams are designated as Beams 1 through 6 and the bays are designated as Bays 1 through 5 from west to east, upstream to downstream. The substructure consists of two (2) reinforced concrete abutments labeled South Abutment and North Abutment (**Sketch 2 and Photos 1 – 8**).

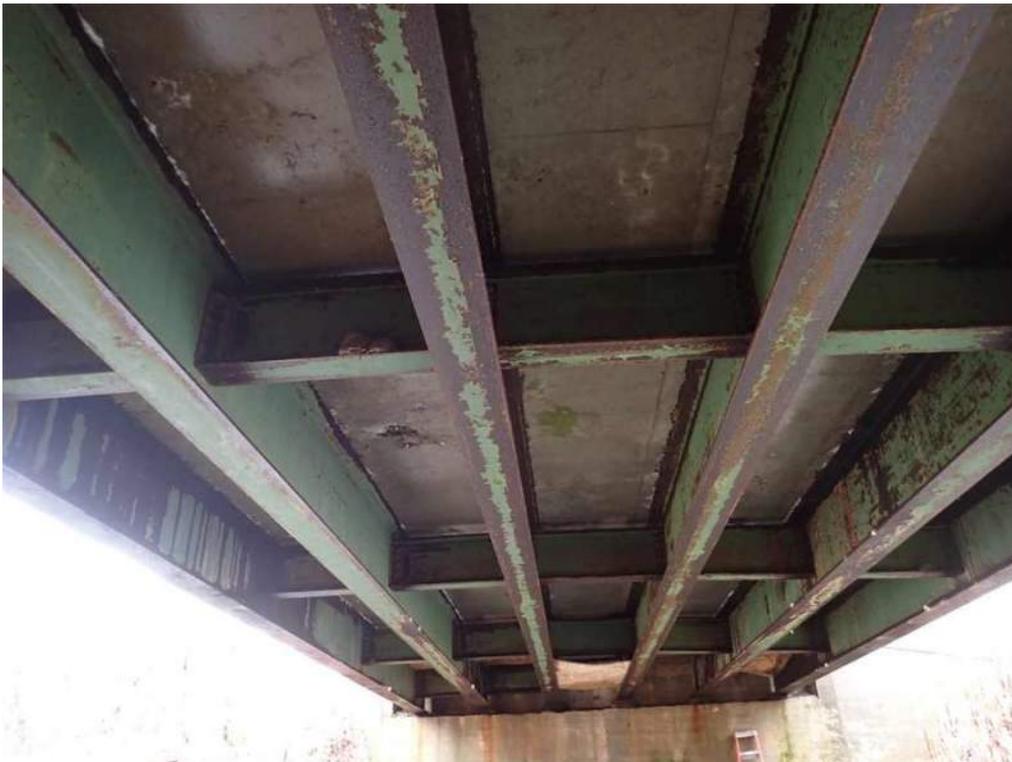
Photo 8: Typical Underside, looking north.

- Bay 2, between South Abutment and Diaphragm 2: 1'-0" long x 6" wide x 1" deep scale.
- Bay 2, between Diaphragm 2 and Diaphragm 3: 1'-4" diameter x up to 2" deep scale (**Photo 8**).

The paint system has failed throughout the entire superstructure (**Photos 8, 9, & 12-17**).
