STRUCTURES INSPECTION FIELD REPORT

ROUTINE INSPECTION

BR. DEPT. NO.
A-13-015

CITY/TOWN ASHFIELD	8-STRUCTURE NO. A13015-0FK-MUN-NBI	11-Kilo. POINT 000.000	41-STATUS P:POSTED	90-ROUTINE INSP. DATE MAR 21, 2025
07-FACILITY CARRIED HWY BELDNGVIL RD	MEMORIAL NAME/LOCAL NAME Br.No. 15 Leon Hall	27-YR BUILT 1940	106-YR REBUILT 0000	YR REHAB'D (NON 106) 0000
06-FEATURES INTERSECTED WATER BEAR RIVER	26-FUNCTIONAL CLASS Rural Local	DIST. BRIDGE INSPECTION ENGINEER <i>Michael P. McCabe</i> M. P.E. McCabe		
43-STRUCTURE TYPE 302 : Steel Stringer/Girder	22-OWNER Town Agency	21-MAINTAINER Town Agency	TEAM LEADER M. Estrada <i>Mark J. Estrada</i>	PROJ MGR Michael Baker Intl Inc <i>[Signature]</i>
107-DECK TYPE 1 : Concrete Cast-in-Place	WEATHER Cloudy	TEMP. (air) 2°C	TEAM MEMBERS R. YOUSSEF

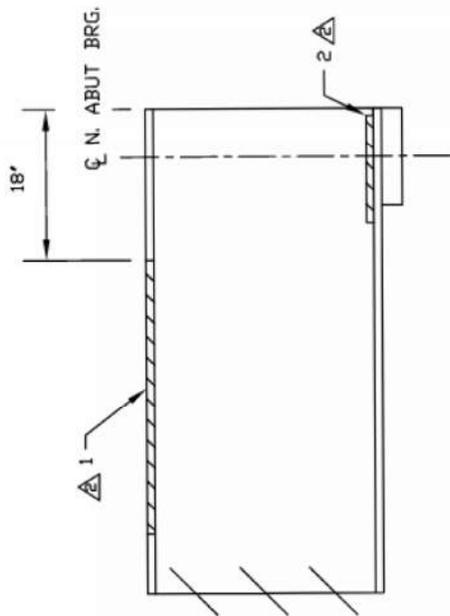
**BEAM 4 AT NORTH ABUTMENT
EAST ELEVATION
(N.T.S.)**

DEFECTS (NOTE, MEASURED AT EAST ELEVATION UNLESS OTHERWISE NOTED):

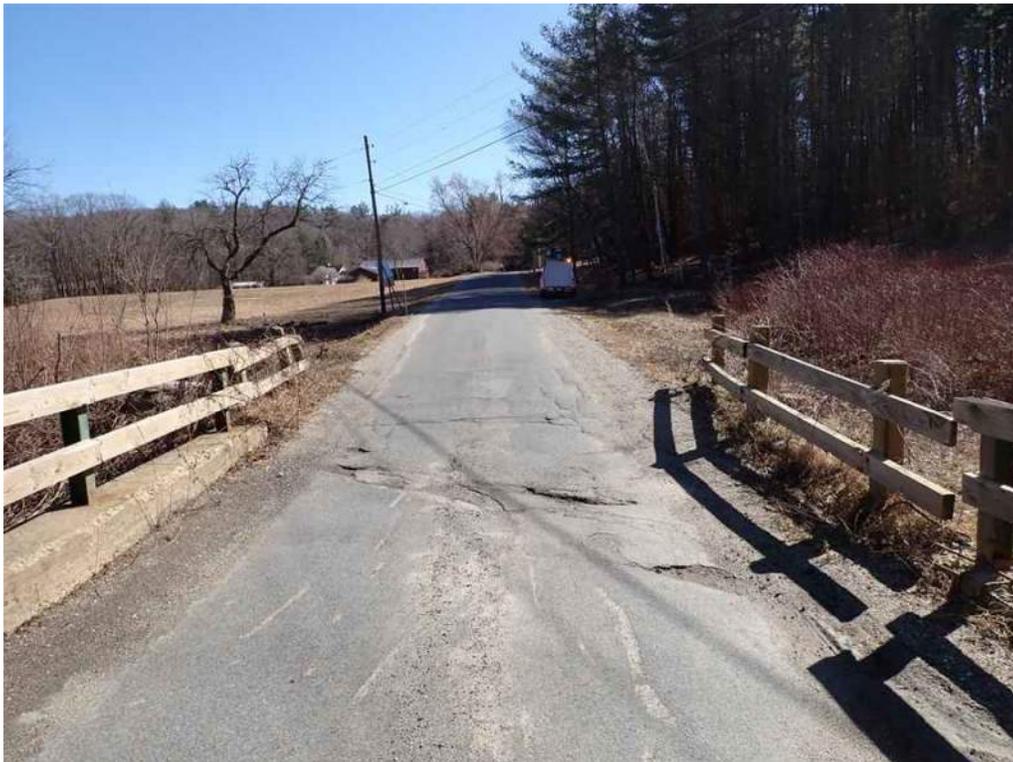
Photo 4: South Approach from bridge, looking south.

The remaining approach guardrails end in the transition area (**Photos 4 & 6**).

The remaining approaches have no guardrail ends in place (**Photos 4 & 6**).

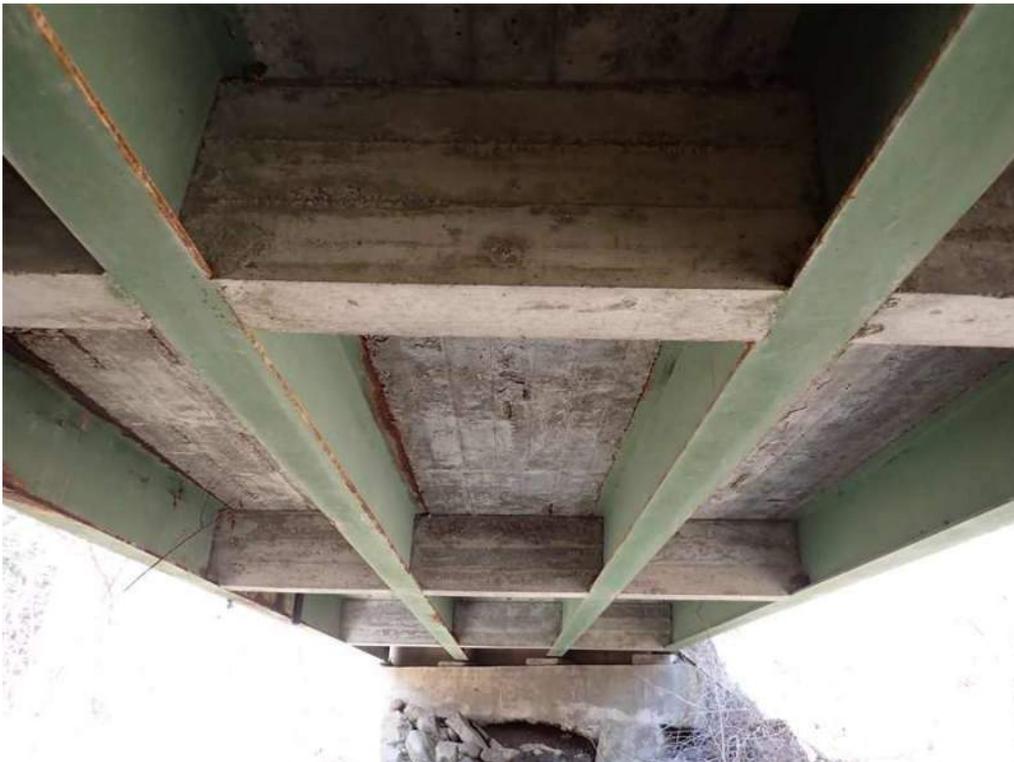
Photo 8: Typical Underside, looking north.

At Beam 4, below the drain pipes and at the south end, the paint has failed (**Photos 14 & 15**). At the remainder of the structure, the paint is chalky with areas of light rust (**Photo 8**).

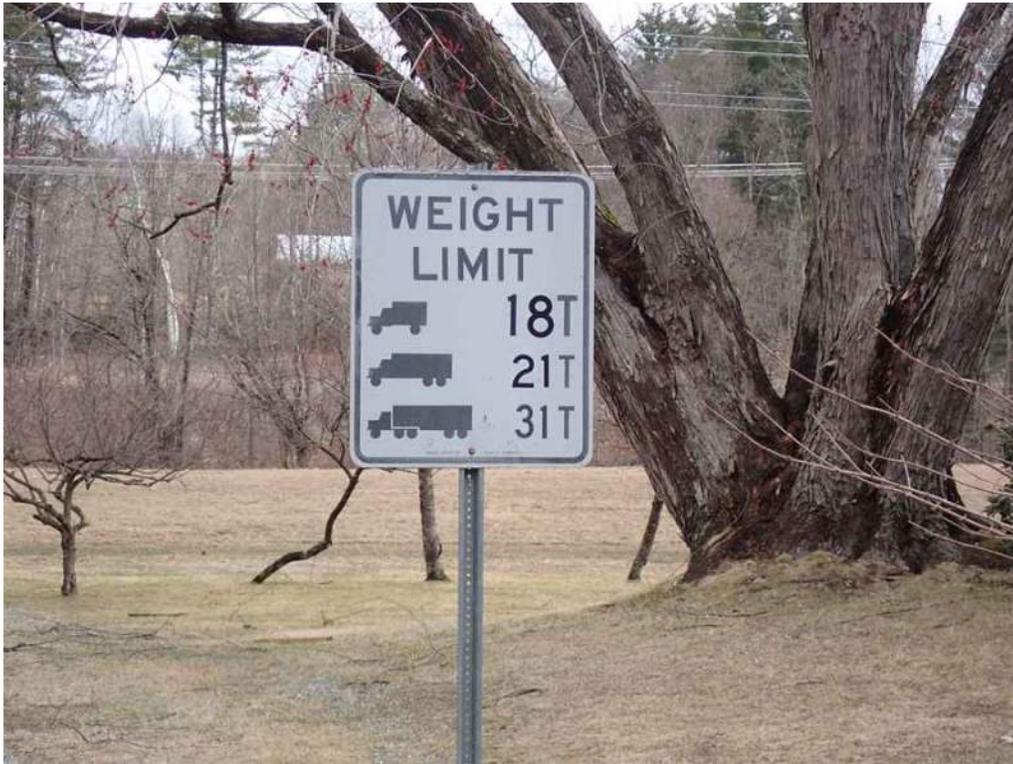
Photo 9: South Approach Advanced weight posting sign, looking north.

The bridge has two (2) At-Bridge and two (2) Advanced weight posting signs posted for 18 tons on two axles, 21 tons on three axles, and 33 tons on five axles, with the exception of the Advanced weight posting sign at the South Approach, which is incorrectly posted as 18 tons on two axles, 21 tons on three axles, and 31 tons on five axles (**Photo 9**). The At-Bridge weight posting sign at the South Approach is tilted to the east away from the roadway (**Photo 10**).
